**An Archaeological Interpretative Survey of  
Old Nevergood Farmhouse, Brick Kiln Lane,  
Horsmonden, Kent**

**Project Ref. 2518**

**Commissioned by Richard Meadley Associates  
on behalf of Mr and Mrs N Woodford**

**by  
David Martin FSA IHBC MIFA & Barbara Martin AIFA**

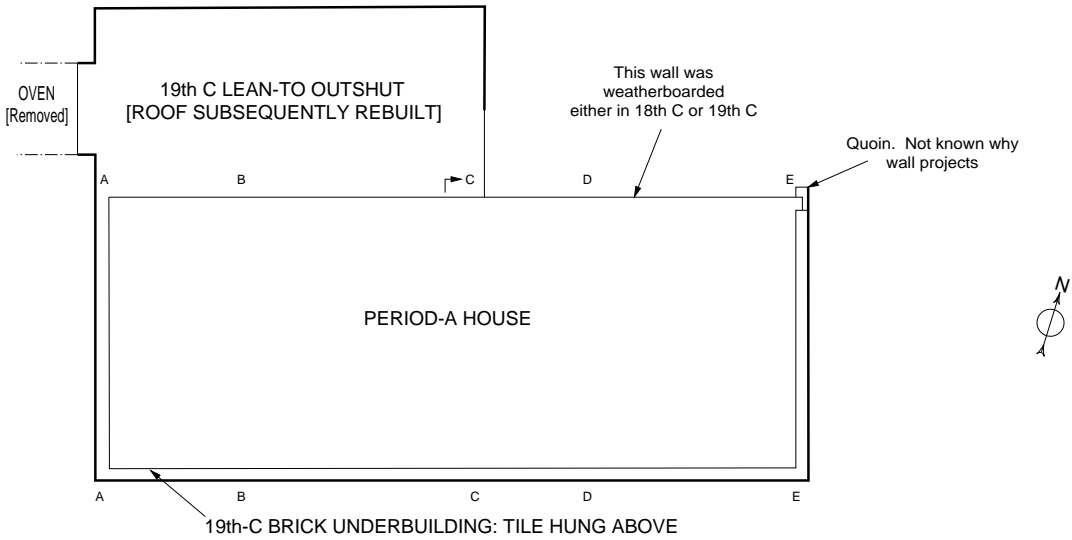
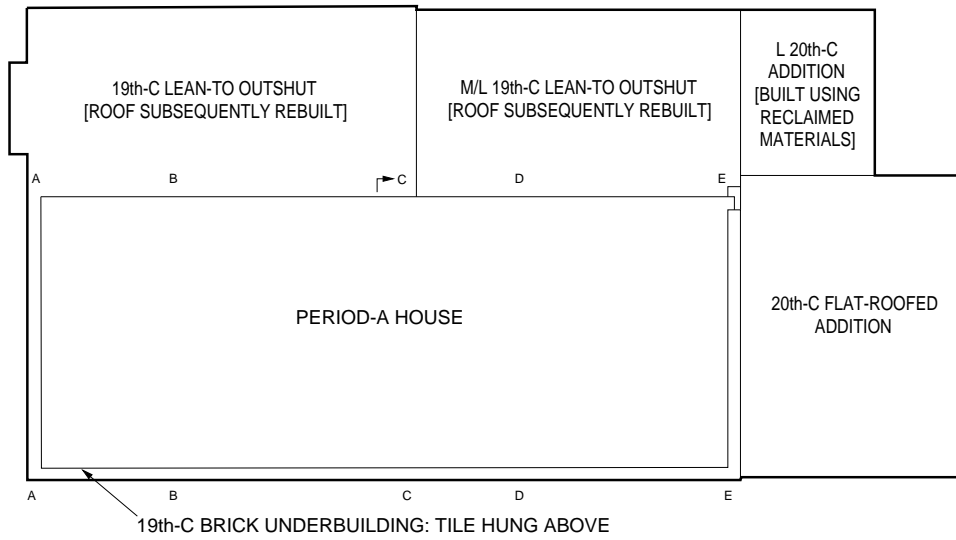
This is a four-bay timber-framed house built to a textbook three-unit plan in the years around 1600 [**Period A**]. It is constructed to a high standard, with close studding within its rear elevation. Its front elevation may once have been more elaborately finished than it now is. The roof is steeply pitched, with half-hipped terminals. Despite having been reduced in height slightly, the axial chimney is dominant.

Only minor alterations were made to the building during the 17th and 18th centuries [**Period B**]. Although the general external shape has remained unaltered, it was in the early/mid 19th century [**Period C**] that the building took on its present appearance. The ground-floor walls were underbuilt in brick and the first-floor walls tile-hung. The western half of the rear lean-to outshut also belongs to this period: the eastern half was added later.

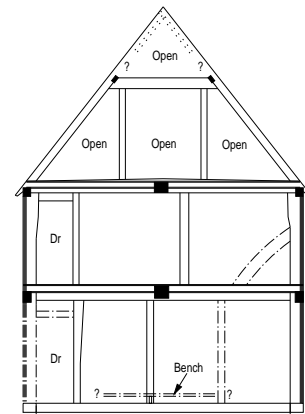
TRUSS B-B FROM EAST

Of the three internal partitions the most straightforward is truss B-B, which divides the western end bay from the hall. This wall's original arrangement is today somewhat disguised by later alterations and modern intruded timbers, but is fully recoverable. Its original form is shown in Drawing No. 2, Truss B-B. On the ground floor the wall had a doorway at its southern end, with the remaining part divided into three panels by studs. Within the 'central' stud is a small round-ended mortice at the base. This is evidence for a former fixed bench running along the wall. In the reverse (western) face of the two surviving studs within this section of wall are a series of large-diameter peg holes, indicating the positions of former shelves within the western service room. On the first floor too there was a doorway at the southern end, but in this instance the remainder of the wall was divided into two large panels by a single stud, whilst against the rear principal post was a footbrace (now removed, but evidenced by peg holes and a mortice in the principal post and by an assembly mark visible in the crossbeam).

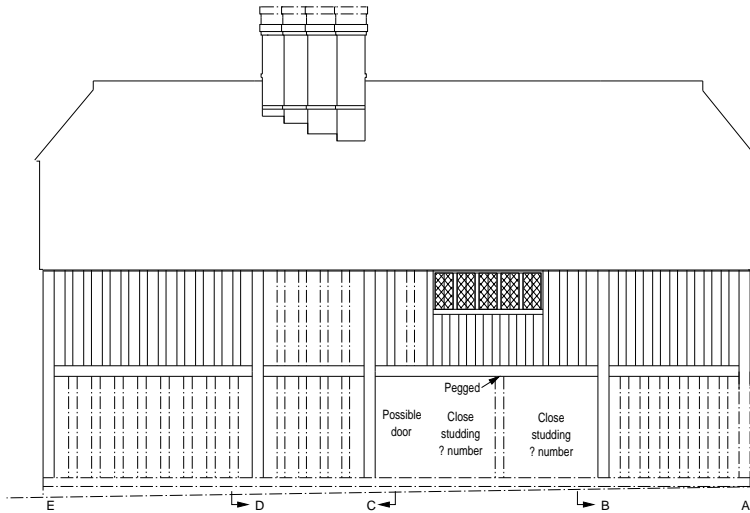
NORTH ELEVATION

Only within the period-A rear wall (now internal) can details of the original infill framing be seen. This framing was entirely of close studding which, although now exposed to view within both wall faces, was originally intended to be masked by lath and daub on the interior. Even within this section of wall some of the studs have been totally removed, whilst many of the others represent replacements inserted when the house was renovated in the mid/late 20th century - some of the replacements are not into the original mortices, and thus the pattern of studwork does not in all cases precisely replicate the original design. All of the studs which remain from the original build show nail holes and lath stains on their internal surface, indicating where the original daub has been removed - these studs are shown in solid outline in the reconstructed North Elevation in Drawing No. 3: those which have been replaced or removed are indicated in chain-dotted outline.

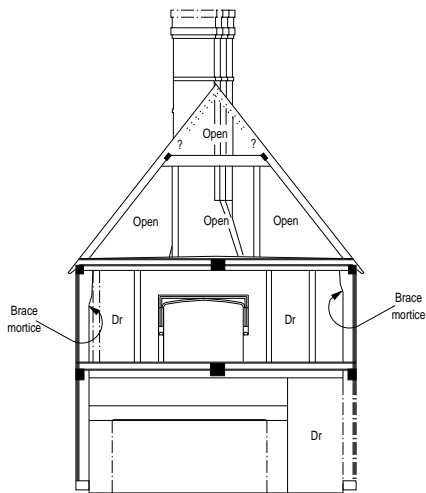
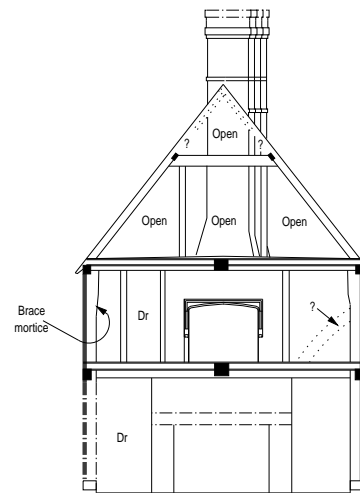
As with the rear wall of the house, trusses C-C and D-D (flanking the chimney bay) present problems of interpretation at first-floor level. There are no such problems on the ground floor, where the fireplaces taking up most of the space, with a lobby doorway to one side. On the first floor the carpenter incorporated doorways into truss C-C on either side of the fireplace, but, curiously, mortices in both principal posts indicate that footbraces were also intended. These could not have been fitted without fouling the positions of the doorways and must either have been cut in error or the design of the truss was changed radically during fabrication, though it is difficult to see how. The mortices do not seem to be explained by the use of secondhand material, unless the timbers were rejects from a previous frame of similar date. The principal posts of truss D-D also contain mortices for footbraces, though in this instance there was only one doorway and thus the brace to the north of the chimney could have been fitted. Here too there is now a doorway, but it represents a later insertion.

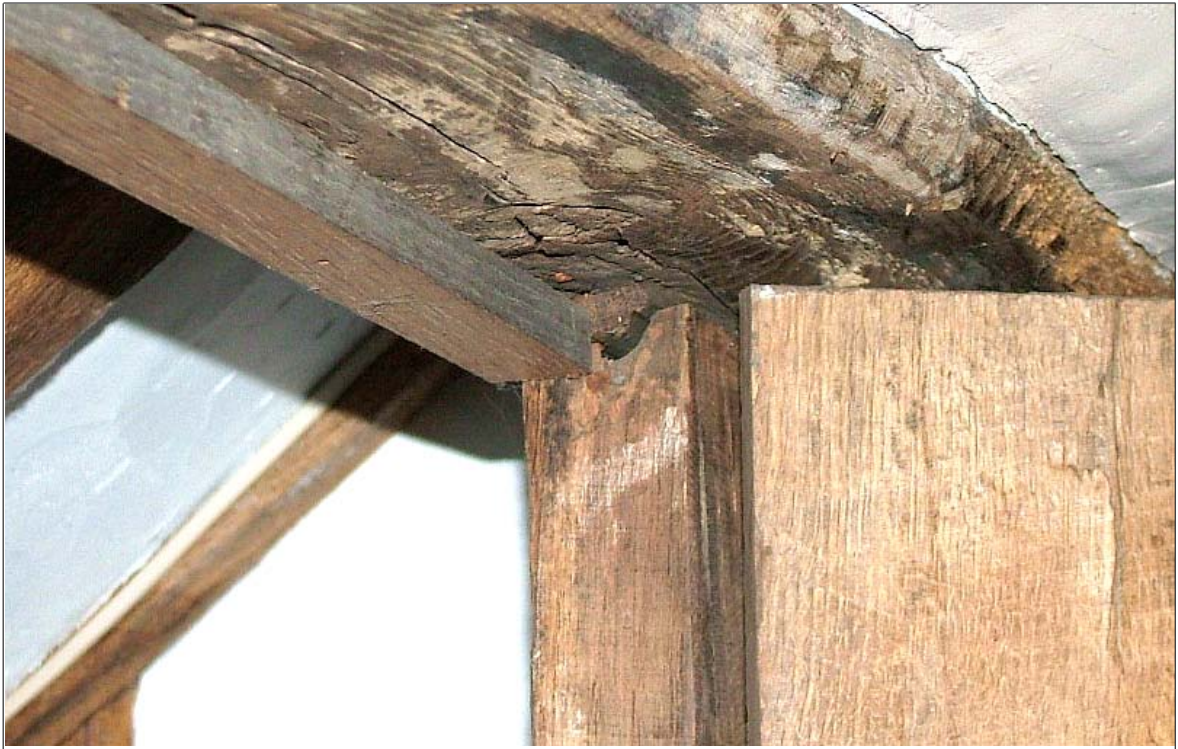
Plate 1

There is an interesting and curious variation in the way the original close studs within the north elevation were fixed into position. Within the service bay, chimney bay, parlour bay and on the ground-floor within the hall bay the close studs are/were fixed into mortices at their head in the usual fashion. In contrast, within the first-floor section of the hall bay the close studding is held in position by notching the heads of the studs around short, thin timbers nailed to the underside of the wallplate (a procedure known as 'cogging') [Plate 1]. Whereas the jointed-in sections of studwork had to be fitted into position during the primary erection of the frame, this notched-in section of studwork would have been inserted once the frame was fully erected. This curious fixing method is by no means unique, but is normally used to carry out alterations which entailed inserting timbers into the building at a later date. Not all the studs within this section of wall are fixed in this way. Two studs are jointed into pegged mortices in the usual manner. These two studs are thicker than the others within the wall and would always have been visible (rather than masked by daub) internally: they form the side jambs of a window. The eastern jamb is fitted into an exceptionally long mortice, with the stud positioned hard against the western shoulder and the remainder of the mortice unused. Significantly, the peg securing the joint is positioned to suit the present alignment of the stud.

Detail of 'cogged' joint at head of a close stud (now utilized as the jamb to a modern doorway) in the north wall of the hall chamber. The other joints in this immediate area are similar.

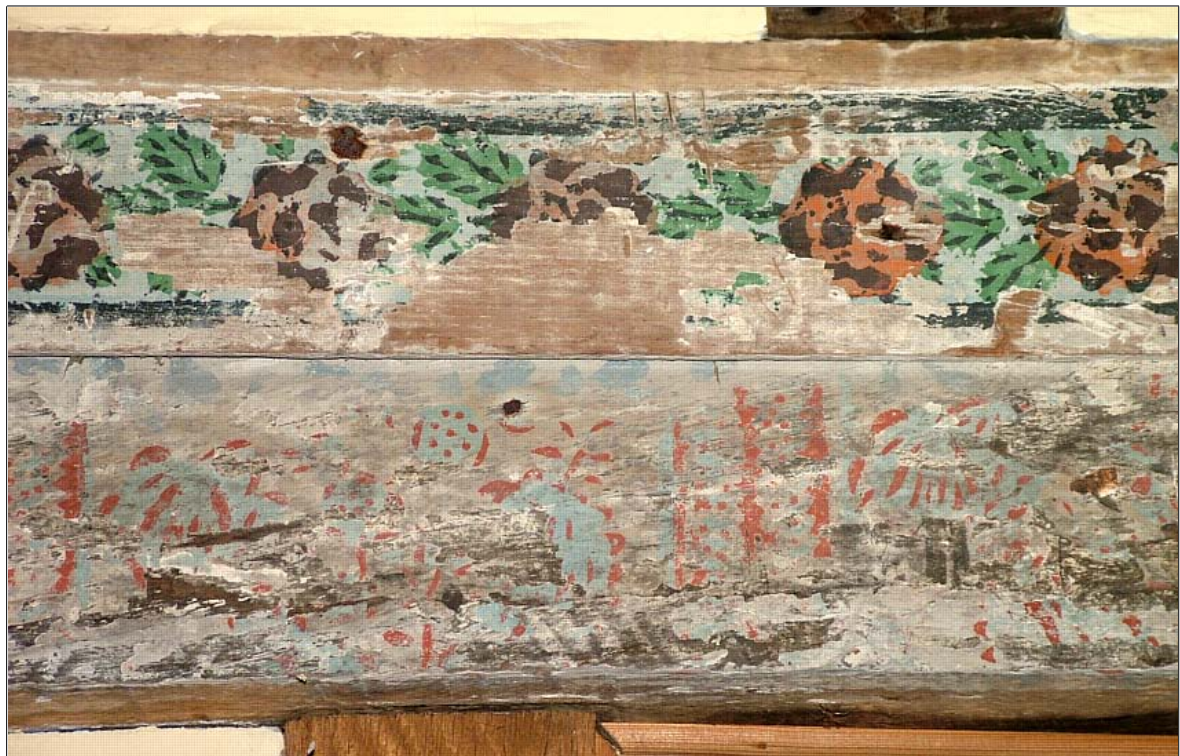
Plate 2

If the underplastered ceilings within the principal rooms were not an original feature, they were introduced in antiquity. In addition to the fixings on the joists, the ceiling within the parlour is evidenced by the stains left by it on an ancient timber cleat fixed to the side girt of the rear wall - the cleat has been applied beneath the joists as additional support for the joist ends. Also visible is the evidence for the skim-coated daub wall infill (since stripped back) which masked the internal face of the close studs within this area (studs since replaced). On the face of the side girt and cleat are the remains of a stencilled, painted scheme, indicating that this room was once colourfully decorated [see Plate 2]. However, the style of this decoration suggests that the scheme was not added until the early 19th century, probably when the brick underbuilding was undertaken [For a similar scheme of c1840 see James Ayres, *The Home in Britain; Decoration, Design and Construction of Vernacular Interiors, 1500-1850* (Faber and Faber 1981), p179]. Evidence of such schemes are rare locally.

Remains of stencilled decorative scheme within parlour.
