**An Archaeological Interpretative Survey of
Barn at Randall's Farm, Westfield, East Sussex**

**Commissioned by C L M Planning on behalf of
Mr S McKimmie**

Project Reference. 2566

REPORT NO. 1635

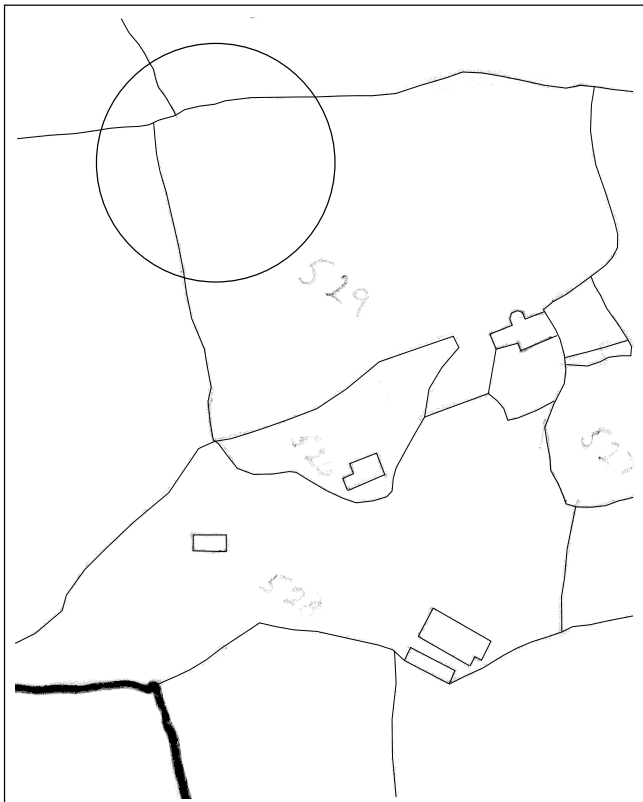
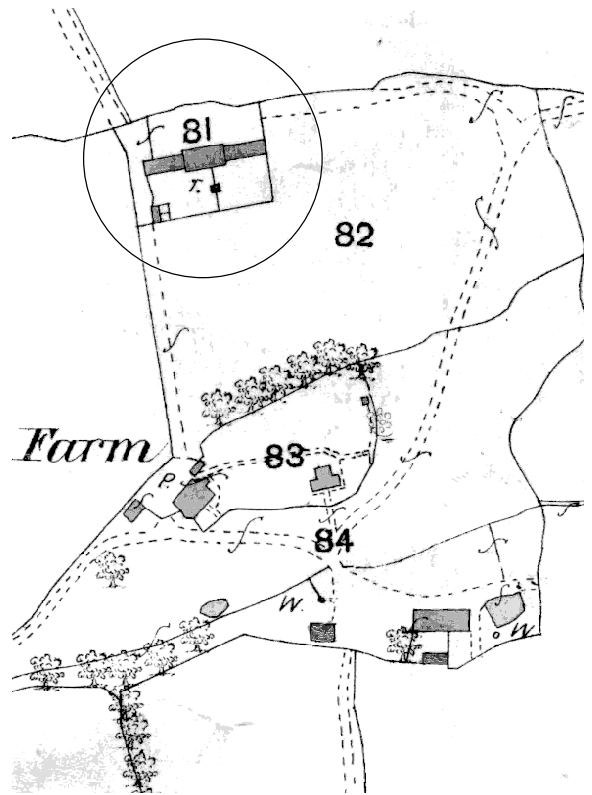
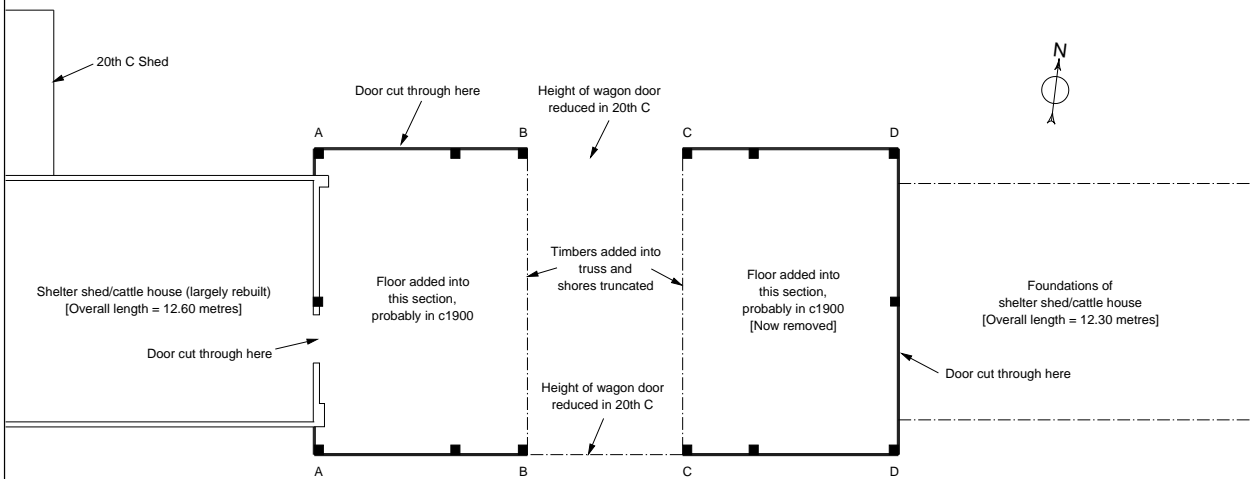
Drawing No. **1635/01**

The frame of this three-bay barn was fabricated in the late 18th century [**Period A**] and was initially erected upon a site now unknown. At this stage it had a traditional hipped roof and seems to have been intended to be freestanding, otherwise it was very much as it exists today.

Evidently it fell redundant in its initial location, for between 1841 and 1873 [**Period B**] the frame was carefully taken down, repaired, and re-erected on its present site, close to the northern boundary of a south-facing 2¾ acre field of pasture, shown as plot 529 on the 1841 Westfield Tithe Map. At that date the combined farm of Randall's and Woodhouse was owned by Rev. George Augustus Lamb and was tenanted by George Bishop. It totalled 130 acres. The farmhouse stood where it does today (on plot 526) with a barn and yard on plot 527, on what is now open farmland to the north east of the house [East Sussex Record Office TDE 154 - for an extract *see* Drawing No. 1635/1]. When the present replacement farmyard was formed in *c*1855 the barn which is the subject of this report was re-erected upon its present south-facing slope, aligned east-west along the contour. It retained its original internal layout: that is, an open crop storage bay on either side of a central midstrey. However, the earlier building was fitted with new wallplates and a new gabled roof set to a more shallow pitch. Given that the remainder of the frame was retained, this suggests that the original roof had become defective, perhaps due to lack of maintenance to its roof coverings. In its new setting the barn was flanked by two long, low shelter sheds or cattle houses, making a bold statement when viewed across the valley from the south.

It was probably around 1900 [**Period C**] that the barn was adapted by the insertion of first floors in order to form a granary within the western end. The apparent inserted first floor within the eastern bay has since been removed.

In the early 20th century a single-storeyed shed with a lean-to roof was added against part of the western shelter shed's northern wall, and major repairs were made to this western annex. As in so many working farms, large new farm buildings of modern design were erected to the south and east of the original traditional complex, largely hiding it from view, despite its elevated location. By 2006 the barn had become totally redundant, the

attached eastern shelter shed had fallen down, as had the western end of the western shed.

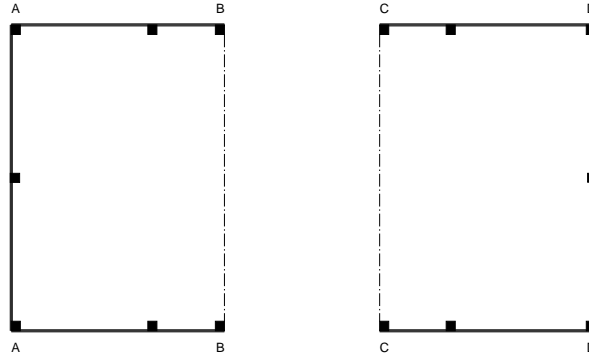
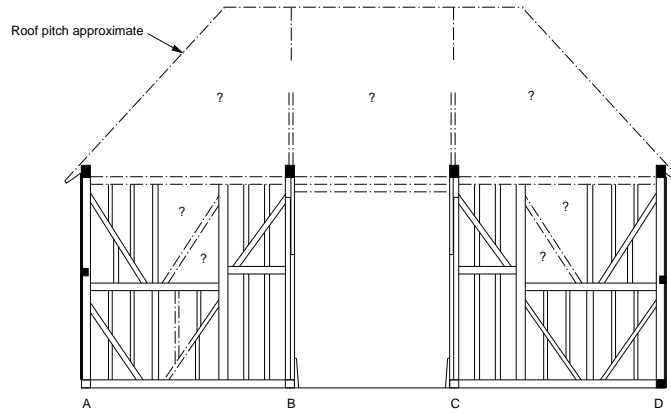
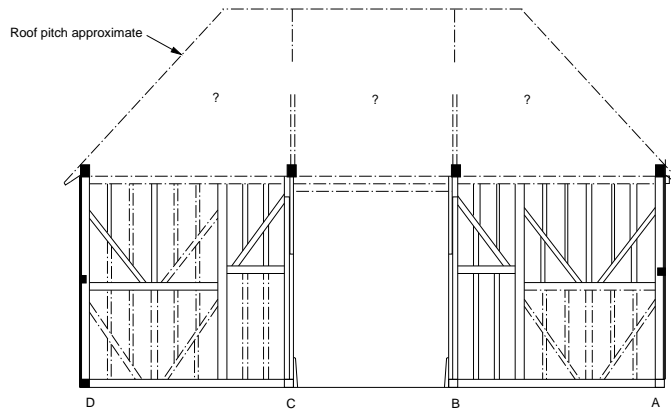
Drawing No. **1635/02**

When first constructed the barn comprised three bays in length and, internally, was open throughout its length and height. Measuring 11.60 metres x 6.05 metres (38'0" x 19'10") overall, it is of slightly above average size for a three-bay barn but, in common with most such buildings within the High Weald, it is small in comparison to the barns of many other regions. The proportions were changed during period B when the structure was re-roofed to a lower pitch, but it is, nonetheless a relatively lofty building with walls which measure 4.20 metres (13'9") from underside of soleplate to top of wallplate.

Both end bays are of equal size: they were designed for crop storage, at that time having been absent of upper floors. The central bay - the midstrey or wagon way - had full-height doors in both long elevations and was designed to house the threshing floor.

The main frame utilizes standard traditional timber-framed techniques of construction, having jowled principal posts which support the wallplates and tiebeams in normal assembly throughout. The jowls are heavy and exceptionally long, with rounded bowls typical of 18th-century work. Both the side and end walls of the two end bays are

subdivided in their length by full-height intermediate posts, those in the side walls being incorporated at one-third distance along each bay in order to best suit the wall design. The level of the side girts and cross beams is staggered on either side of these posts so as not to weaken them at the joints - this too is a feature which represents an 18th-century innovation (*see* Drawing Nos. 1635/2 and 3).

Unlike in earlier timber frames, the infill framing itself utilizes regularly-spaced studs spaced relatively closely so as to support the weatherboard cladding. Such techniques became increasingly common as the 18th century progressed and by the end of the century the studs were often nailed into the frame after the principal timbers had been erected. In this instance they are traditionally morticed and tenoned into position - all, that is, except the joints to the replacement period-B wallplates, which are nailed (*see* Period B). A full compliment of raking struts are included within the walls at both the upper and lower levels, fully triangulating the structure against racking. As is usual, these interrupt the studs, which at this point are angle-cut and nailed to them. In the original scheme the struts were morticed and tenoned into position and had pegged joints (but *see* Period B below).

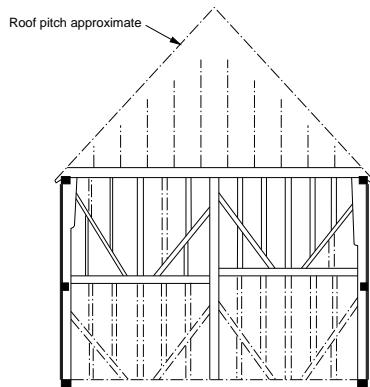
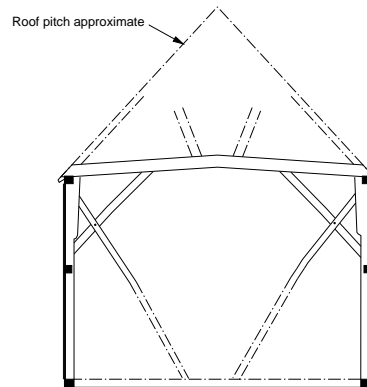
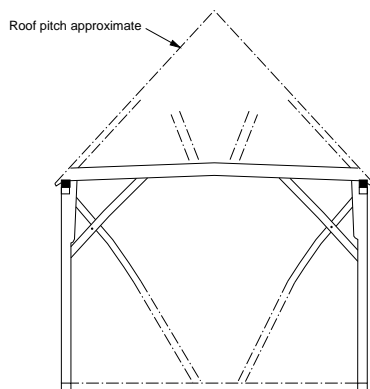
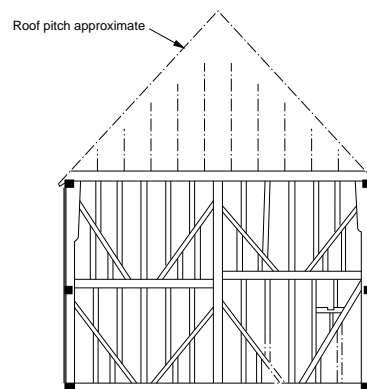
Drawing No. **1635/03**

Both internal trusses (B-B and CC) have cambered tiebeams and combine the use of arch braces and long down-going shores as an original feature. The virtually straight arch braces triangulate from the principal posts to the tiebeam and, as is usually the case, these are faced up towards the wagon way face of the trusses, whereas the long down-going raking shores are faced up towards the reverse side, allowing the two to pass. The arch braces and the raking shores are face pegged together where they cross, giving extra triangulation against racking. Unusually for this period there is no mortice evidence in the internal faces of the principal posts to indicate that the trusses incorporated dwarf boarded walls flanking the threshing floor and encapsulating the bottoms of the raking shores. However, in the early use of down-going shores sometimes the dwarf walls were only fitted between the feet of the shores and did not cross the full width of the barn, allowing access on either side. As the feet of the shores were removed during Period C, this point cannot be confirmed.

In many 18th-century (and, indeed, mid/late 17th-century) fully-hipped roofs the bay divisions do not coincide with the bay divisions of the main frame below. However, in this instance pegged mortices in the top face of the two internal tiebeams (trusses B-B and C-C) indicate that proper traditional roof trusses were supported by the tiebeams. The mortices in the ends of the two tiebeams carried the feet of the principal rafters, whilst those towards the centre show that the trusses incorporated raking struts. Whether these struts supported clasped side purlins or rose to principal rafters which in turn carried butt purlins is impossible to know - the former is by far the more common arrangement locally.

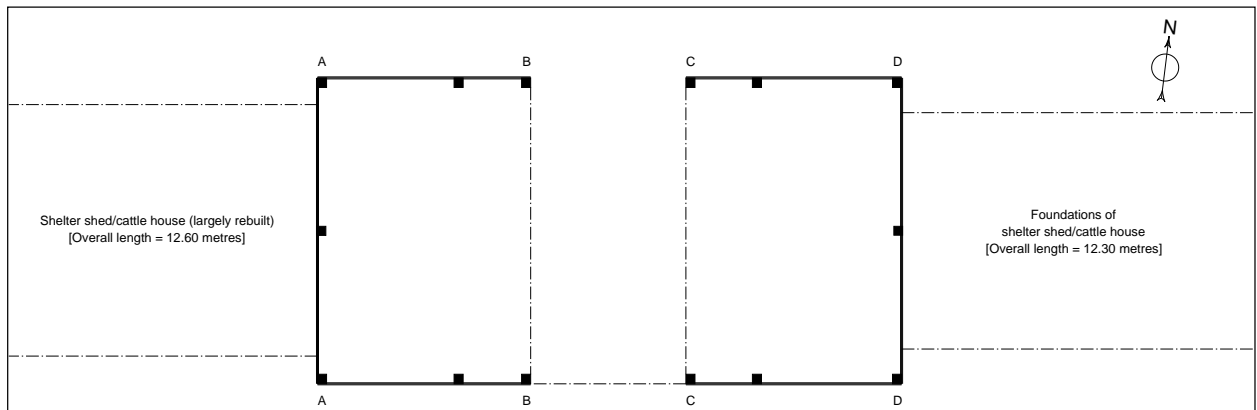
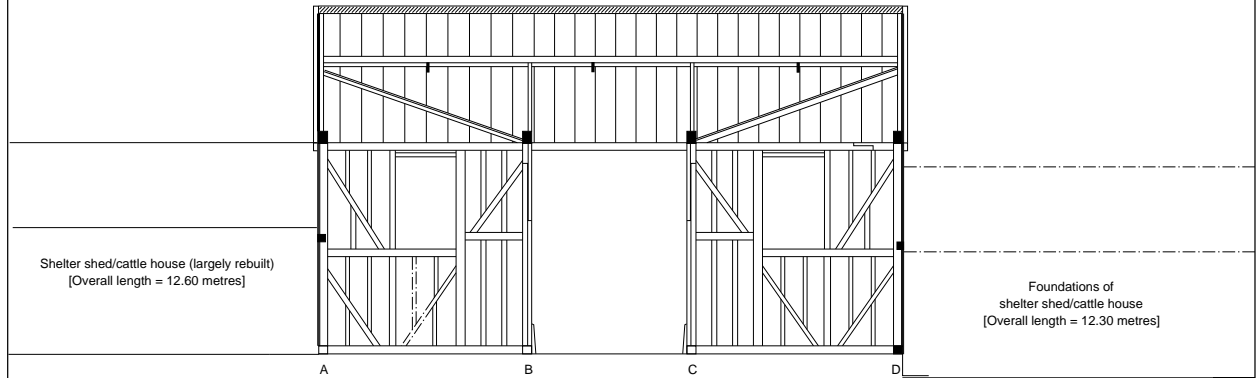
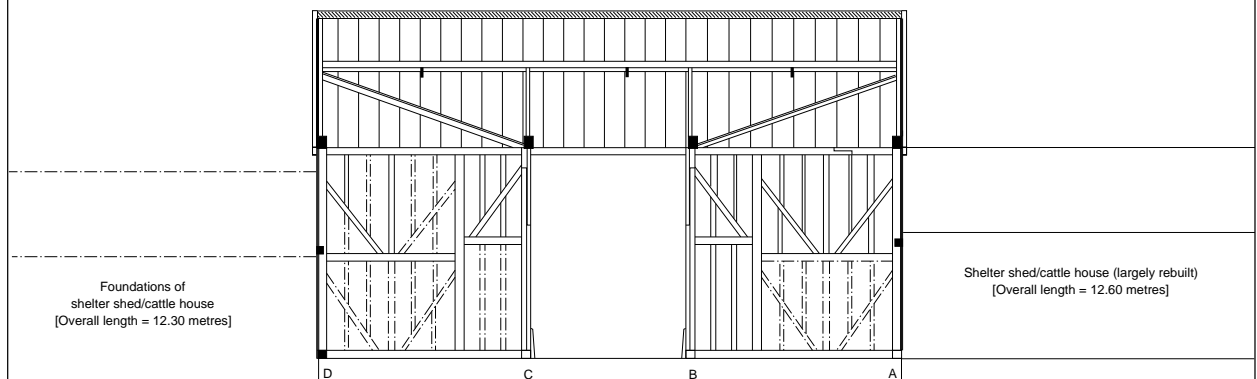
Drawing No. **1635/04**

When the frame of the barn was taken down care was taken not to damage the component parts - the erection marks indicate that this was not a case of demolition with the intention of reusing the timbers *ad hoc*, but dismantling for re-erection in its original form. Given this observation, it is somewhat surprising to note that all the tenons on the raking struts were cut through, instead of the pegs being withdrawn and the joints taken apart as elsewhere in the building. Both the pegs and sawn-off tenons were left *in situ* and, when re-erected, the struts were merely nailed into position against the sawn-off tenons. It can only be assumed that the carpenters did not regard the time taken to dis-assemble these joints to be warranted, and certainly by this date it was usual practice to nail struts and studs into position. In fact, because they were defective the barn required new wallplates and here too the heads of the regularly-spaced studs were likewise nailed into position against the new plates, despite the existing joints having been reused elsewhere. Only the principal posts and intermediate posts were secured to the new plates by means of mortice-and-tenon joints, and even in these instances the timbers were not pegged into position, but

The wallplates excepted, the only recognizable alteration to the framing was the inclusion of two doorways or 'pitching hatches' within the upper part of the two end bays in the north elevation. In order to accommodate these, in each case a panel of studwork was omitted, as too was the raking strut. The former raking strut is evidenced by its pegged mortices. It can be certain that the hatches were not inserted later, during period C, because there are no nail holes in the soffit of the wallplate above either hatch to indicate removed studs. All other timbers within the frame were re-positioned into their original mortices, reusing the original assemblage. No period-B alterations are detectable within the open trusses.

As reconstructed, the barn was set on English-bonded brick ground walls. Because of the slope on the site the ground wall on the southern side is *c*1.50 metres (5'0") tall, and here the ten courses of brickwork rise above a sandstone base.

When the frame was re-erected the wagon doors in both the north and south elevations were retained as full height openings, but the 'under-plates' was not reinstated - instead the mortices for these plates were left empty. Nailed to the inner faces of the principal posts (door jambs) are slides for lift boards. All four slides remain in position. As their name implies, they were used to accommodate removable boards which were dropped into position at the base of the openings in order to prevent grain from bouncing out when threshing was taking place and to discourage both wild and farmyard animals from entering the building.

As noted under 'Wall Design and Open trusses', two high-level doorways or pitching hatches were incorporated into the north wall of both end bays when the frame was erected. Both have separate nailed-in timbers forming their heads, just below the wallplate. As initially installed their cills were formed by the side girts, though new cills at a higher level were fitted later (*see* Period C). No other doorways were incorporated at this date.

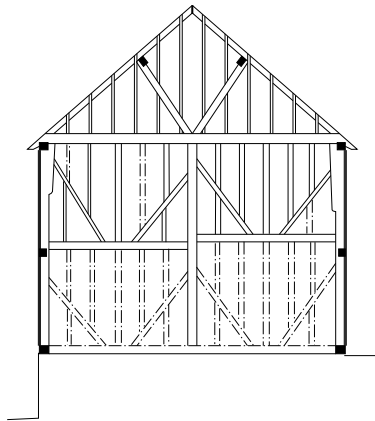
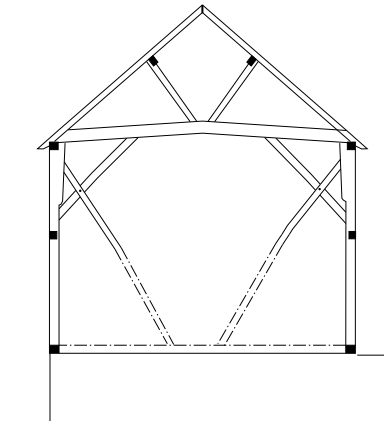
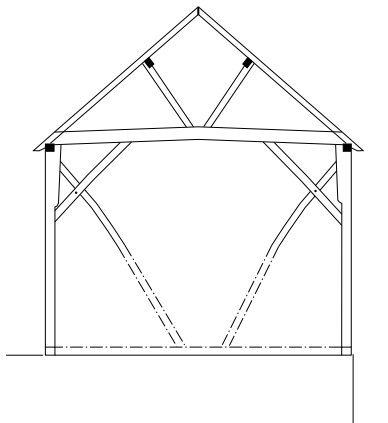
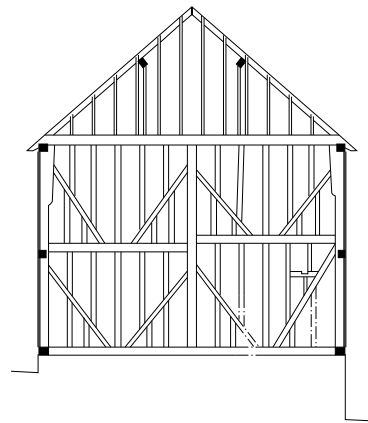
Drawing No. **1635/05**

Pitched off of new (Period B) wallplates of the same heavy cross section as the originals, the roof is of cut-and-pitched type with the rafters merely nailed to the top face of the wallplates (rather than fitted into traditional birdsmouths) and likewise nailed to the continuous ridgeboard at the apex. Both wallplates have halved-and-table-pegged scarf joints towards their end - the joint in the north wallplate is at the eastern end whilst that in the southern plate is towards the western end.

As reconstructed at this date, the roof is of relatively shallow pitch, fully gabled, and covered with imported (presumed Welsh) slates. It is of clasped-side-purlin type, the side purlins being carried by raking struts over the two internal tiebeams and by three nailed-in intermediate collars. Rising diagonally from the tiebeams, up the internal face of the rafters within the eastern and western bays are plank windbraces which are nailed to each rafter in order to prevent the roof from racking. The gables are infilled using regularly spaced thin studwork which are nailed to the tiebeam at the base and notched-and-nailed around the rafters at the head. Within the western gable a pair of struts rise past the internal face of the studs in order to support the ends of the purlins, but for some uncertain reason there are none within the eastern gable - instead additional studs are incorporated for this purpose.
