**An Archaeological Interpretative Survey
of
Farm Buildings at Colbrans,
Laughton, East Sussex**

Project Ref. 2945

REPORT NO. 1660

LAUGHTON - FARM BUILDINGS AT COLBRANS

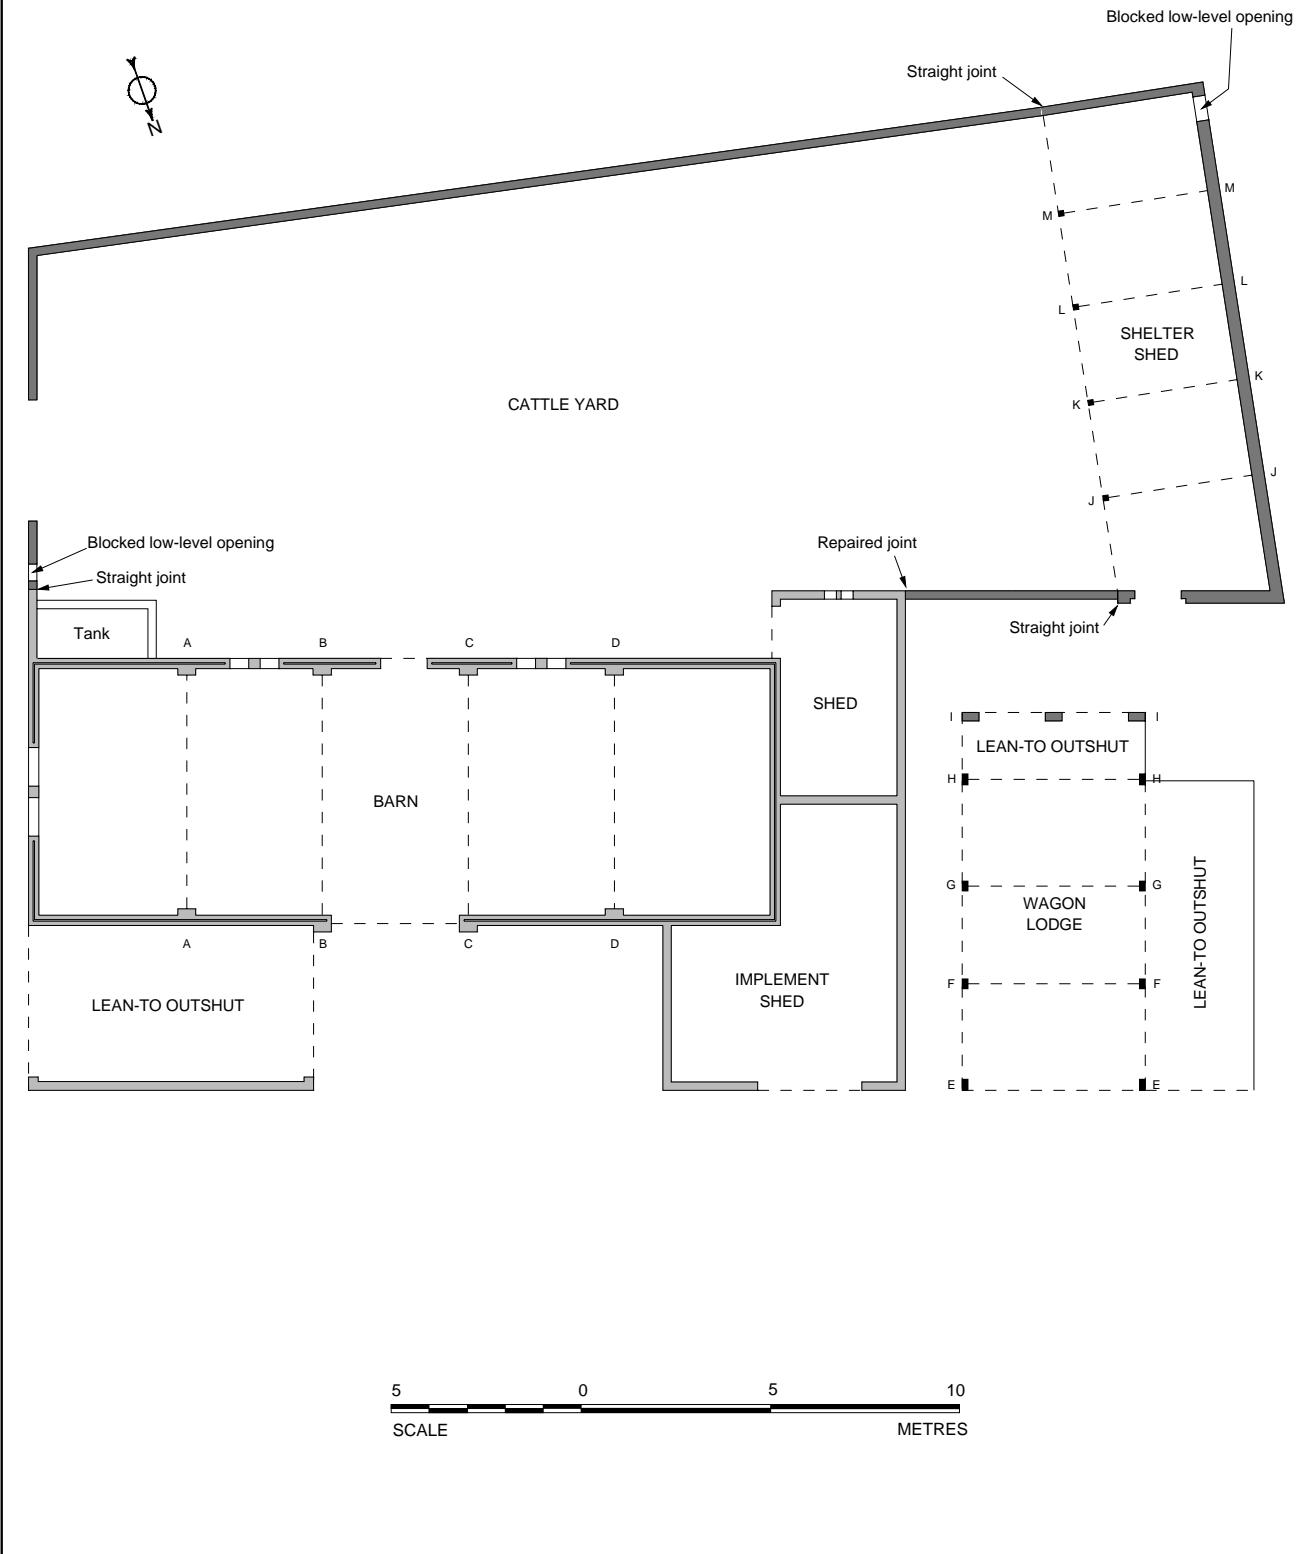
FARM BUILDINGS AT COLBRANS, LAUGHTON, EAST SUSSEX OUTLINE PLAN OF BARN, WAGON LODGE, SHELTER SHED AND YARD				Site Ref	P87/04
				Drawing No.	1660/2
Drawn By	D Martin	Revision No	-	Date of original survey	2007
				Date of this revision	2007

Reused within the barn, tying the wallplates at the bay divisions marked A-A, B-B, C-C and D-D in Drawing No. 1660/2, are the four secondhand tiebeams referred to earlier, probably reused from the building's predecessor. Three of these tiebeams (A-A, B-B and D-D) indicate that the main body of the building from which they originated was of similar width to the present structure. The fourth tiebeam (C-C) has an extra redundant headbrace mortice at one end indicating that it has been reused at least twice, the initial use being from a wider structure.

Because the tiebeams contain mortice information which may be relevant to the present building's predecessor, they are described below. The pattern of the mortice evidence indicates that they have been reused out of their original sequence.

The tiebeam at Truss A-A has a mortice for a heavy central intermediate post, flanked at some distance by a stud on either side, beyond which are mortices for headbraces. This indicates a closed wall, though there are no stave holes (necessary to support panels of daub infill between the former upright timbers) which indicate that this truss was almost certainly clad with weatherboarding. On top of the tiebeam (where it has not rotted) is a central peg hole, perhaps indicating that this tiebeam is of medieval date and supported a crownpost.

At truss B-B the underside of the tiebeam incorporates mortices for two studs with headbraces beyond. In this instance there are round-ended mortices for stave holes between the main mortices, showing that this tiebeam stood at the head of a daub-infilled wall. The mortices are set for a wall which was flush towards the western side of

the truss, which is contradictory to its present position within the sequence, even allowing for the possibility of the original barn having been extended.

Truss C-C has three mortices visible beneath it, all for headbraces. The pair of mortices at the southern end indicate that the tiebeam had been reused twice, once from a wider building, after which it was cut down in its length to match that of the other reused tiebeams. This tiebeam came from an arch-braced open truss.

The final tiebeam, at Truss D-D, is slightly cambered within its length and is likewise from an arch-braced open truss.

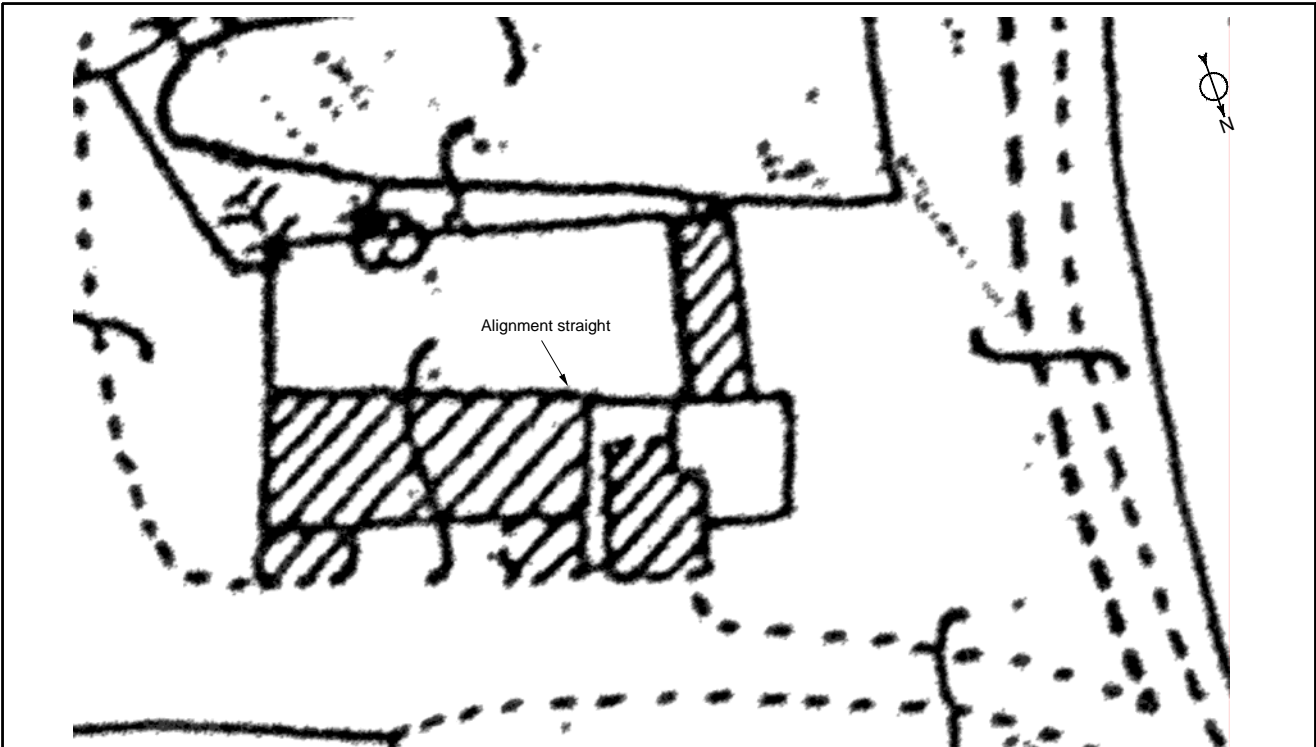
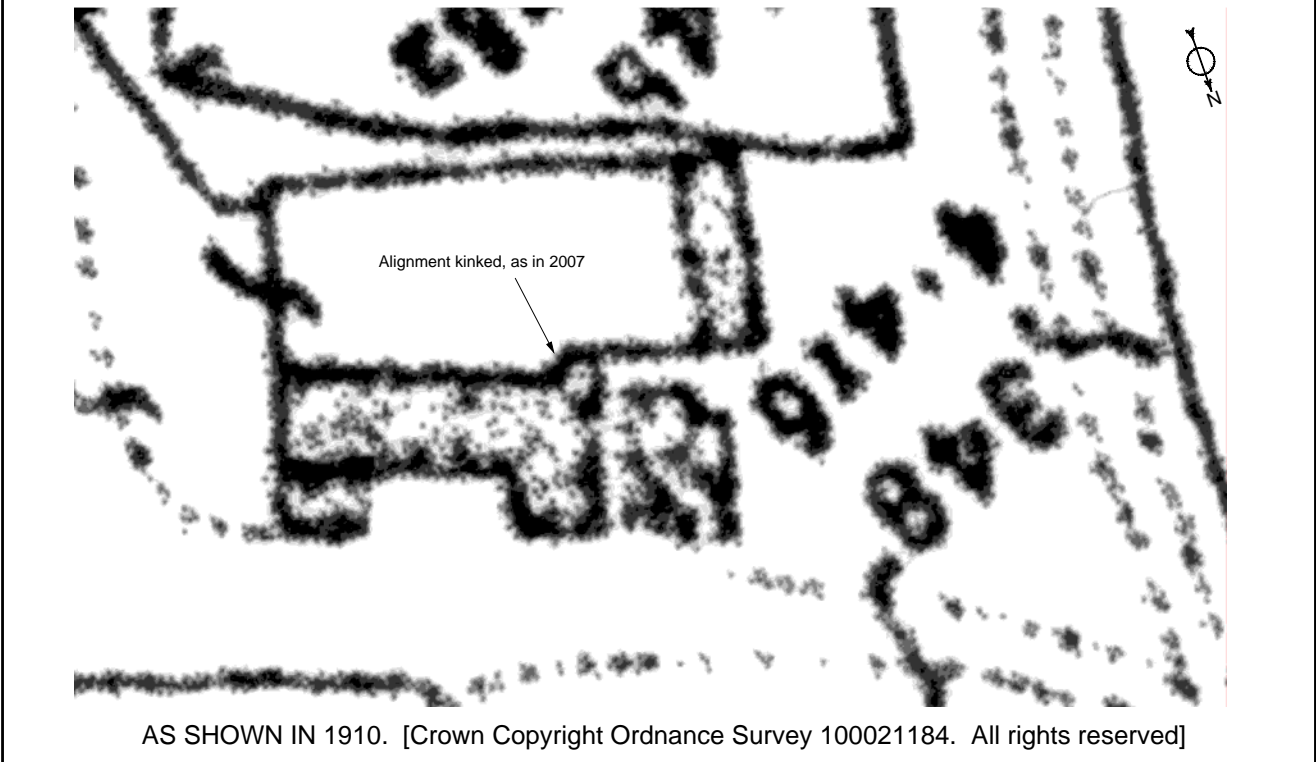
FARM BUILDINGS AT COLBRANS, LAUGHTON, EAST SUSSEX ENLARGEMENTS OF 1899 AND 1910 25" O.S. PLANS				Site Ref	P87/04
				Drawing No.	1660/4
Drawn By	D Martin	Revision No	-	Date of original survey	2007
		Date of this revision	2007

Taken at a glance, the historical maps of 1875 to 1976 reproduced in Drawing No. 1660/1 appear to show little development in the layout of the buildings since the late 19th century: the footprint throughout the period is very much as still existing today. However, there is one subtle, but significant difference between the depiction as given

in 1899 and that of 1910 in that the former shows the south wall of the barn set in line with the yard's northern wall, whereas the 1910 plan shows the same kinked alignment as exists within the arrangement today (compare enlarged details in Drawing No. 1660/4 with the outline plan as currently existing and depicted in Drawing No. 1660/2). This cartographic evidence does not prove that the barn was rebuilt between 1899 and 1910 - the difference could be accounted for by the removal of a southern aisle, but such a date fits well with the architectural features contained within the building - walls of cavity construction built in stretcher bond with a slate damp proof course, concrete lintels to the openings, iron ventilation grills, and a cut-and-pitch roof of reused, widely-spaced machine-cut softwood designed to carry a sheet covering. Under normal circumstances the combination of these two sources of data would be sufficient, though some local residents apparently give the date of the barn's reconstruction as the mid 20th century (*pers. comm.* Glenn Moore) and, although such a late date seems less likely on account of the slate dpc and the present condition of the ventilation grills, such a date cannot be ruled out. What is certain is that the present building represents a total 20th-century rebuild on the footprint of its predecessor - the only material reused from the earlier structure are four tiebeams, refixed out of sequence.

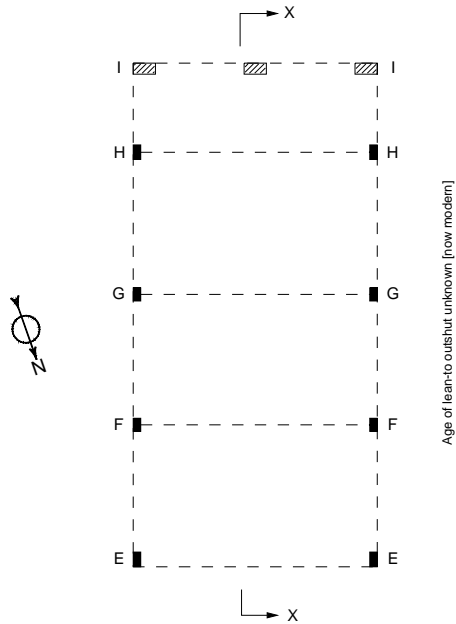
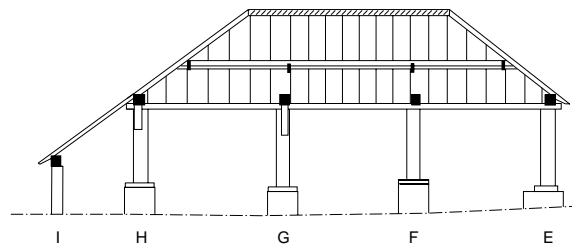
FARM BUILDINGS AT COLBRANS, LAUGHTON, EAST SUSSEX RECONSTRUCTION DRAWINGS OF WAGON LODGE AS REBUILT				Site Ref	P87/04		
				Drawing No.	1660/5		
Drawn By	D Martin	Revision No	-	Date of original survey	2007	Date of this revision	2007

As first built, the lodge was essentially a roof supported by heavy posts (on average 265 mm x 140 mm). The posts are absent of jowled heads, which instead joint directly into the (130 mm x 145 mm) wallplates without any direct contact with the tiebeams. The posts (probably secondhand material) rise from short timber soleplates which are in turn carried by two-and-a-half brick by one-brick piers. The piers are of varying heights, apparently to suit the slope on the ground and the available length of the individual posts, and several piers having now partially overturned. The tiebeams are carried in normal assembly, being dovetailed over the wallplates. There appears to have been remarkably little provision incorporated in the construction to prevent racking. The only restraint against longitudinal racking is the tight, double-pegged, mortice-and-tenon joint between the head of the posts and the wallplates - there is no bracing. Even less provision is incorporated across the building. Metal straps have been included/?added to strap the tiebeams to the wallplates and two knee braces/brackets of timber are

nailed into position to triangulate between the western posts of trusses G-G and H-H and the tiebeams, but there is nothing else. It is unclear whether the knees represent primary features or later additions but, whichever is the case, the design is both poor and weak. On the western face of the western wall posts timber splints run down the posts, continue down the face of the brick piers and into the ground so as to act as strengtheners, but these were added when the lodge racked, as was inevitable given the design.

The roof, together with the western wallplate, represent a 19th-century replacement of the original. Given the replacement of the wallplate it would be logical that the lodge was dismantled and rebuilt as part of this repair, but the fact that the new roof does not accurately reflect the subsidence of the frame suggests to the contrary. The redundant birdsmouths for the rafters of the original roof are visible in the retained eastern wallplate and tiebeams, but are absent from the replacement western wallplate. The present 19th-century roof is of hipped construction and uses clasped side purlins supported by nailed-on collars, now mostly modern replacements. At the apex is a continuous ridge board.

Unlike the rebuilt roof over the main part, the roof over the southern end lean-to outshut uses rafters of roughly squared poles. At their heads they are carried by the tiebeam of truss H-H. The wallplate of the outshut is secondhand material and has had to be spliced in its length. The rafters may indicate that the roof over the main section of the building was likewise originally of this rough form - it would reflect the rest of the construction!

[THE BUILDING HAS SUFFERED SEVERE MOVEMENT SINCE RECONSTRUCTION]

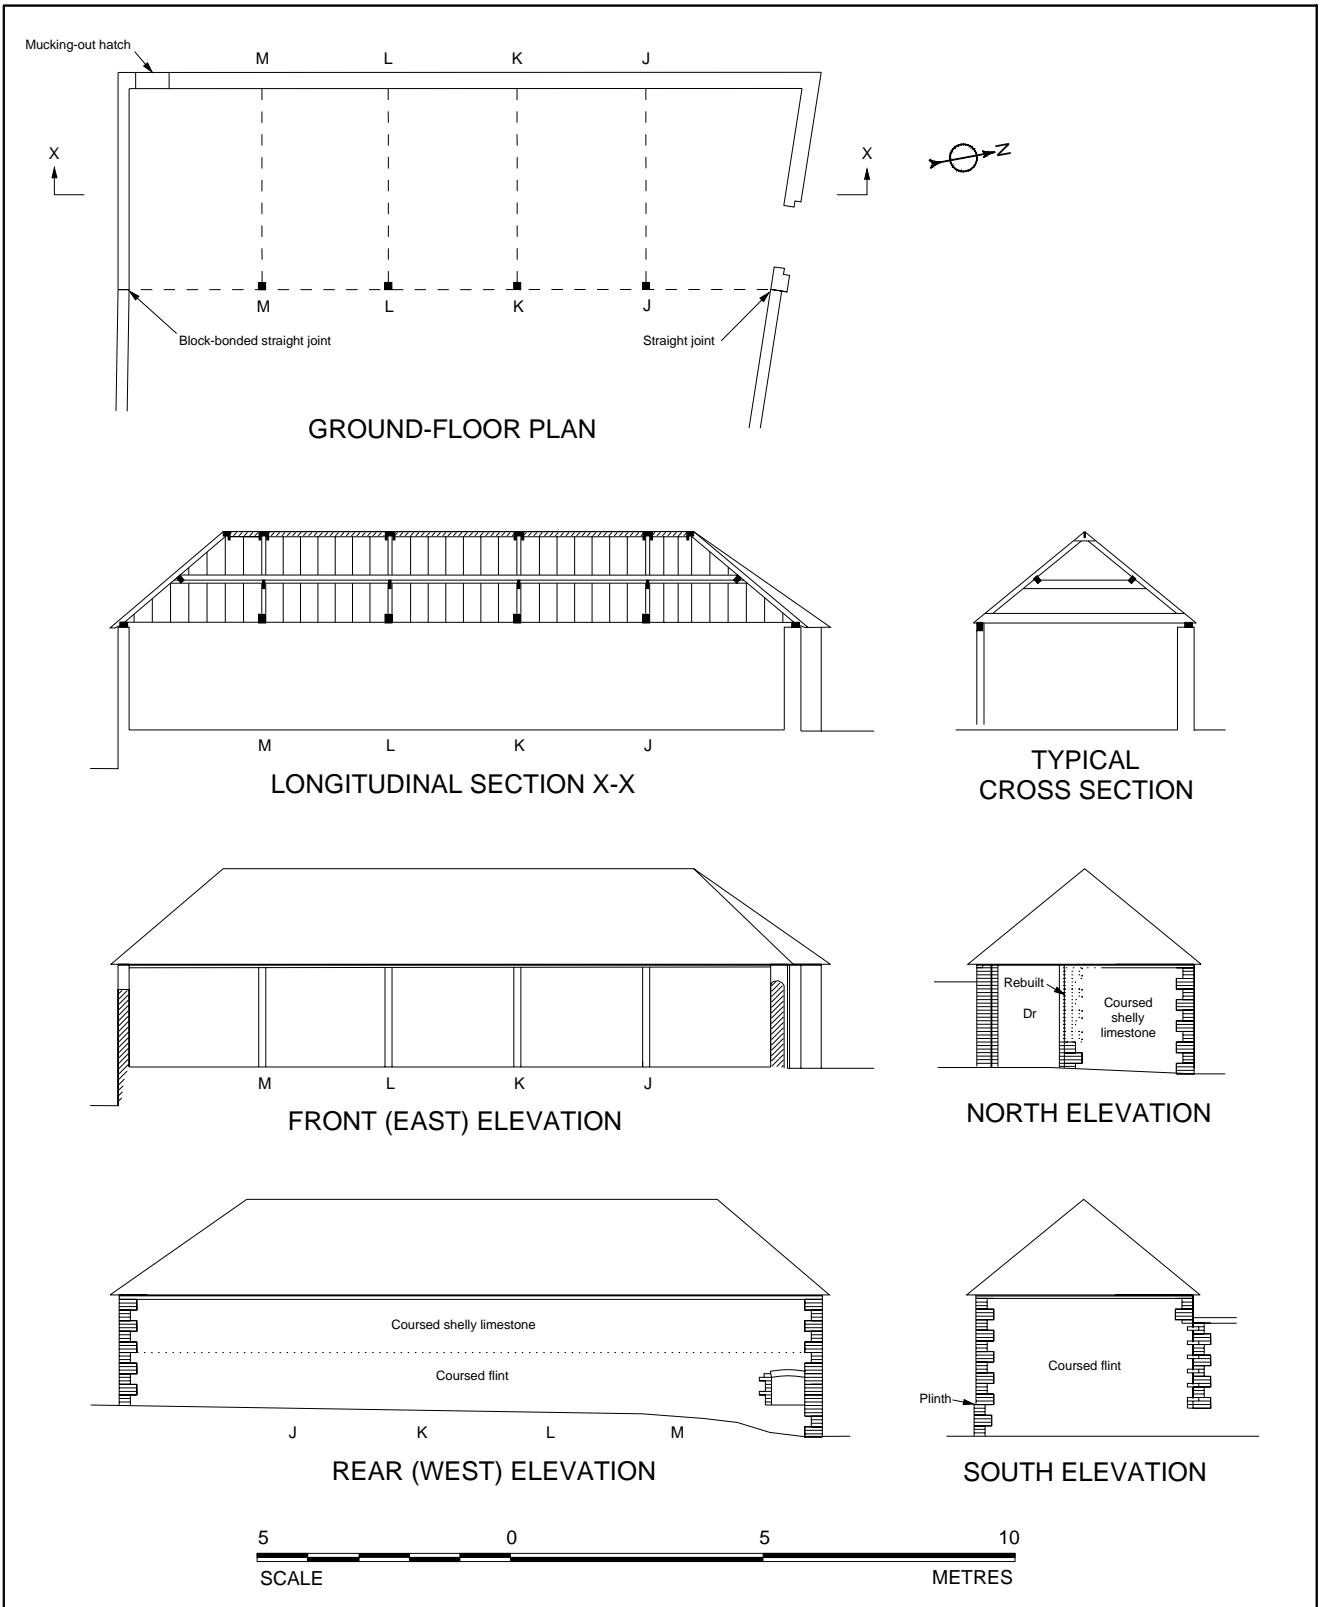
FARM BUILDINGS AT COLBRANS, LAUGHTON, EAST SUSSEX RECONSTRUCTION DRAWINGS OF SHELTER SHED AS FIRST BUILT				Site Ref	P87/04
				Drawing No.	1660/6
Drawn By	D Martin	Revision No	-	Date of original survey	2007
				Date of this revision	2007

Except for the timber posts incorporated within the open front, the building is of mass wall construction, using methods common along the South Downs and their scarp foot - the Downs adjacent to Ringmer are about two miles distant from the site. A mix of materials have been utilized: mostly coursed flint and a local blocky, shelly limestone, but with a few random bricks laid on edge, at a slightly canted angle, incorporated into the inner facing. The mortar of the horizontal courses are lined out - a typical early 19th-century feature locally. All dressings are of brick toothed in blocks three courses high, alternating one-and-a-half bricks, and one brick wide. The lower half of the western (rear) wall is mainly un-knapped flints laid in lime mortar, but, above this, roughly-squared blocks of shelly limestone has been used. This variation could merely reflect the materials available, but perhaps indicates that the lower section incorporates a boundary wall which was raised and widened internally when used for the shelter shed. The southern wall in contrast is of coursed flints (mainly un-knapped) throughout its height, whilst the northern wall uses neat, roughly-squared shelly limestone throughout.

At the south-eastern corner, where the shelter shed abuts the yard wall, the shed utilizes the quoin of the earlier yard wall, to which it is block bonded using a cut-in stretcher brick every fourth course. Where the shed rises above the level of the yard wall a standard brick quoin finishes off the corner. The brickwork terminates some distance above modern ground level with rough-faced wall below, indicating that the ground level has been lowered.

Set at a low level adjacent to the brick quoin at the southern end of the western (rear) wall is an original 660 mm x 550 mm opening (now blocked) capped a brick-on-edge segmental arched head. This probably represents a mucking-out hole. The only other opening through the three mass walls is at the eastern end of the northern elevation where a doorway leads northwards. The brick jambs of the opening incorporate external brick-built closing rebates, as opposed to the more usual timber jambs. On the eastern side the jamb is incorporated into the north-eastern quoin of the building: all but the base of the western jamb has been rebuilt.

Along the open front (facing into the yard) the wallplate is supported by principal posts without jowls. There are no additional supports beneath the front wallplate, either in the form of under-plates or arch bracing. Because the posts within the open front are slightly wider than the wallplate, their faces extend up the internal face of the wallplate as thin upstands of timber. There are no joints between these upstands and the tiebeams, which are dovetailed over the wallplates in the usual manner. However, over the end walls the tiebeams are plate-like in section and are set level with the front and

The fully hipped, clasped-side-purlin roof is built with prefabricated trusses over each of the four internal tiebeams (J-J, K-K, L-L, M-M). At the apex, supported by cleats nailed against the side faces of the principal rafters, are ridgeboards to which the heads of the common rafters are nailed. Each prefabricated truss incorporates a jointed-in collar and a pair of principal rafters bridle jointed at the apex. These timbers, together with the pair of common rafters supporting the head of each hip, the hip rafters, clasped side purlins and ridgeboards are neatly carpentered using sawn, squared, hardwood timbers. In contrast, the common rafters and jack rafters are roughly squared softwood poles.

Because of the angled alignment of the northern end wall, the hipped terminal at this end is built on a skew and, as a result, its pitch varies as it crosses the building, with five jack rafters in the rear slope, but only four in the front slope.

Although now covered in corrugated sheeting, the centres of the battens which remain suggest that, as with the main house, the roof was original covered with slate.
