**An Archaeological Interpretative Survey  
of  
1 & 2 Coppard's Bridge,  
Chailey, East Sussex**

**Project Ref. 3208**

## REPORT NO. 1676

### CHAILEY - 1-2 COPPARD'S BRIDGE

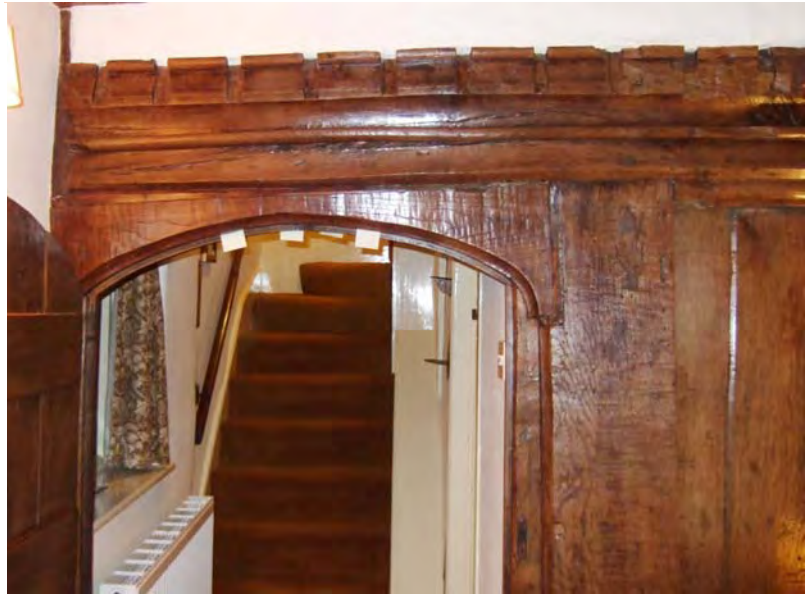
*Plate 1*

*Dais partition showing head of parlour doorway, moulded dais beam and panelling*

At the opposite (dais) end of the hall is truss D-D. At its lower level this partition is infilled by a vertical-plank screen set into a purpose-cut groove in the soffit of the dais beam. Commonly, panelling of this type was strengthened on the reverse side at mid height by a horizontal rail, but there is no evidence for such a rail in this instance. Positioned centrally along the length of the panelling is a wide stud, the front face of which is bevelled, giving the timber a triangular profile in section. Beyond the eastern end of the panelling is a wide, arched-headed doorway leading into the parlour. Mortices cut into the hall face of the door jamb indicate the position of a draught spere, which would have doubled as a bench end. The former fixed dais bench is evidenced by mortices in the jamb and central stud and by additional mortices in some of the planks. To judge from their level, these seem to have been intruded subsequently to suit a slightly higher bench. The bench itself is further evidenced by a distinct horizontal line on the hall face of the planks — this scar indicates that the seat consisted of 60 mm thick planks. The 300 mm deep dais beam which spans the building immediately above the panelling is moulded with a simple design of rolls and cavetto mouldings, capped by crenellations (Plate 1). The upper part of the partition follows the same design as within truss D-D, but with the panels more equally spaced.

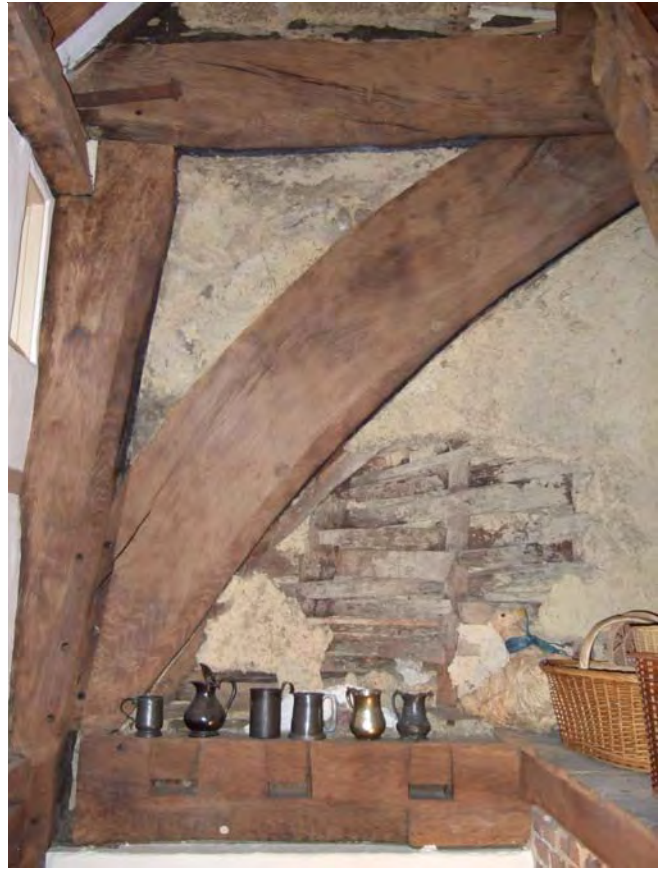
*Plate 2*  
*Surviving eastern brace of hall truss,*  
*viewed from north.*

Truss C-C (Drawing No. 1676/5) crosses the open hall, preventing the wallplates from spreading, dividing the two bays of the hall, and forming an impressive architectural feature. The principal posts of the truss each incorporated an integral chamfered nib running up their inner face as far as the spring-point of the arch brace. That nib to the rear post still survives, though now largely hidden behind a door lining. From these sprang 120 mm x 420 mm chamfered curved arch braces, of which one still remains *in*

*situ* (Plate 2). At the head they were morticed and tenoned into the underside of the tiebeam, abutting against an integral, chamfered nib which extends across the central part of the tiebeam's soffit, which itself is slightly cranked. The function of the nib was to carry the profile of the braces across the central part of the building, thereby giving a more impressive shape to the arch. In addition to the chamfered nibs, the leading edges of the principal posts and tiebeam are boldly chamfered with the chamfers terminated at the ends by means of stepped-and-splay-cut stops. Above the centre of the tiebeam rose a freestanding crownpost (removed).

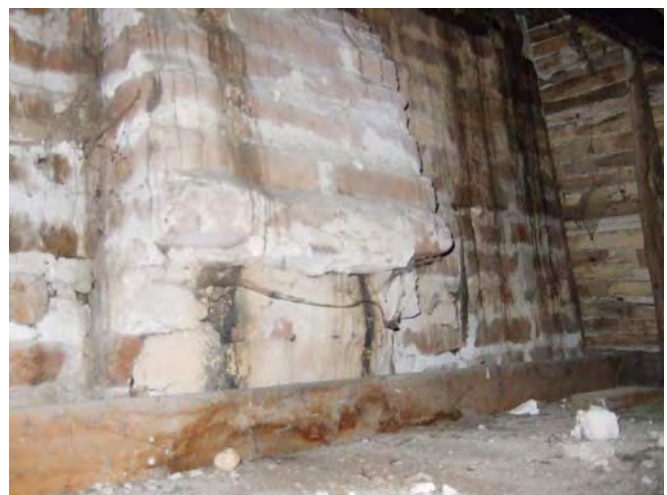
The second chimney originally filled much of the added period-C northern bay, though the north-facing fireplace was removed in the 19th century in order to make room for a new parlour served by a small fireplace which projects only slightly from the chimney's spine wall. At least part of the fireplace's eastern jamb appears to have been retained, incorporated into the parlour's eastern wall, but the western jamb has been totally removed and thus the position of this jamb is uncertain — for this reason it is indicated in dotted outline in Drawing No. 1676/7. Despite the removal of the fireplace and the first-floor part of its flue, the upper courses of the flue's tumbling still survive and is visible within the roof area (Plate 3). Despite some minor modification, the kitchen fireplace survives, as too does that serving the kitchen chamber, though the latter is now blocked. Both have brick jambs and plain, but well proportioned timber lintels. The design of that in the kitchen chamber is unusual in that its jambs are only half-brick wide and the lintel projects forward from the jambs, being supported by projecting timber

*Plate 3*  
*Cut-back remains of tumbling to former flue serving service outshut, viewed from north.*

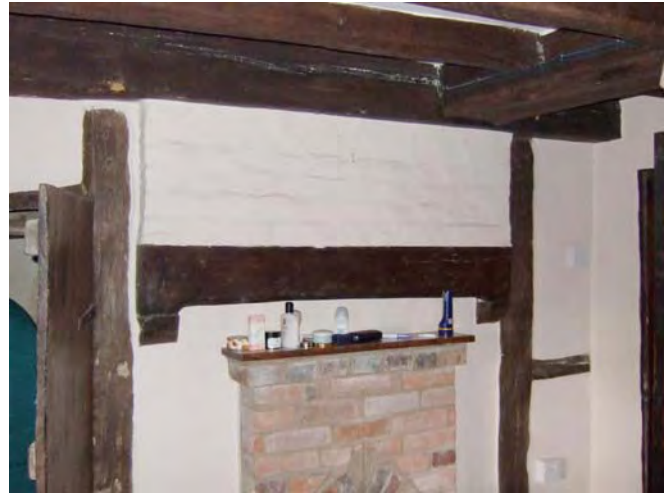
corbels (Plate 4). As with that serving the hall chamber, this fireplace likewise retains its brick hearth, edged with a timber kerb. Despite having been heightened, the chimney cap survives and is of rebated type with the three flues aligned across the axis of the building. That serving the kitchen occupies the eastern part of the cap, that serving the kitchen chamber the western part, whilst the narrow central flue originally served the [removed] north-facing fireplace.

*Plate 4*  
*Kitchen chamber fireplace showing lintel supported by projecting timber corbels.*

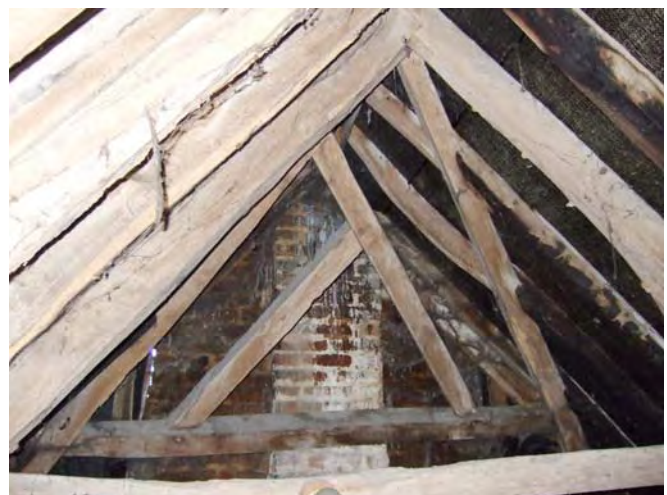
The principal modification involved the total reconstruction of the period A/C roof to a less steep pitch using in-line butt-purlin construction, framed in six bays, of which the two end bays were occupied by the hipped terminals. No butt purlins were incorporated into the side slopes of the hipped bays, but purlins were included within the end slopes, trimming the jack rafters. As is to be expected at this period, neither of the hips incorporate either a high-set collar at its apex, or a central jack rafter. Indeed, the northern hip includes a bizarre arrangement of intersecting, angled jack rafters above its purlin (Plate 5). The purlin doubles as a trimmer for the cap of

*Plate 5*  
*Arrangement of jack rafters above butt purlin within the northern period-D hip.*

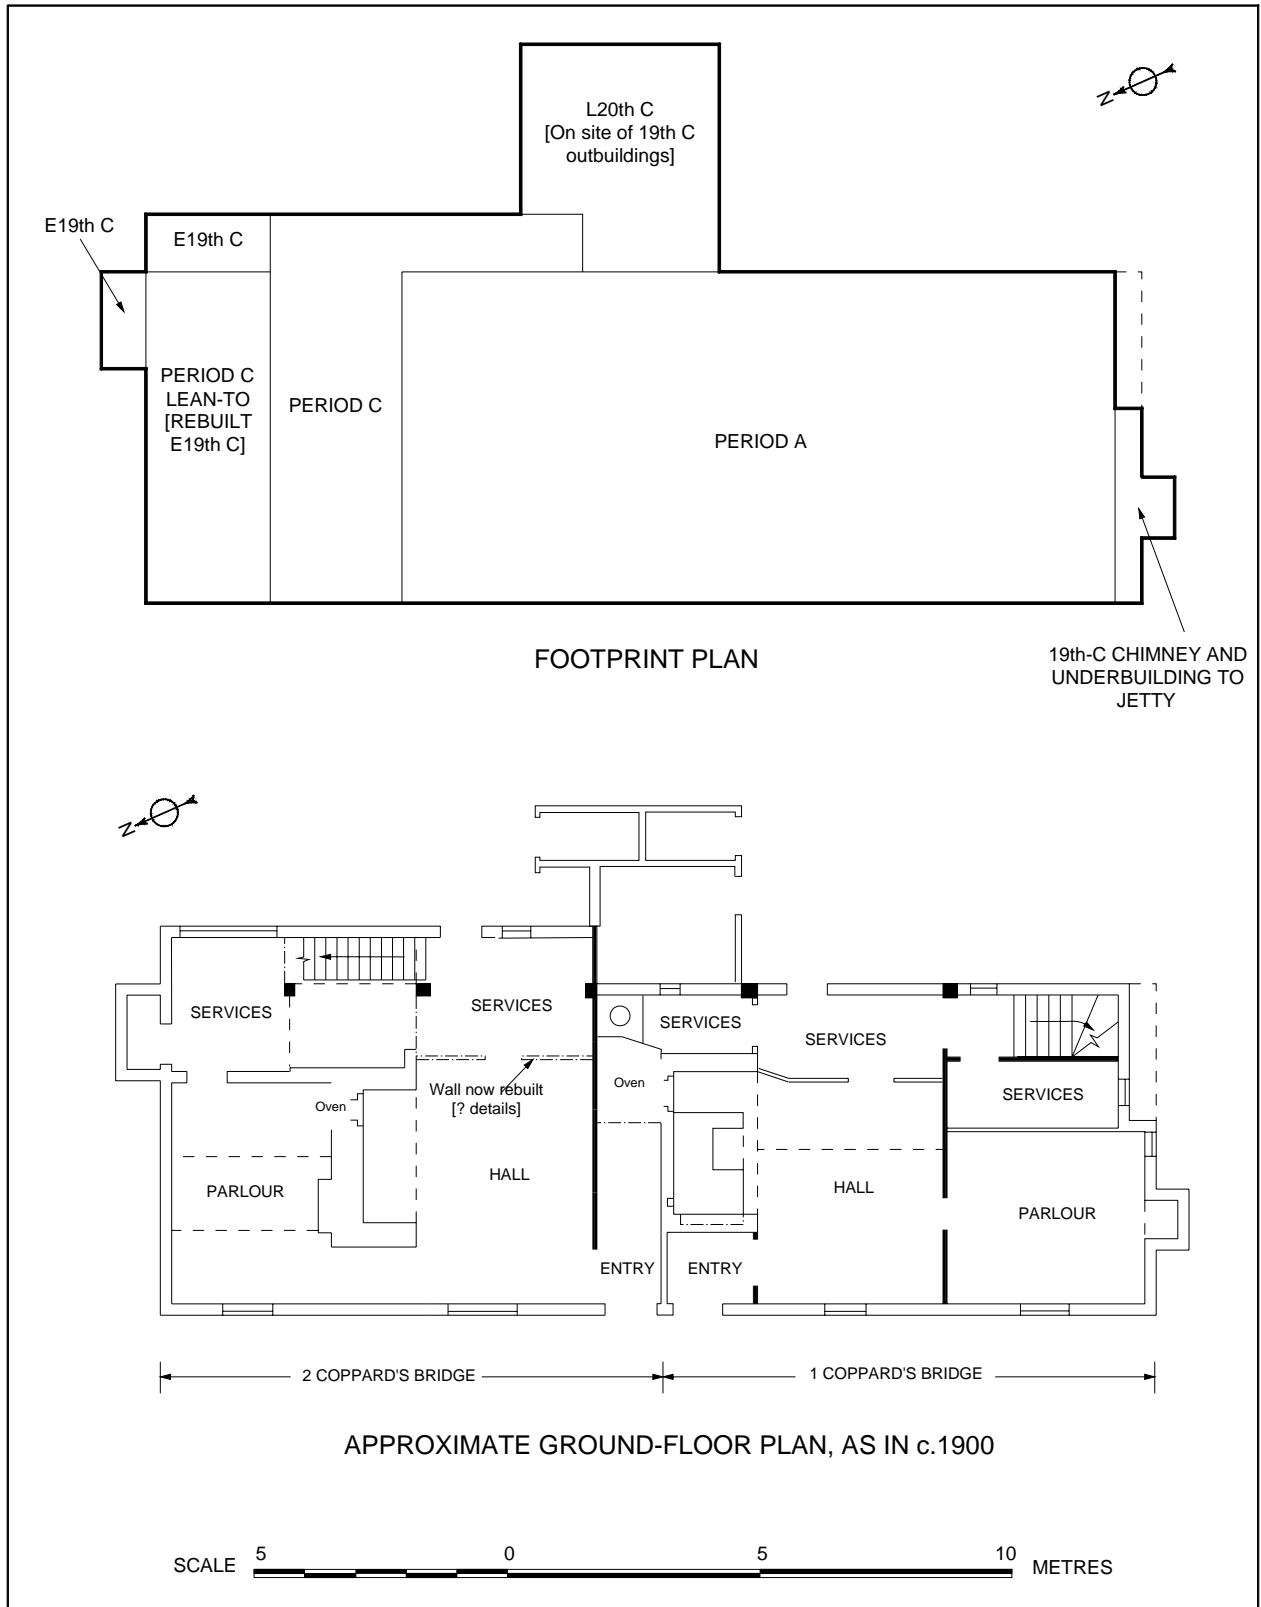
<b>1-2 COPPARD'S BRIDGE, CHAILEY, EAST SUSSEX OUTLINE PLAN SHOWING SEQUENCE OF DEVELOPMENT</b>				Site Ref	<b>P117/03</b>
				Drawing No.	<b>1676/1</b>
Drawn By	J Clubb	Revision No	-	Date of original survey	2008
				Date of this revision	2008

Behind the building's present relatively late looking tile-hung and brick-underbuilt facade is a large four-bay timber-framed hall house of c.1475 [**Period A**]. The layout was standard — on the ground floor a two-bay open hall with a pair of service rooms to the north (with chamber above) and a parlour to the south (also with chamber above, carried on a jetty at the southern end). There were draught sperees protecting the front and rear doorways. One of the two arch braces of the hall truss remains *in situ*, as does the dais panelling beneath a moulded dais beam. The panelling shows good evidence for a fixed bench, which incorporated a bench end / draught spere. Walls generally are of footbraced large-panel design. The crownpost roof has been totally rebuilt.

The owners appear to have been slow to floor over their hall and, when they did, they undertook the procedure in two distinct phases. The first of these, carried out c.1575 [**Period B**] involved flooring over the low-end bay only, giving an extra first-floor chamber. The ground-floor of this bay seems to have served as a spacious entrance area, separated from the main body of the hall by a screen against which, no doubt, the open hearth stood.

A number of alterations were carried out c.1600 [**Period C**] of which one was the flooring over of the upper bay of the hall. Associated with this, a ceiling was inserted into the hall chamber, a two-flue chimney was thrust through the period-B floor so as to heat the hall and hall chamber, and new windows were inserted into both areas. The other alterations of this general date may have been carried out at the same time, or could have been undertaken as discrete phases of alterations. Because of the doubt, all are here classified collectively as period C. The principal of these involved adding a rear-aisled bay and end lean-to outshut onto the northern end of the period-A house and extending the new aisle southwards so as to run along the rear of the northern period-A bay. The object of these alterations was to convert the medieval services into a kitchen (heated by a new three-flue chimney within the added bay) and transfer the services into the addition. One of the new service rooms was heated by a fireplace (since removed) within the stack. Part of the rear aisle housed a new staircase. On the first floor, the old service chamber (new kitchen chamber) had a ceiling inserted, was heated by a fireplace in the new stack, and was lit by a frieze of ovolo-moulded windows inserted into the front elevation. Other alterations of about this period include the re-siting of the stairs at the parlour end, insertion of a ceiling into the parlour chamber, and re-infilling parts of the walls using small-panel framing.

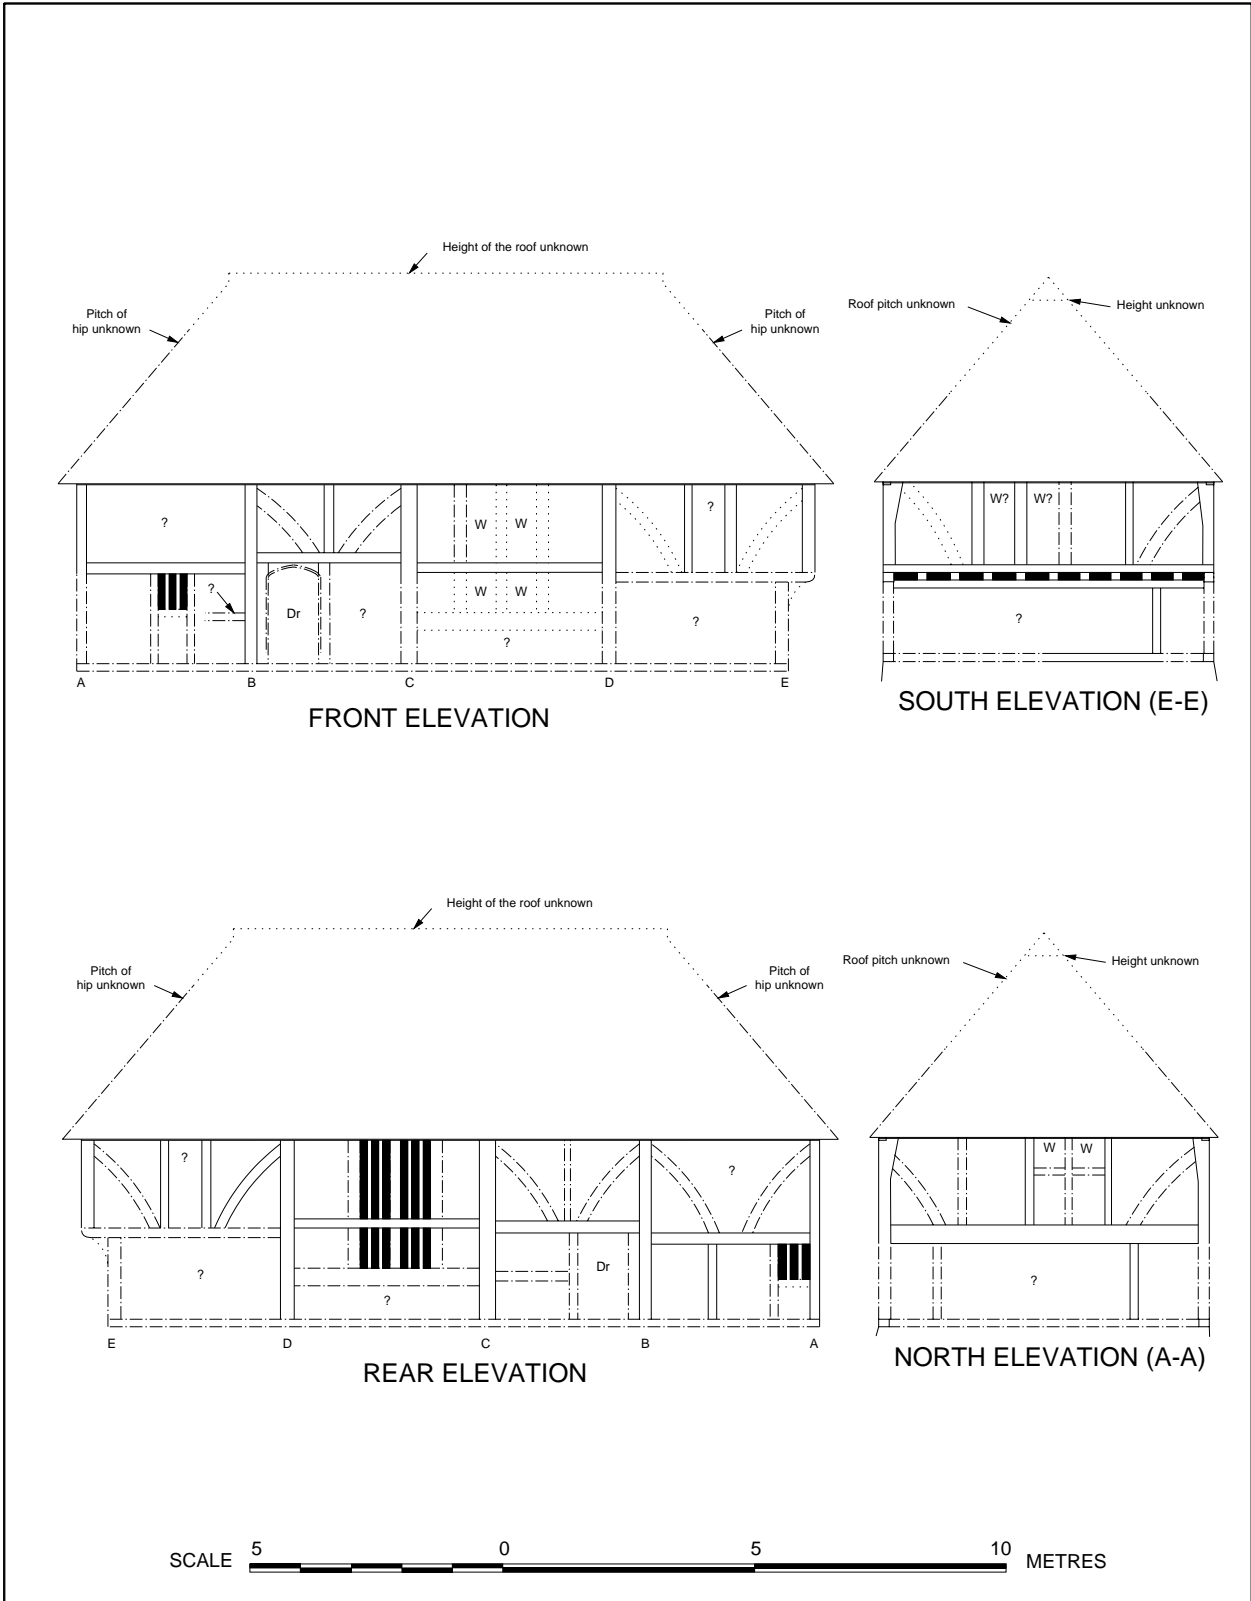
<b>1-2 COPPARD'S BRIDGE, CHAILEY, EAST SUSSEX PERIOD-A RECONSTRUCTION DRAWINGS</b>				Site Ref	<b>P117/03</b>
				Drawing No.	<b>1676/4</b>
Drawn By	<b>J Clubb</b>	Revision No	-	Date of original survey	<b>2008</b>
				Date of this revision	<b>2008</b>

Reconstructions of the wall design are shown in Drawing Nos. 1676/4-5. The walls are framed using large panels of daub, separated one from the other by studs and triangulated to the principal posts at first-floor level using curved footbraces. At least within the rear wall, northern wall, and the two internal trusses, the braces are/were positioned so as to be exposed within the external/primary face. It should be noted that not all the joints which secure the period-A braces and studs to the frame are pegged, and thus in some places the presence of setting-out lines have had to be utilized to identify the locations of hidden/removed timbers. The period-A daub infill was supported by traditional staves fitted at their heads into typical small round-ended mortices or 'stave holes'.

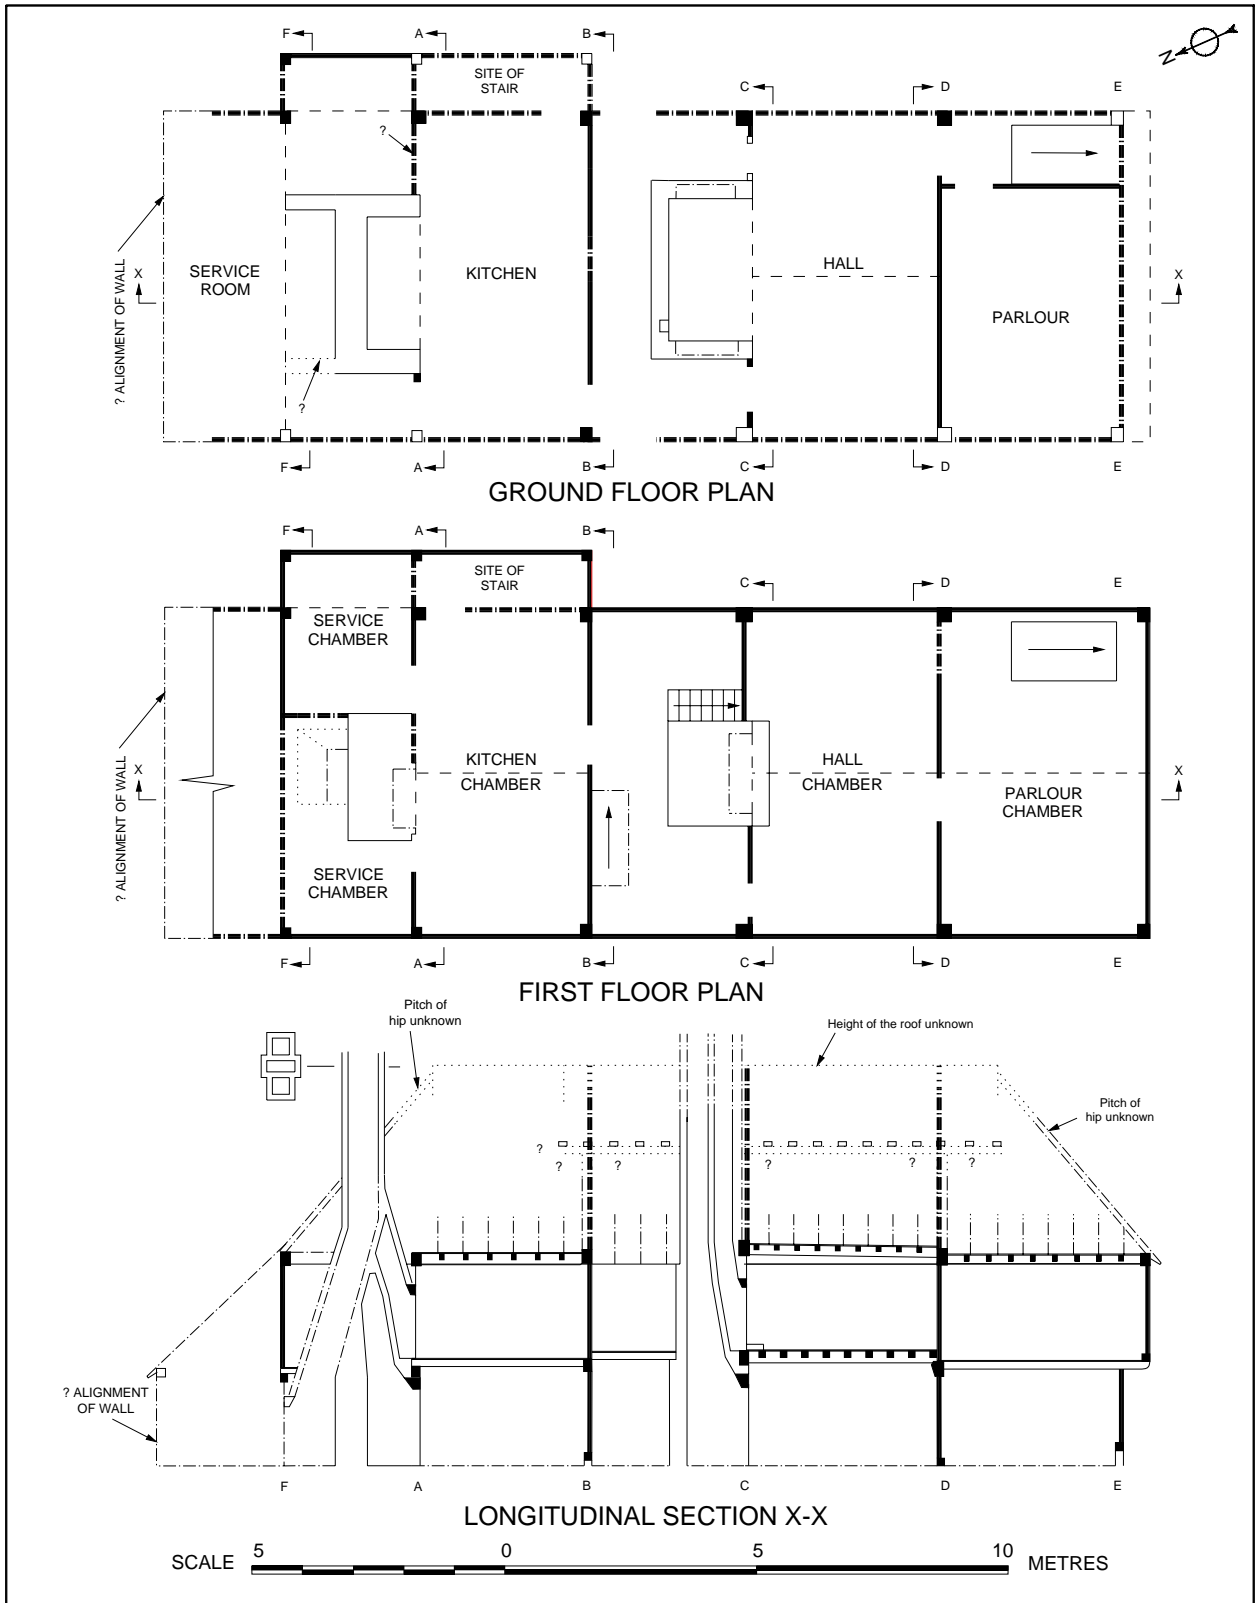
<b>1-2 COPPARD'S BRIDGE, CHAILEY, EAST SUSSEX PERIOD-C RECONSTRUCTION DRAWINGS</b>				Site Ref	<b>P117/03</b>
				Drawing No.	<b>1676/7</b>
Drawn By	J Clubb	Revision No	-	Date of original survey	2008
				Date of this revision	2008

As already mentioned, both medieval stairs were replaced at this date by new staircases in revised locations (see Drawing No.1676/7). Both stairs have been replaced since. In contrast, the staircase leading to the attic area over the hall chamber and parlour chamber still survives. Sited within the hall's low-status low-end chamber, it consists of a straight flight of triangular-section treads supported by a sloping carriage. It is tempting to suggest that the treads have been reused from one of the two removed period-A stairs. A second similar flight survives within the period-C extension beside the kitchen chimney, but this was refixed in this location at a subsequent date. Originally, this too was located within the hall's low-end chamber and gave access to the attic area over the northern end of the house. As a blocked doorway at attic level shows, the stair remained in this location during period D. To judge from three mortices in the southern face of the tiebeam of truss B-B, immediately beneath the blocked attic doorway, the stair evidently incorporated a landing arrangement at its head.

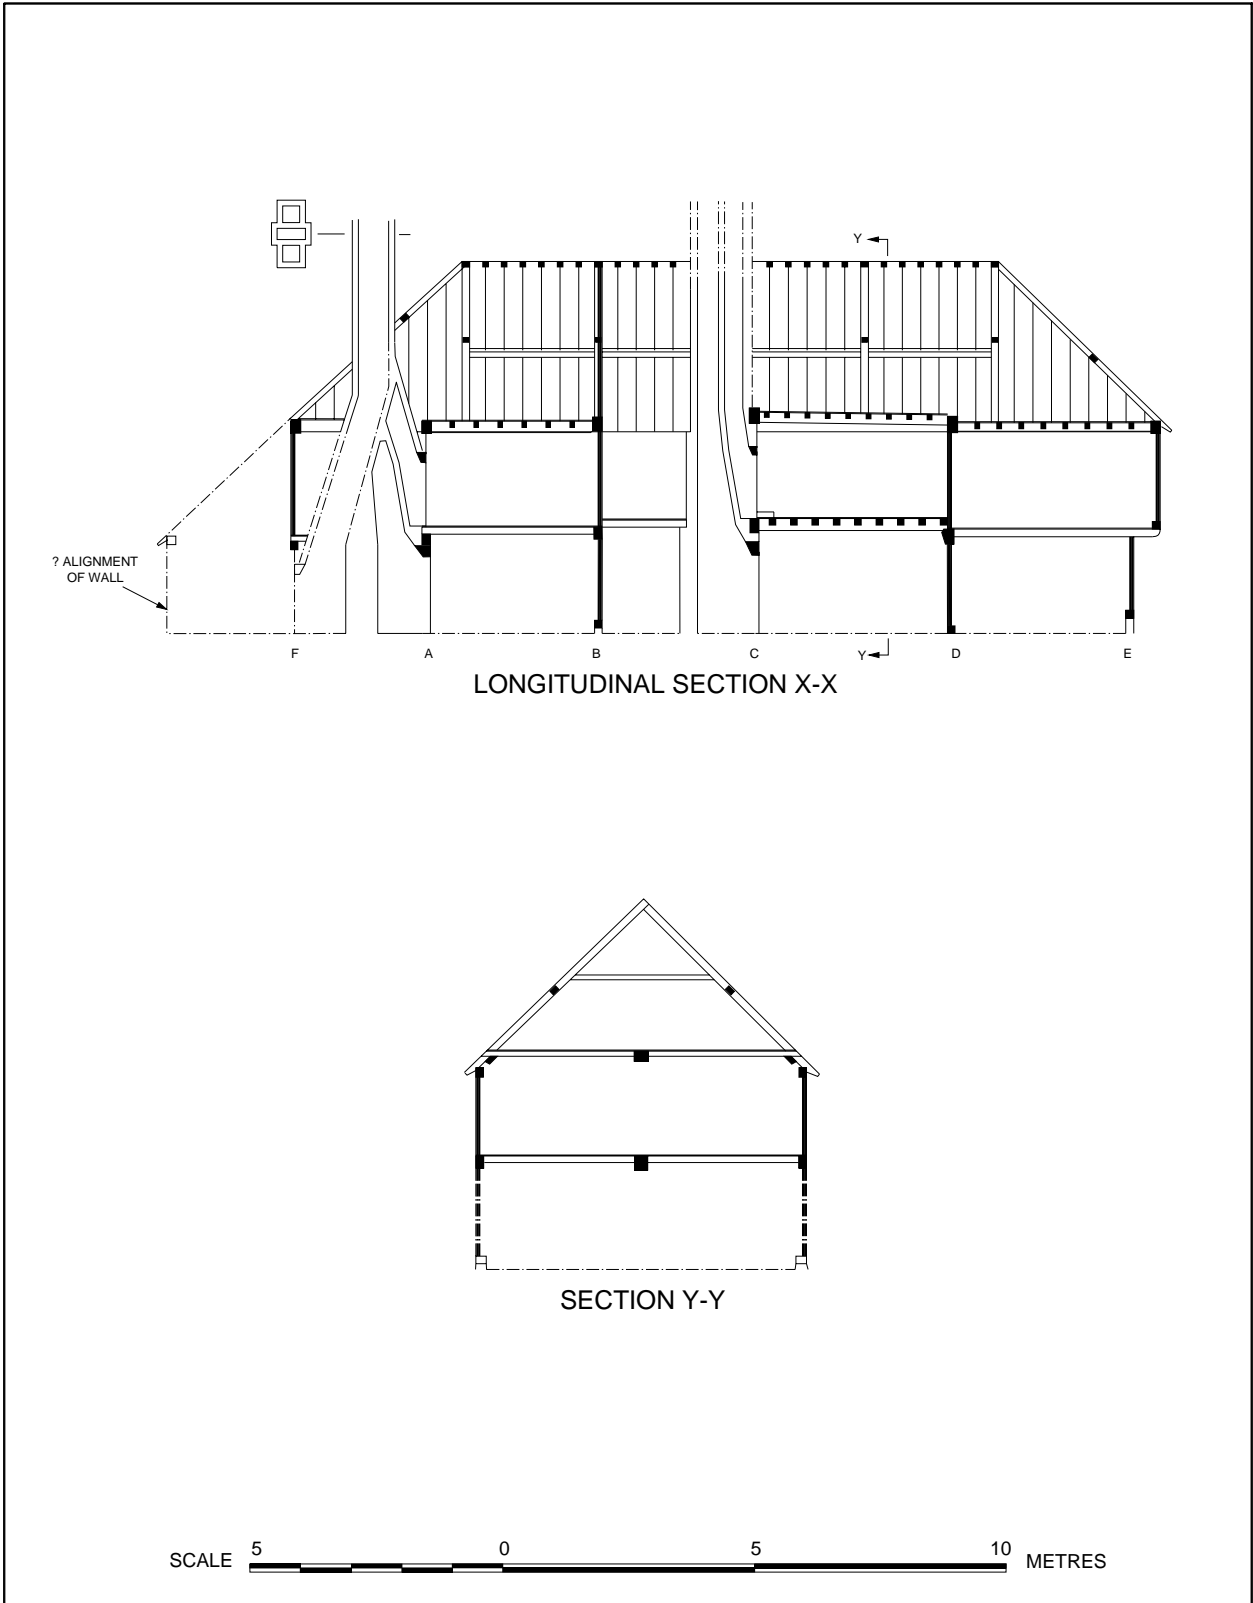
<b>1-2 COPPARD'S BRIDGE, CHAILEY, EAST SUSSEX PERIOD-D RECONSTRUCTION DRAWINGS</b>				Site Ref	<b>P117/03</b>
				Drawing No.	<b>1676/10</b>
Drawn By	<b>J Clubb</b>	Revision No	-	Date of original survey	<b>2008</b>
				Date of this revision	<b>2008</b>

Apart from the addition of an oven [since removed] against the eastern jamb of the hall fireplace, little or no alteration was made to the internal layout at this period.
