**An Archaeological Interpretative Survey of  
Moss Cottage, Newbridge, Hartfield, East Sussex**

**Project Ref. 3213  
Report No: 2008231**

**by  
David Martin FSA IHBC MIFA & Barbara Martin AIFA**

**2007**

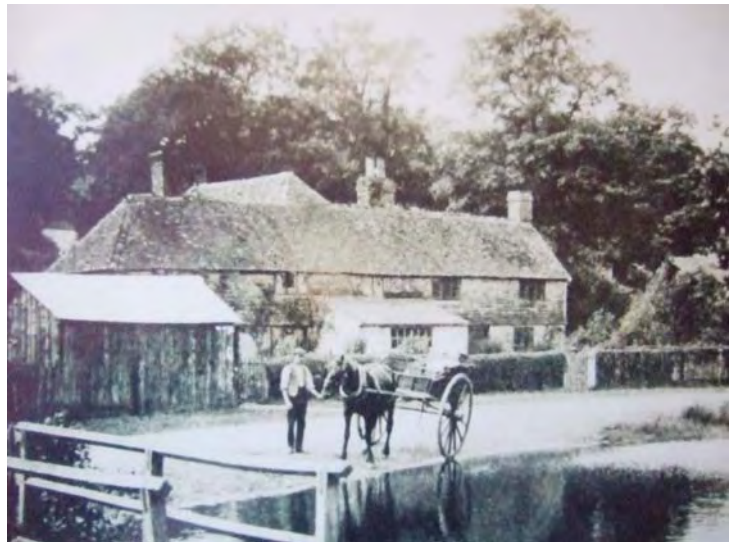
Plate 2

Exterior from west — pre 1929

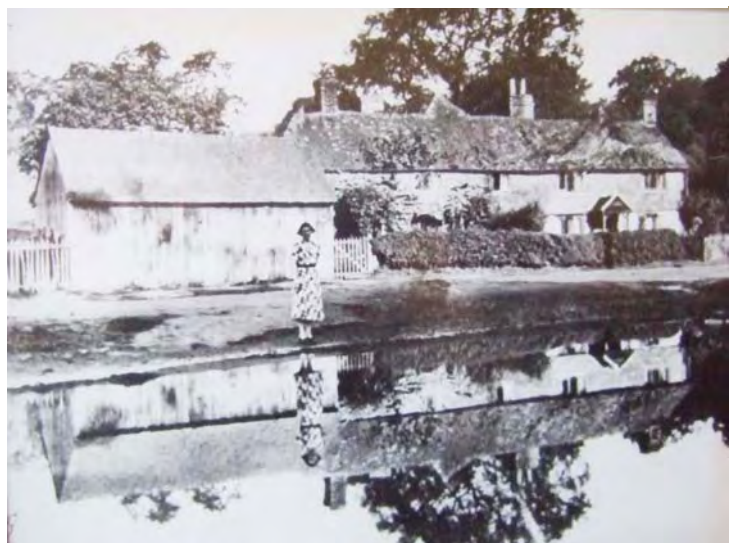
Plate 3

Exterior from west — Later than Plate 2 and after 1909

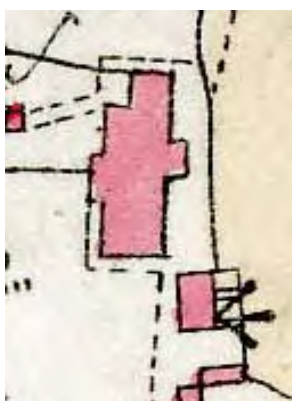
Plate 4  
Enlarged extract from  
1874 1:2500 O.S.  
[Sheet 16.08]

As Plate 4 illustrates, by 1874 lean-to outshuts had been added to the rear of the period-A and period-C additions but, significantly, not to the rear of the period-D addition. Both added outshuts were of late date, having been constructed after the original period-A rear wall had been weatherclad and the southern ground-floor wall brick underbuilt, but nothing more can be said as both were rebuilt during the mid/late 20th century — this is likely to have been due to their inferior quality. Also by 1874 a short lean-to outshut with shallow-pitched slate roof had been added against the front wall of the house — this is clearly visible in Plate 2 as well as Plates 4-6, but had been demolished by 1929 (Plate 7). Jenny Smith (the present owner) has been told that the lean-to served as a shop, which seems very likely.

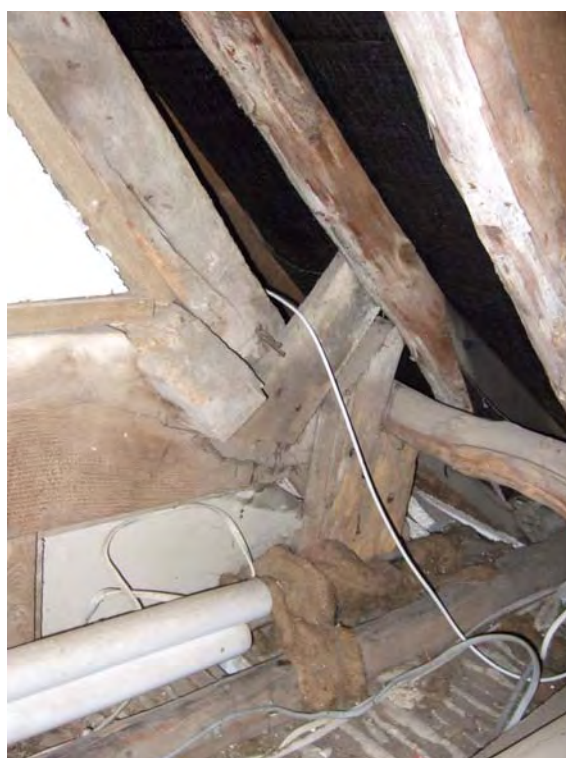
*Plate 8*  
*Whitened pole rafters within addition of c.1800, looking south towards period-A northern end wall. Note shallower pitch of rear slope to added roof*

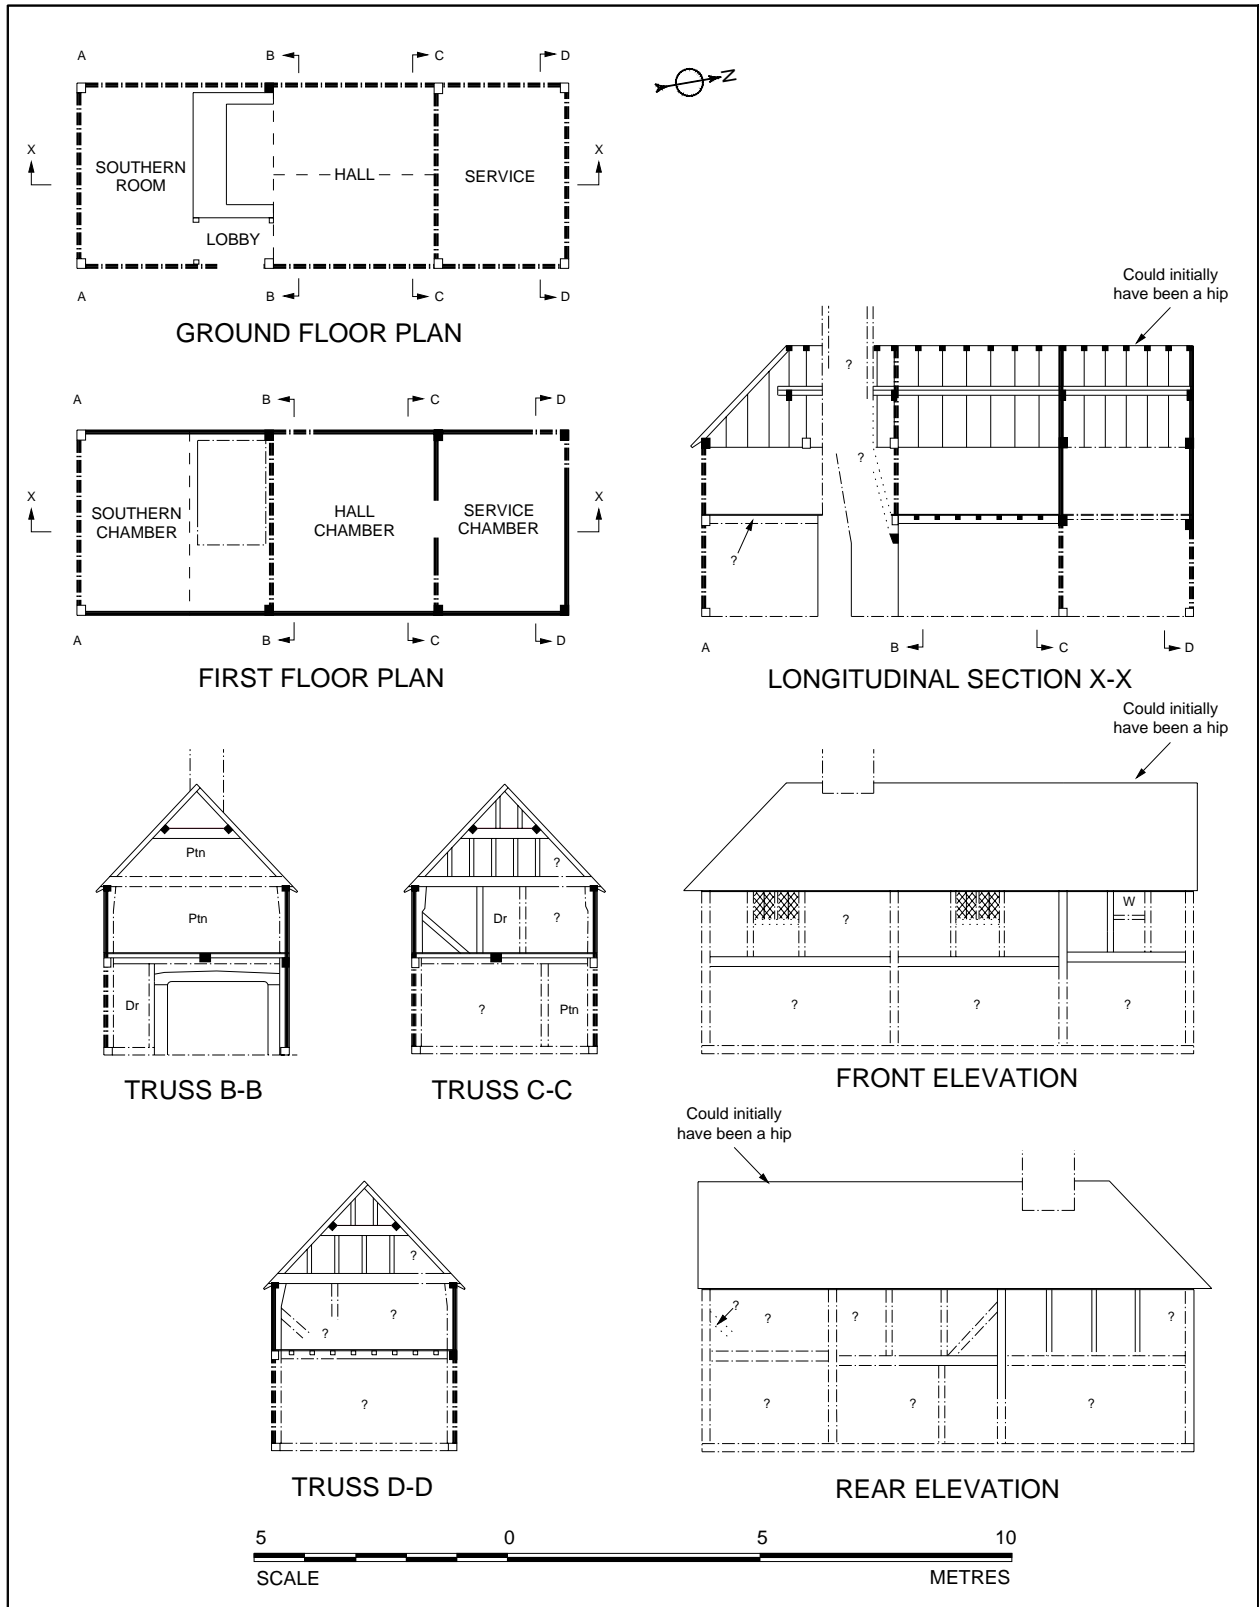
<b>MOSS COTTAGE, NEWBRIDGE, HARTFIELD, EAST SUSSEX</b>				Site Ref	<b>P75/08</b>
<b>PERIOD-A RECONSTRUCTION DRAWINGS</b>				Drawing No.	<b>1675/4</b>
Drawn By	<b>J Clubb</b>	Revision No	-	Date of original survey	<b>2007</b>
				Date of this revision	<b>2007</b>

As initially constructed the building comprised three bays, with each bay housing a separate room with chambers above. It was a small house, measuring 9.65 metres (31'8") long x a mere 3.65 metres (12'0") wide, making it one of the narrowest extant buildings of its period locally. On the ground floor the southern and northern rooms were un-heated, whilst the central bay — the hall — was served by an inglenook fireplace from the outset. The chimney was built into the northern part of the southern bay, leaving room to the east for a lobby entry servicing the front door (now blocked). Because the upper part of the chimney has been reconstructed it is impossible to tell whether the hall chamber was heated. All three first-floor chambers were open to the roof, which is hardly surprising bearing in mind that the first-floor side walls measure only 1.30 metres (4'3") from floor to top of wallplate.

rafters. The rear wallplate at this point has been removed and the upper face of the end tiebeam is hidden from view, so these timbers cannot be used to advance the hypothesis further. Secondly, the side purlins are roughly jointed immediately to the north of the collar of truss C-C and there is a difference in the size of the timbers at this point, possibly suggesting that the period-A purlins originally terminated at the truss. Lastly — though this could be imagination — there appears to be a slight difference in quality between the two sections of roof. The design of the terminal would not have been changed without good reason and, at first, it is difficult to see why such an alteration would have been made. But, in fact, if the (unproven) alteration dates from period B there is a very good reason. Because of the difference in floor levels and storey heights. the wallplates of the period-B rear range are located a full 670 mm (2'3") above those of the period-A range. This would have made weathering the addition against a hip very difficult, and very unsightly. Changing a hip to a gable overcomes this problem very adequately and cheaply. Even so, there could be other reasons for the anomalies noted above — because of the doubt, the present gable is shown in the period-A reconstruction drawings, qualified accordingly.
