**An Archaeological Interpretative Survey of
Chillmill Manor, Brenchely, Kent**

**Project Ref. 3347
Report No. 2008237**

**by
David Martin FSA IHBC MIFA & Barbara Martin AIFA**

**Archaeology South-East
Institute of Archaeology
University College London**

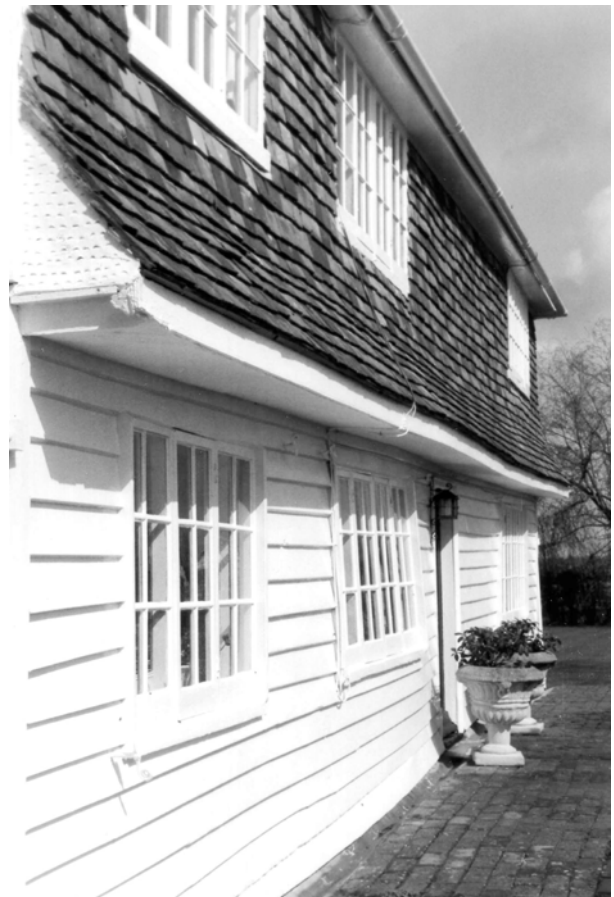
Plate 1
Methersham, Beckley, showing pentice roof.

light and a more up-to-date external appearance. The pentice roof running along the front facade is, in its present form, a 20th-century reconstruction, but probably replicates a feature added at this period, for although the present version forms part of the restoration undertaken between 1908 and 1938, a pentice seems to be indicated in the pre-restoration 1908 1:2500 O.S. plan. Similar pentice roofs exist in a number of local houses of this period, as, for instance, at Methersham Farm, Beckley, East Sussex, shown in Plate 1.

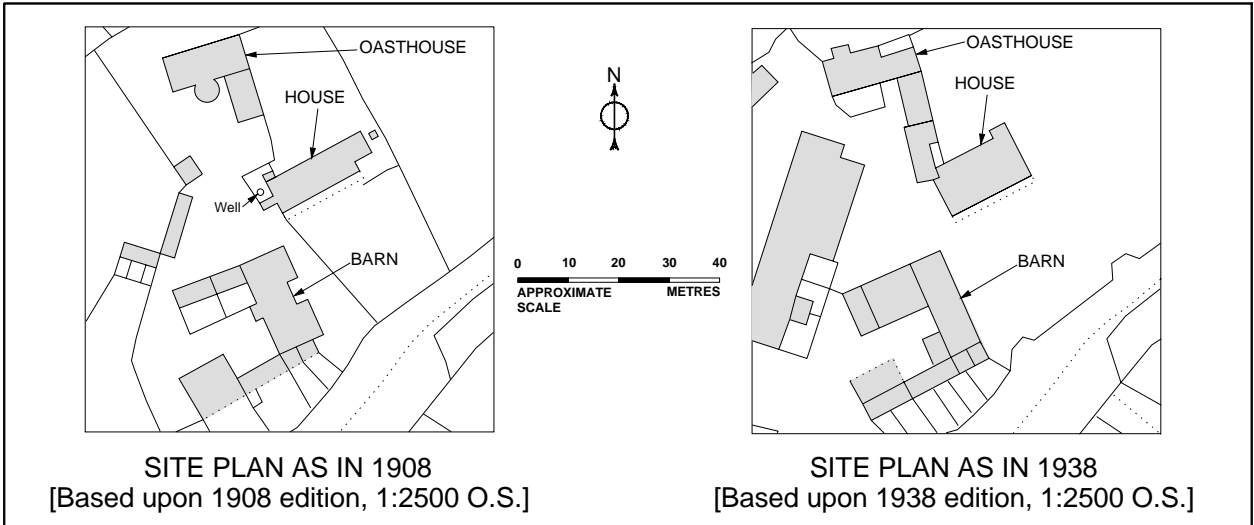
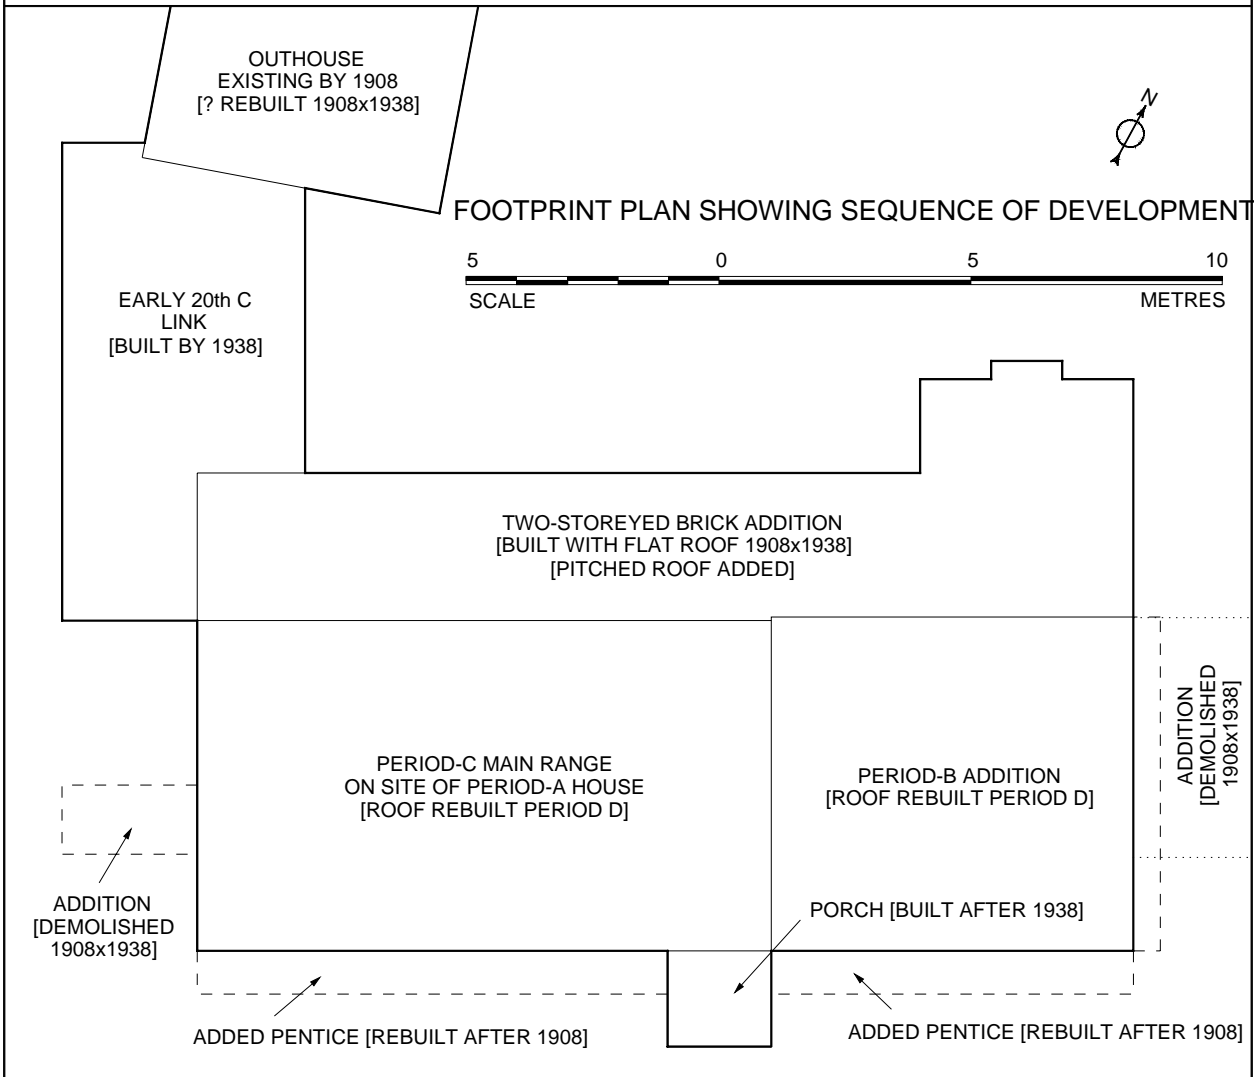
CHILLMILL MANOR, BRENCLEY, KENT				Project Ref	3347
HISTORICAL MAPS AND DEVELOPMENT PLAN				Drawing No.	1
Drawn By	J Clubb	Revision No	-	Date of original survey	2008
				Date of this revision	2008

Chillmill Manor is sited on the western side of Fairman's Lane which runs south from Brenchley to Lamberhurst, approximately 0.6 of a mile to the SSW of Brenchley Church. It stands at approximately 77 metres above mean sea level on the crest of a spur of high land. It is set back slightly from the road, to which it is aligned at a slight angle with its long axis orientated ENE-WSW (hereafter assumed E-W). The principal elevation faces SSE (hereafter assumed S) towards the road. To the west, between the house and road and built at right angles to both is a timber-framed barn (now converted and in separate ownership), whilst to the rear at the same end is an oasthouse (likewise now converted and in separate ownership) with a single-storeyed outbuilding running forward towards the house. Since before 1938 the house and outbuilding have been linked by a two-storeyed extension, but they are shown detached in the 1908 revision of the 1:2500 Ordnance Survey plan (see Drawing No. 1).

Viewed from the road the overall shape of the house remains very much that of the mid 18th century when the present roof was built, but it is important to emphasise immediately that, in its detail, the present appearance (both internally and externally) is largely the result of a very extensive programme of restoration and rear extension work carried out in two phases between 1908 and 1938, probably in the 1920s. All the windows date from this period, as too does most of the secondary timberwork. Indeed, excluding the eastern end elevation (which has been restored to its historical form) and four restored (though blocked) windows, all that remains of the historical walls and partitions within the building are the principal members of the main frame and a few braces and studs. These timbers are shown in solid outline in the reconstruction drawings attached to this report. Excepting these, most of the visible timberwork in the walls and partitions dates from the early 20th-century restoration, apparently inspired by (and in some places retaining) the studwork of an earlier phase of restoration (mid/late 18th century) when the building was re-fenestrated and weatherclad. Ironically, although most timberwork is today exposed to view, the phase of alteration copied by the 20th-century restorers was one which introduced new studwork intended to support laths/battens, for their aim was to mask the timbers behind coverings. Despite the severity of the 20th-century restoration, the early development and much of the historical wall design can be reconstructed on paper based upon redundant mortices and peg holes visible in the timbers of the main frame. As far as can be told, all original daub infill within the building has been removed. It should be emphasised that the infill

The earliest surviving part of the house at Chillmill is restricted to the eastern two end bays (*ie* the section to the east of the axial chimney). Based upon stylistic evidence, this part dates from the closing years of the 15th century [**Period B**]. It was built against the eastern end of a still earlier [**Period A**] house which at this time was retained, but was itself rebuilt subsequently. The period-B work is of high quality and houses a large ground-floor parlour with either one or two chambers over. It was either constructed to replace the earlier house's in-line parlour, or as an enlargement to the original building, aimed at increasing the private accommodation.

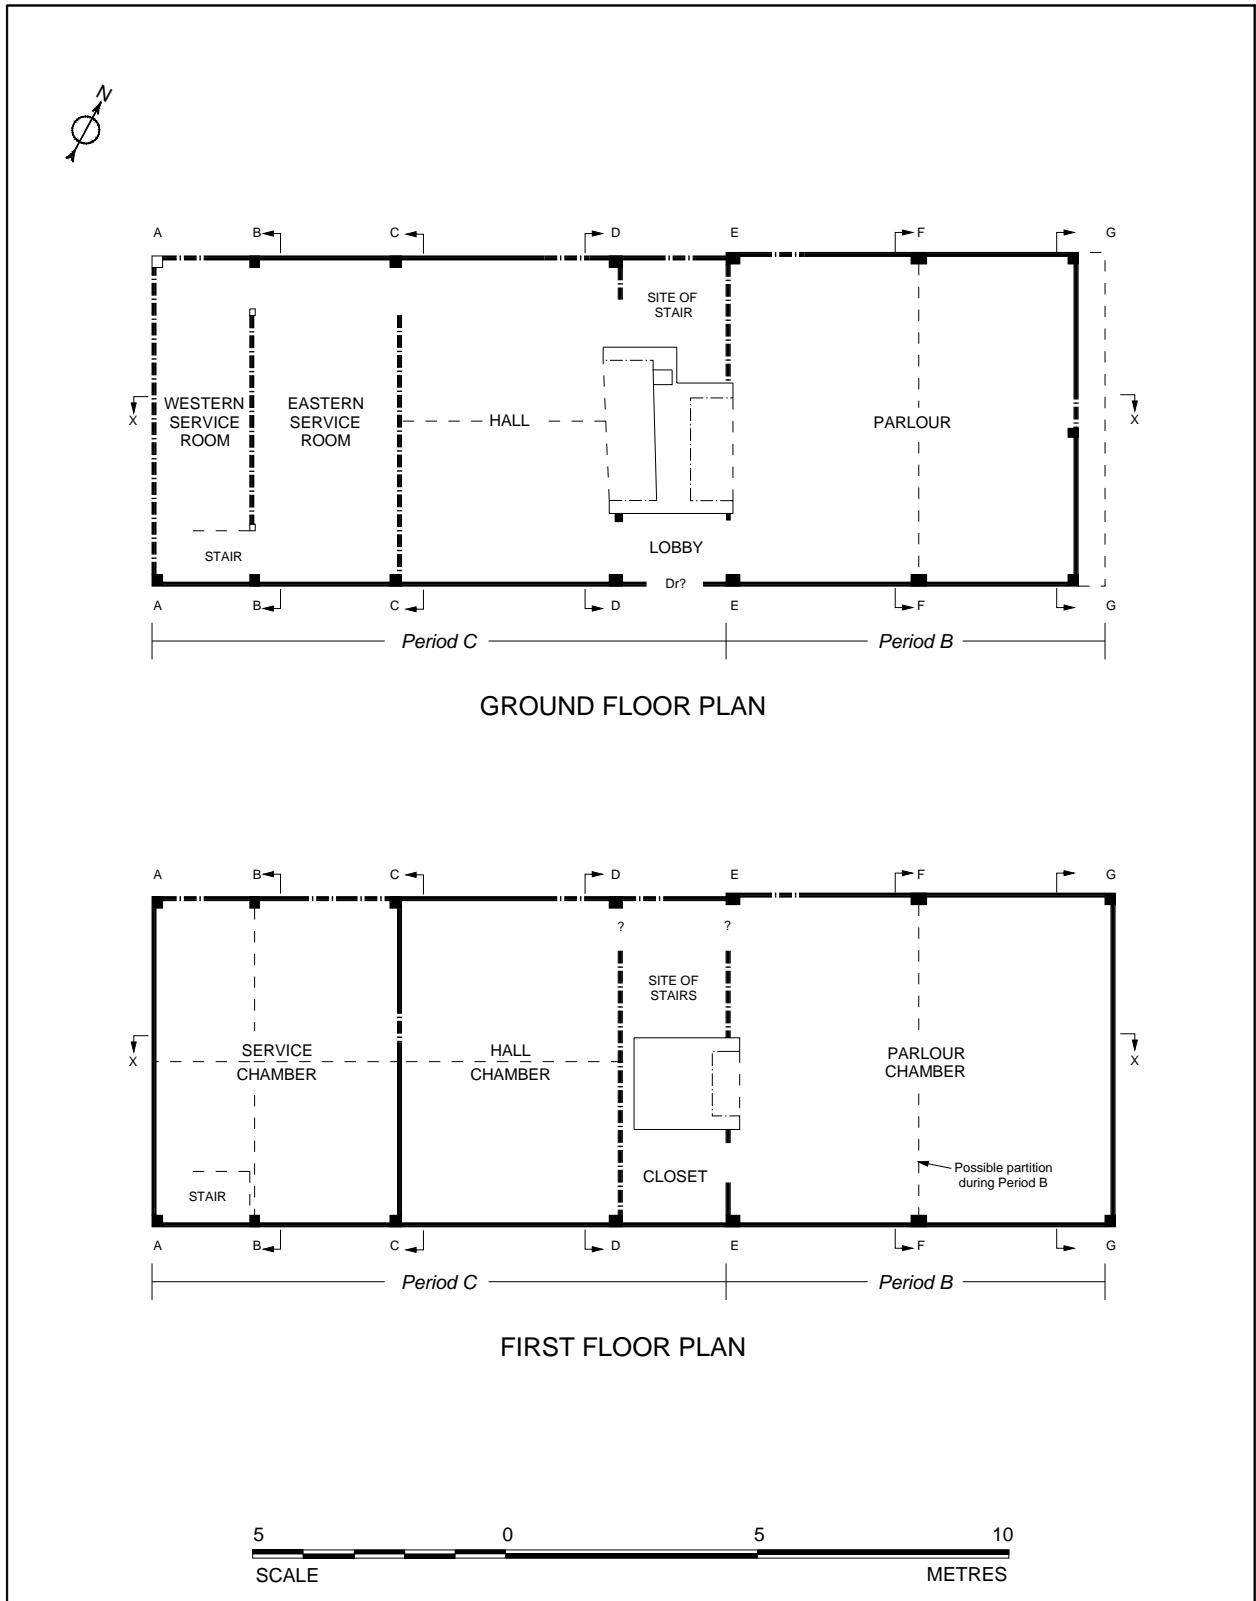
CHILLMILL MANOR, BRENCHLEY, KENT				Project Ref	3347
PERIODS-B AND -C RECONSTRUCTION DRAWINGS				Drawing No.	2
Drawn By	J Clubb	Revision No	-	Date of original survey	2008
				Date of this revision	2008

As has already been mentioned above, the present 7.70 metre x 6.60 metre (25'3" x 21'8") two-bay eastern end of the house represents an extension to an earlier house, though perhaps in itself replacing an earlier structure upon the same site. The period-B frame incorporates an eastern end jetty. On the ground floor the two bays formed a single large room with a very impressive c.2.70 metre (c.8'10") storey height measured from original floor level to underside of the joists. This room was entered from the earlier building to the west via an off-centred doorway (evidenced by mortices in the crossbeam). The arrangement on the first floor is in more doubt. Today this space too functions as a single room, but cut into the soffit of the tiebeam which crosses the chamber are not only mortices for a pair of former arch braces which rose from the principal posts, but also stave holes for a former partition. It is possible that the tiebeam represents a later repair reusing a secondhand timber, but there are no obvious indications that this is the case — in fact all the evidence suggests to the contrary. It therefore seems likely that there were originally two chambers at this level. The problem is, there is no evidence for a doorway through the alleged partition, so if there were two chambers both must have been reached from the room below via their own staircases. There is today no evidence for one, let alone two former stair traps through the floor joisting, but sufficient of the joists have been replaced in modern times for the evidence to have been removed. A further complication is the fact that the windows in the three external walls are arranged as pairs of centrally-placed openings, an arrangement which would best suit a single large two-bay first-floor chamber. However, this arrangement could have been chosen in the interests of external symmetry, repeating the similar arrangement which is known to have existed on the ground floor. Regardless of whether built to accommodate one or two chambers, the first-floor area seems originally to have been open to the roof — a usual feature at this period. The height of the walls at this level is less generous than on the ground floor, though at 2.00 metres (6'7") measured from first floor to top of wallplate, they are, nonetheless, more lofty than in most houses of this period.

The parlour is well built and uses good-quality timbers, neatly finished and of average or slightly above average scantling. The prefabricated frame has swelling jowls to its principal posts, which support the wallplates and tiebeams in normal assembly. All the principal timbers have neatly chamfered edges terminated using stepped and splay-cut/hollowed stops. Mortices indicate that the north, south and eastern external walls were close studded at both ground- and first-floor levels, though only that in the eastern end wall and over one former window in the front elevation now survives *in situ*. Although originally internal, the western wall (truss E-E) which formerly abutted the earlier building was likewise close studded at the lower level, though here the studs

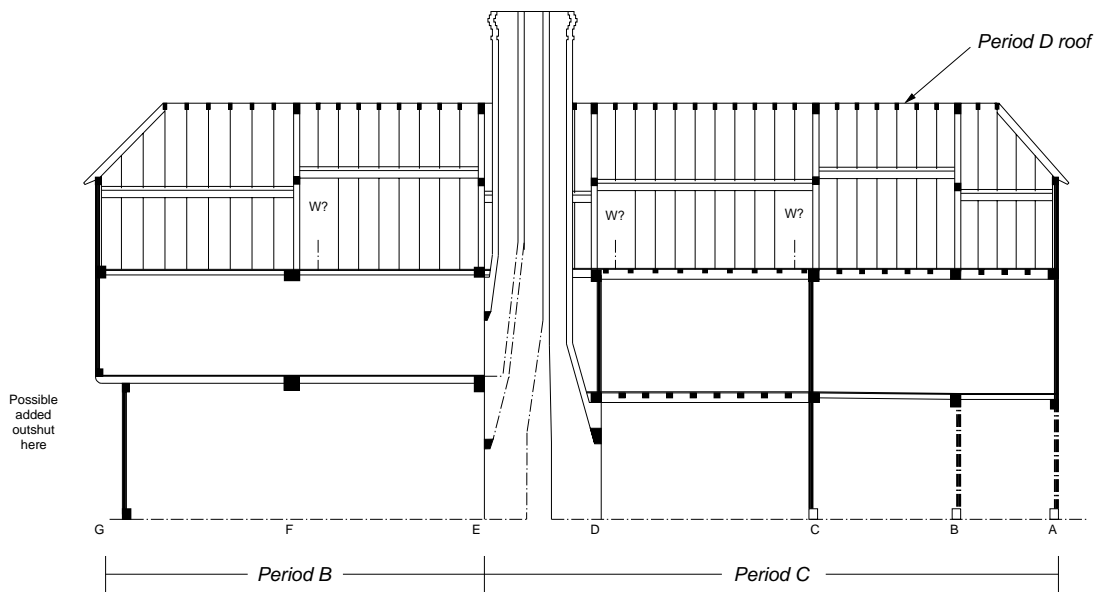
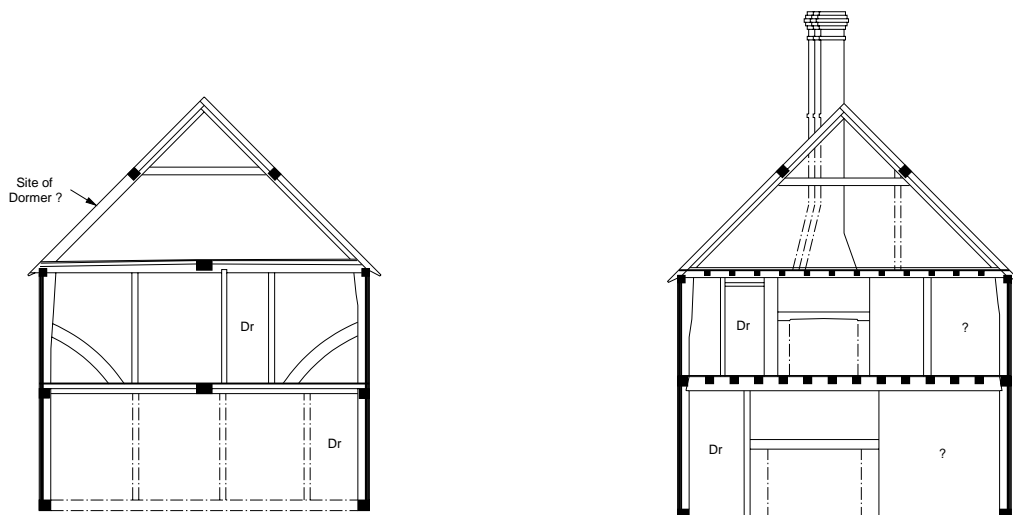
CHILLMILL MANOR, BRENCLEY, KENT				Project Ref	3347
PERIOD-D RECONSTRUCTION DRAWINGS				Drawing No.	7
Drawn By	J Clubb	Revision No	-	Date of original survey	2008
				Date of this revision	2008

As already noted, it was during this general period that the external walls were weather clad, the earlier infill framing being replaced by regularly-set thin studs in order to adequately support the external cladding and rebuilt internal lath-and-plaster partitions. Due to the extent of the early 20th-century restorations, it is difficult now to ascertain what specific alterations were made to the wall framing at this date, but the work seems to have involved upgrading the whole building and re-positioning the windows (all are now 20th-century timber casements). Although now removed, evidence suggests that at this date there were three dormer windows lighting the attic rooms (see 'Roof' below).

Despite the considerable re-infilling of the walls, the principal structural alteration of this period involved the total reconstruction of the roof, almost certainly to a slightly lower pitch than previously. The present period-D roof is of staggered-butt-purlin construction, reusing many of the earlier rafters as its new common rafters — some are of medieval date and are halved for collars. Like the purlins, the principal rafters which support the butt purlins are not secondhand, but were purpose cut for the roof. They rise immediately above the tiebeams and are linked by collars, but the internal roof trusses are absent of queen studs or other infill timberwork. Both roof terminals are half hips (absent of high-set collars at their apex) supported by regularly-studded stub gables, possibly incorporating windows beneath the collars. At three points positioned to a regular pattern within the front roof slope a single peg hole is absent from the lower edge of the purlin, suggesting the absence of a period-D rafter at these points. Although this in itself is not proof, it suggests the locations of three dormer windows, all now removed (see Longitudinal Section in Drawing No. 7). The use of dormer windows to augment light within attic spaces and to enhance the appearance of the front elevation is not uncommon at this period where attic areas are being brought into more common use.
