**AN ARCHAEOLOGICAL
INTERPRETATIVE SURVEY
OF
OASTHOUSE AT HAZELDEN FARM,
CRANBROOK, KENT**

**Commissioned by
CHANTECLAIRE Ltd.**

PROJECT REF. 3806

**Archaeology South-East
Institute of Archaeology
University College London**

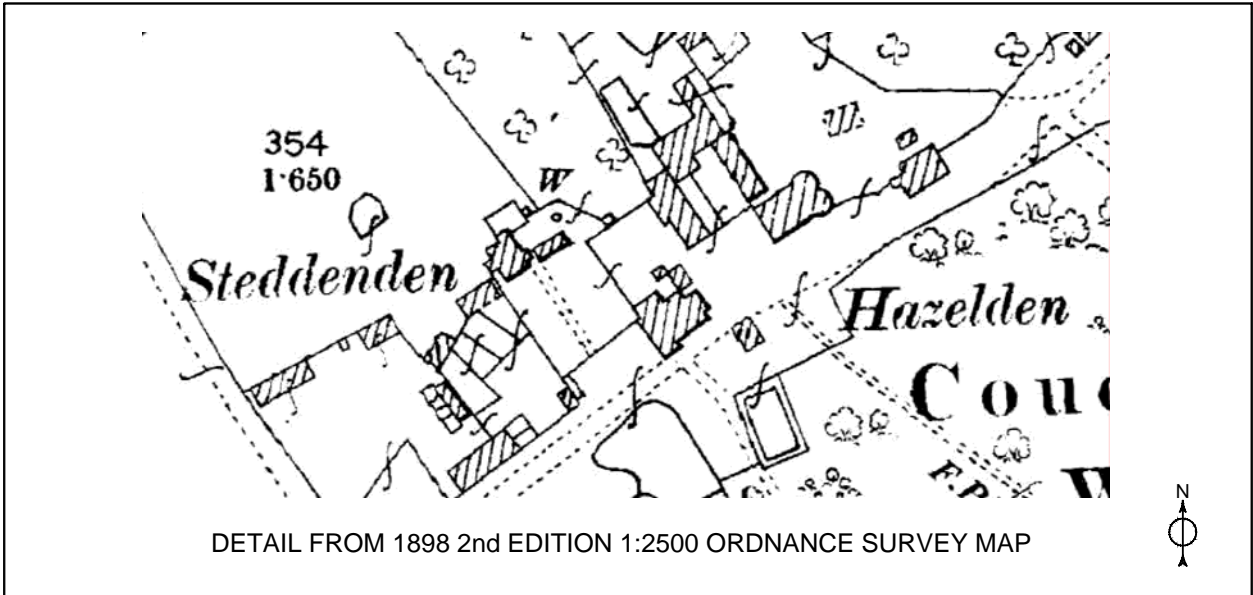
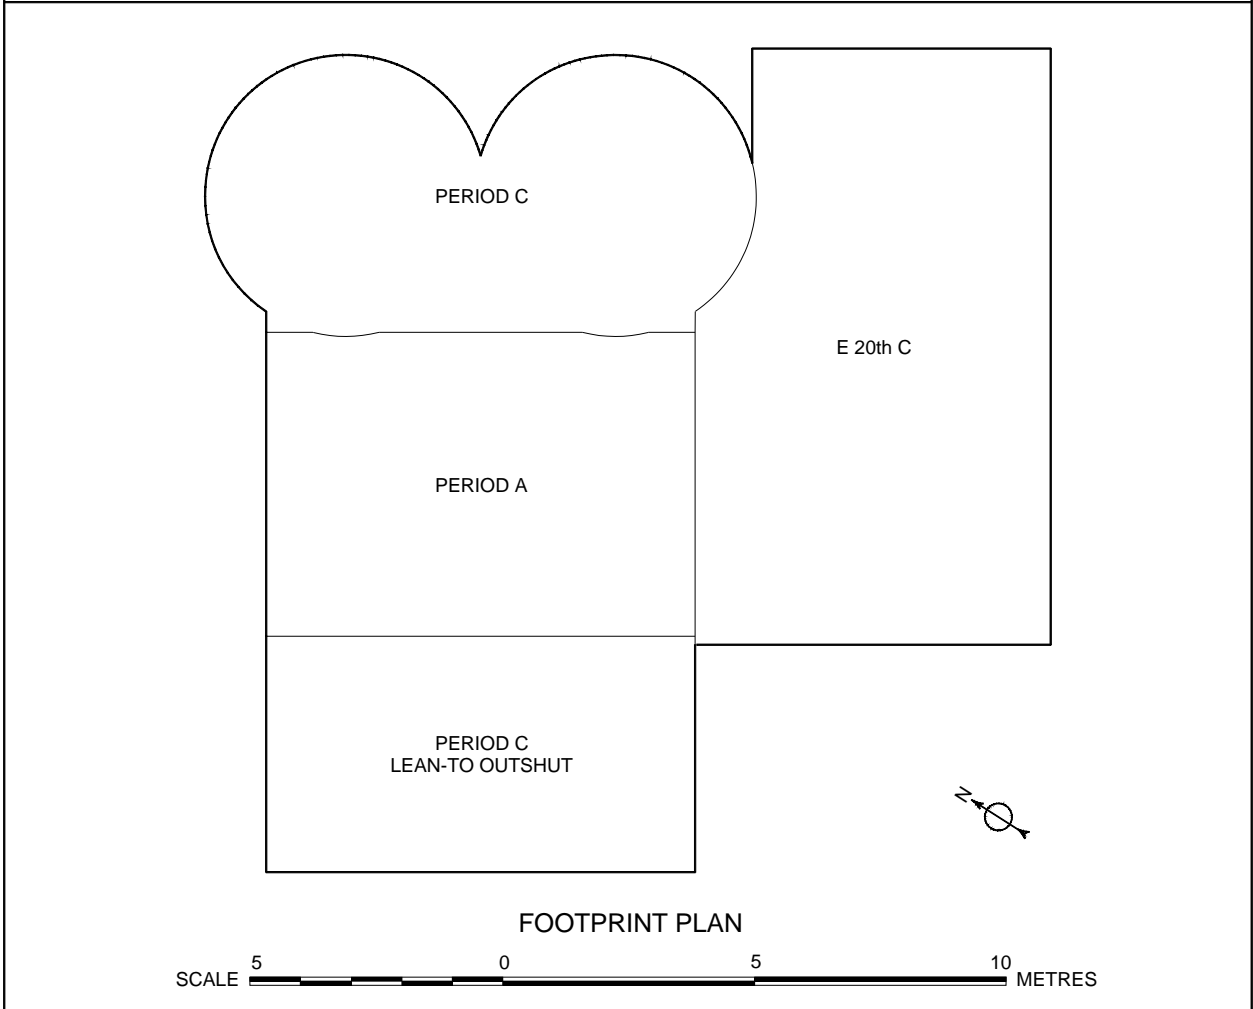
OASTHOUSE AT HAZELDEN FARM, CRANBROOK, KENT OUTLINE PLAN SHOWING SEQUENCE OF DEVELOPMENT				Project Ref	3806
				Drawing No.	2
Drawn By	J Clubb	Revision No	-	Date of original survey	2009
				Date of this revision	2009

A three-bay, two-storeyed, timber-framed structure was built on this site during the 17th century [**Period A**]. The function of this building is unknown, though it appears to have been designed for a specific purpose, having a narrow central bay with larger bays to either side, with high floors over each bay. On the ground floor each area was probably partitioned-off from the central bay, though this point cannot now be proven. The roof was fully hipped and quite shallow, though it was thatched. The structure was accessed via pedestrian doorways at front (west) and rear (east), leading into the central area.

During the 18th or early 19th century [**Period B**] the building was converted to an oasthouse. A conical flue and cowl were inserted into the centre of the roof, and it is probable that the two separate upper floors were removed and replaced by a single drying floor. This period of use must have lasted for some duration, as there was time enough for the tops of the rafters either side of the conical flue to rot and be repaired before the conical flue and associated cowl was removed.

This small oasthouse was enlarged in the mid 19th century [**Period C**] by the addition of two brick-built roundels to the rear (east), and a large lean-to outshut was added at the front (west). The earlier structure, now almost completely enclosed by the new builds, was re-floored, with a staircase just inside the former front wall leading to the first floor and a further fixed ladder leading to a new landing at period-A/B roof level, from which the roundels' high-level drying floors were accessed. Double doors cut through the northern end wall allowed carts to be brought into the structure, and two treading holes were incorporated into the new first floor in order that the hop pockets could be easily filled.

Thus, up to the close of the nineteenth century, the oasthouse continued in its symmetrical form, as can be seen on the 2nd Edition 1:2500 Ordnance Survey (O.S.) map (see Drawing No. 2), with two roundels and plenty of processing and storage space attached. During the early 20th century, greater hop-drying space must have been required, as a third drying floor was built, contained within a brick-built square kiln to the south of the roundels, accessed from a new southwards extension added to the original structure. The extension is capped by a kingpost roof which displays some *ad hoc* elements, especially where the roof turns. In its southern wall it incorporates ground-floor double doors and a first-floor pedestrian opening. The drying floor in the square kiln was originally positioned 4.95 metres (16'3") above ground-floor level, accessed from a high-level door in the structure's western wall and roof slope. In more recent years, this drying floor has been removed, and a new floor built at the same level as the first floor in the earlier structure. The door into the square kiln has been blocked and a new doorway cut through at first-floor level.

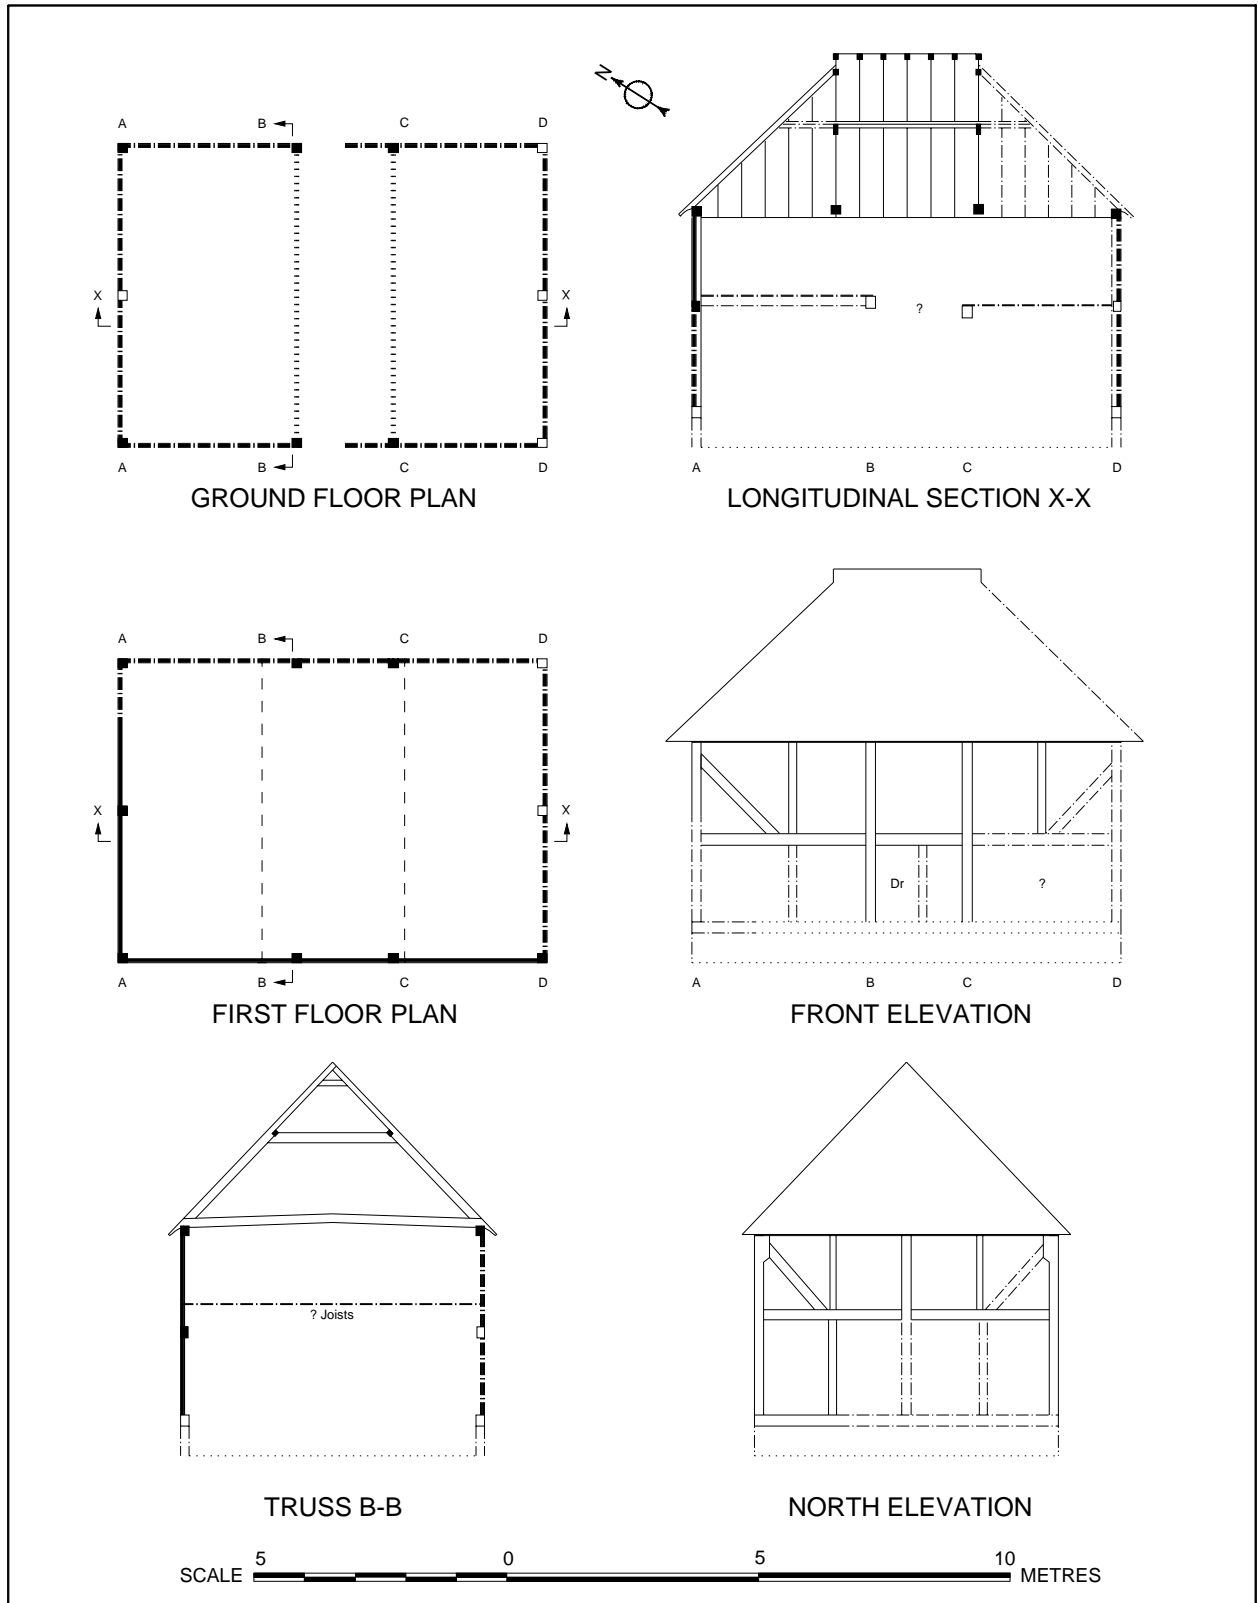
OASTHOUSE AT HAZELDEN FARM, CRANBROOK, KENT PERIOD-A RECONSTRUCTION DRAWINGS				Project Ref 3806
				Drawing No. 3
Drawn By J Clubb	Revision No -	Date of original survey 2009	Date of this revision 2009

The initial structure in this location was a relatively small, three-bay, timber-framed building measuring 8.50 metres (27'10") long and 6.00 metres (19'8") wide, with its principal elevation facing west. The three bays of the building's box frame do not correspond with the three bays of the roof: those in the roof are of almost equal length, whereas the central bay of the main frame is much narrower than the areas to either side. The reason for this very unusual configuration is not known, but there must have been a particular purpose for offsetting the principal posts from the tiebeams. One reason may have been that the crossbeams jointed into the principal posts were required to support the heads of ground-floor partitions, forming a central area linking the front and rear doorways. The tiebeams are framed to respect the roof configuration. The height of the building is 3.95 metres (12'11") from the underside of the soleplate to the top of the wallplate, but the ground floor may have been lowered, as suggested by an original length of soleplate which now stands 590 mm above ground level, on a low brick wall.

As the internal, cambered tiebeams are not positioned above the principal posts of each internal truss, these posts are jowl-less, but the tiebeams are still held in normal assembly over the wallplate. The surviving posts in the north elevation (truss A-A) have splay-cut jowls, and all four corner posts were braced by externally-visible footbraces, of which two survive. In the front elevation, the longer bays (A-B and C-D) incorporate a central stud; the front ground-floor part of bay B-C also has a stud, but this is set slightly off-centre and acts as the jamb for the front door. A similar arrangement existed in the rear wall. The wall panels were infilled with lath and plaster, which has since been removed.

The two openings evidenced within the frame of this period are both pedestrian doorways, positioned adjacent to truss B-B in the front and rear walls. Their locations can be seen as a lack of stave mortices in the underside of the side-girts in this bay, between the principal post and the slightly off-centre intermediate stud, which acted as the door jamb.

The front and rear principal posts in internal trusses B-B and C-C each display a large mortice in their internal faces to take the end of a crossbeam. The position of the mortices in truss B-B are set higher than the mortices in truss C-C, which makes it unlikely (but not impossible) that there was a floor supported between these two timbers of different heights. It therefore seems logical to suggest that there were two floored areas, one between each end wall and the nearest truss, leaving a narrow, un-floored area in the centre. As both of the crossbeams have been removed, this point cannot now be confirmed and no further details of the floors are recoverable.

The roof to the period-A structure is framed in three, almost equal-length bays. It is of clasped-side-purlin type with diminished principal rafters, which rafters measure 130 mm x 170 mm below the purlin but only 130 mm x 110 mm above. Each end of the roof was hipped: the northern terminal remains, but the southern hip and associated hip and jack rafters have been removed. The surviving central jack rafter rises to a high-set collar jointed into the principal rafters, which gives the hip a very shallow pitch. Indeed, the roof itself is quite low, and has a relatively shallow pitch, especially considering that it was thatched (evidenced by rope stains). The surviving purlins have now been cut just beyond the collars, though they seem originally to have extended to the hip rafters.

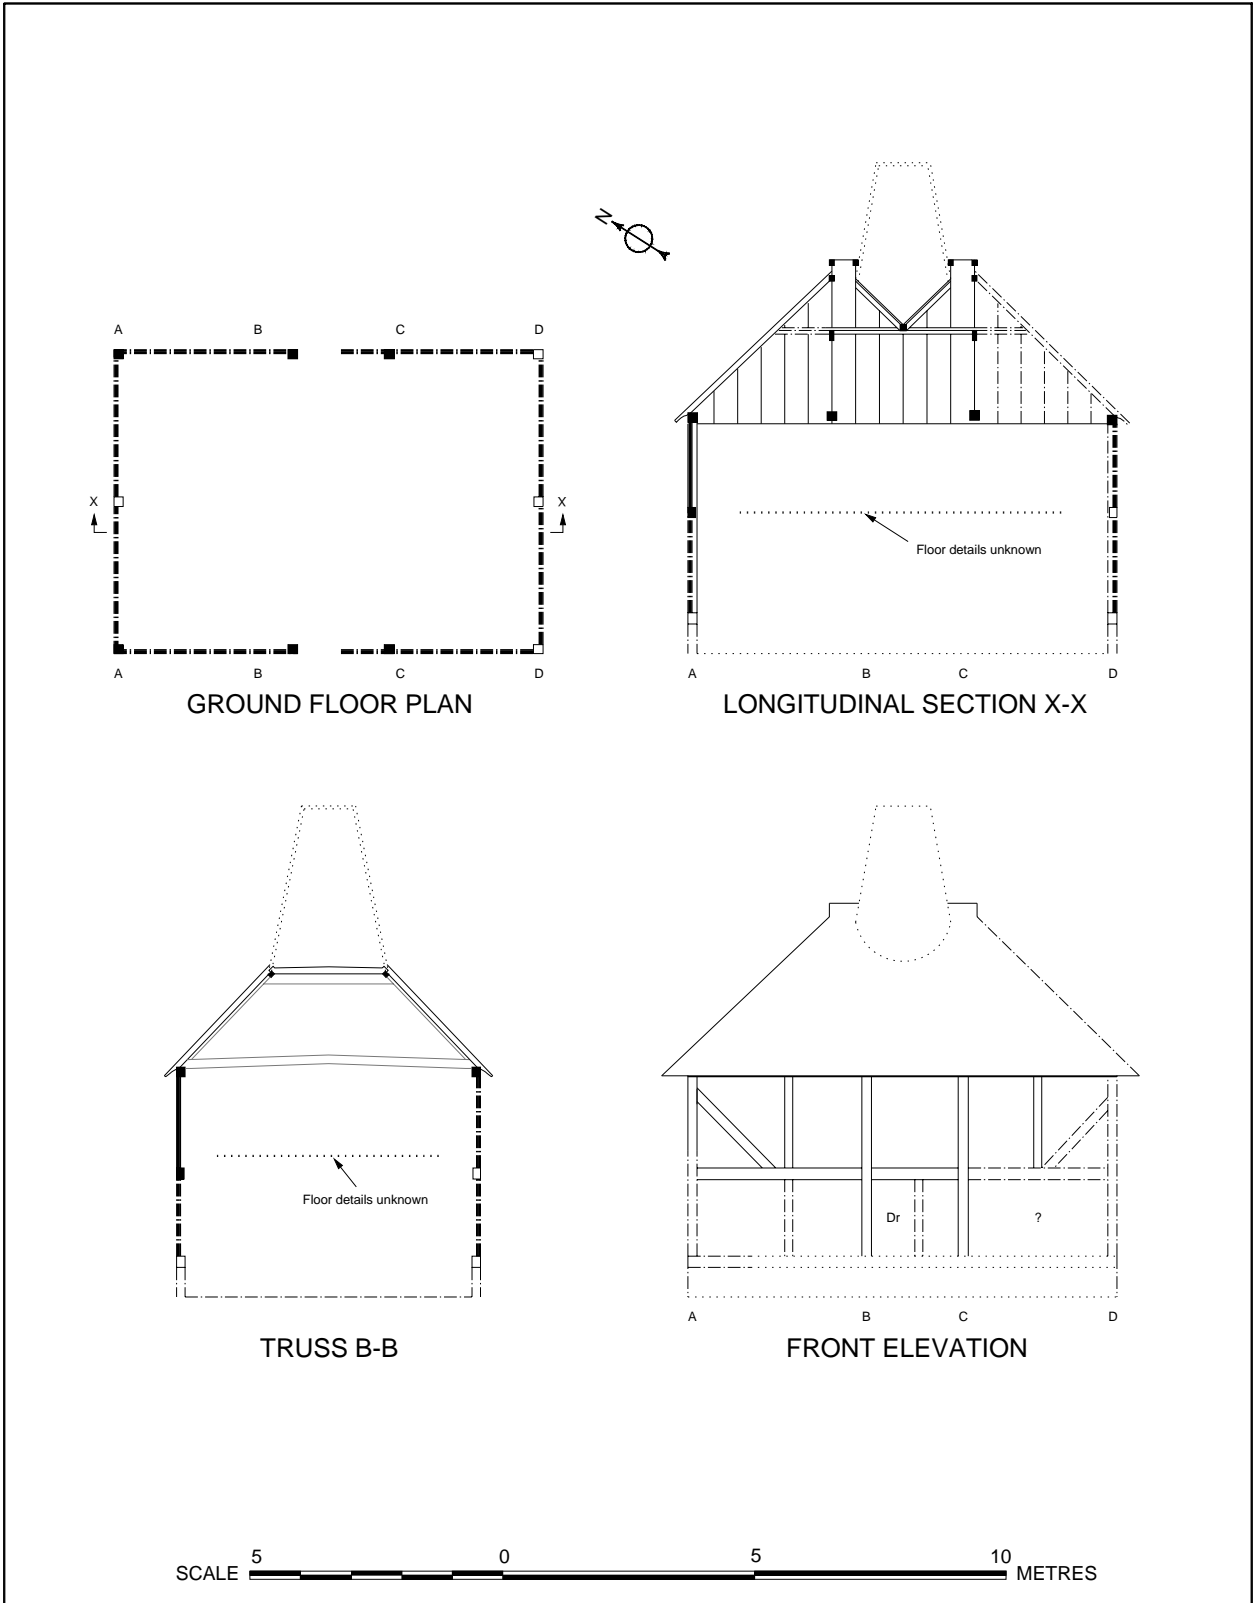
OASTHOUSE AT HAZELDEN FARM, CRANBROOK, KENT PERIOD-B RECONSTRUCTION DRAWINGS				Project Ref 3806
				Drawing No. 4
Drawn By J Clubb	Revision No -	Date of original survey 2009	Date of this revision 2009

During this phase, the earlier structure of unknown function was converted to use as an oasthouse. The (possible) two ground-floor partitions were removed in order that the ground floor could house the kiln. A conical flue and cowl were fitted into the roof.

The roof was altered at this date to take a flue and cowl. In order to support the cowl, a collar was sprung-in mid-way along the roof over the tops of the purlins, and in both roof slopes, timbers were fixed at approximately 45 degrees, rising from the end of the new collar, interrupting the three central rafters. This supported the conical flue which

projected through the roof. Both the flue and its cowl have since been removed.

Probably due to the water run-off to which the rafters were now exposed, the ends of the two full-length rafters either side of the conical flue have rotted. This must have occurred after the flue was built, but before the roof was altered again in period C, as, prior to the removal of the flue, repair splints were added to both sides of both rotted rafters. As is indicated by the rope stains which extend across both the original timbers and the new repairs, the roof was still thatched during this period.

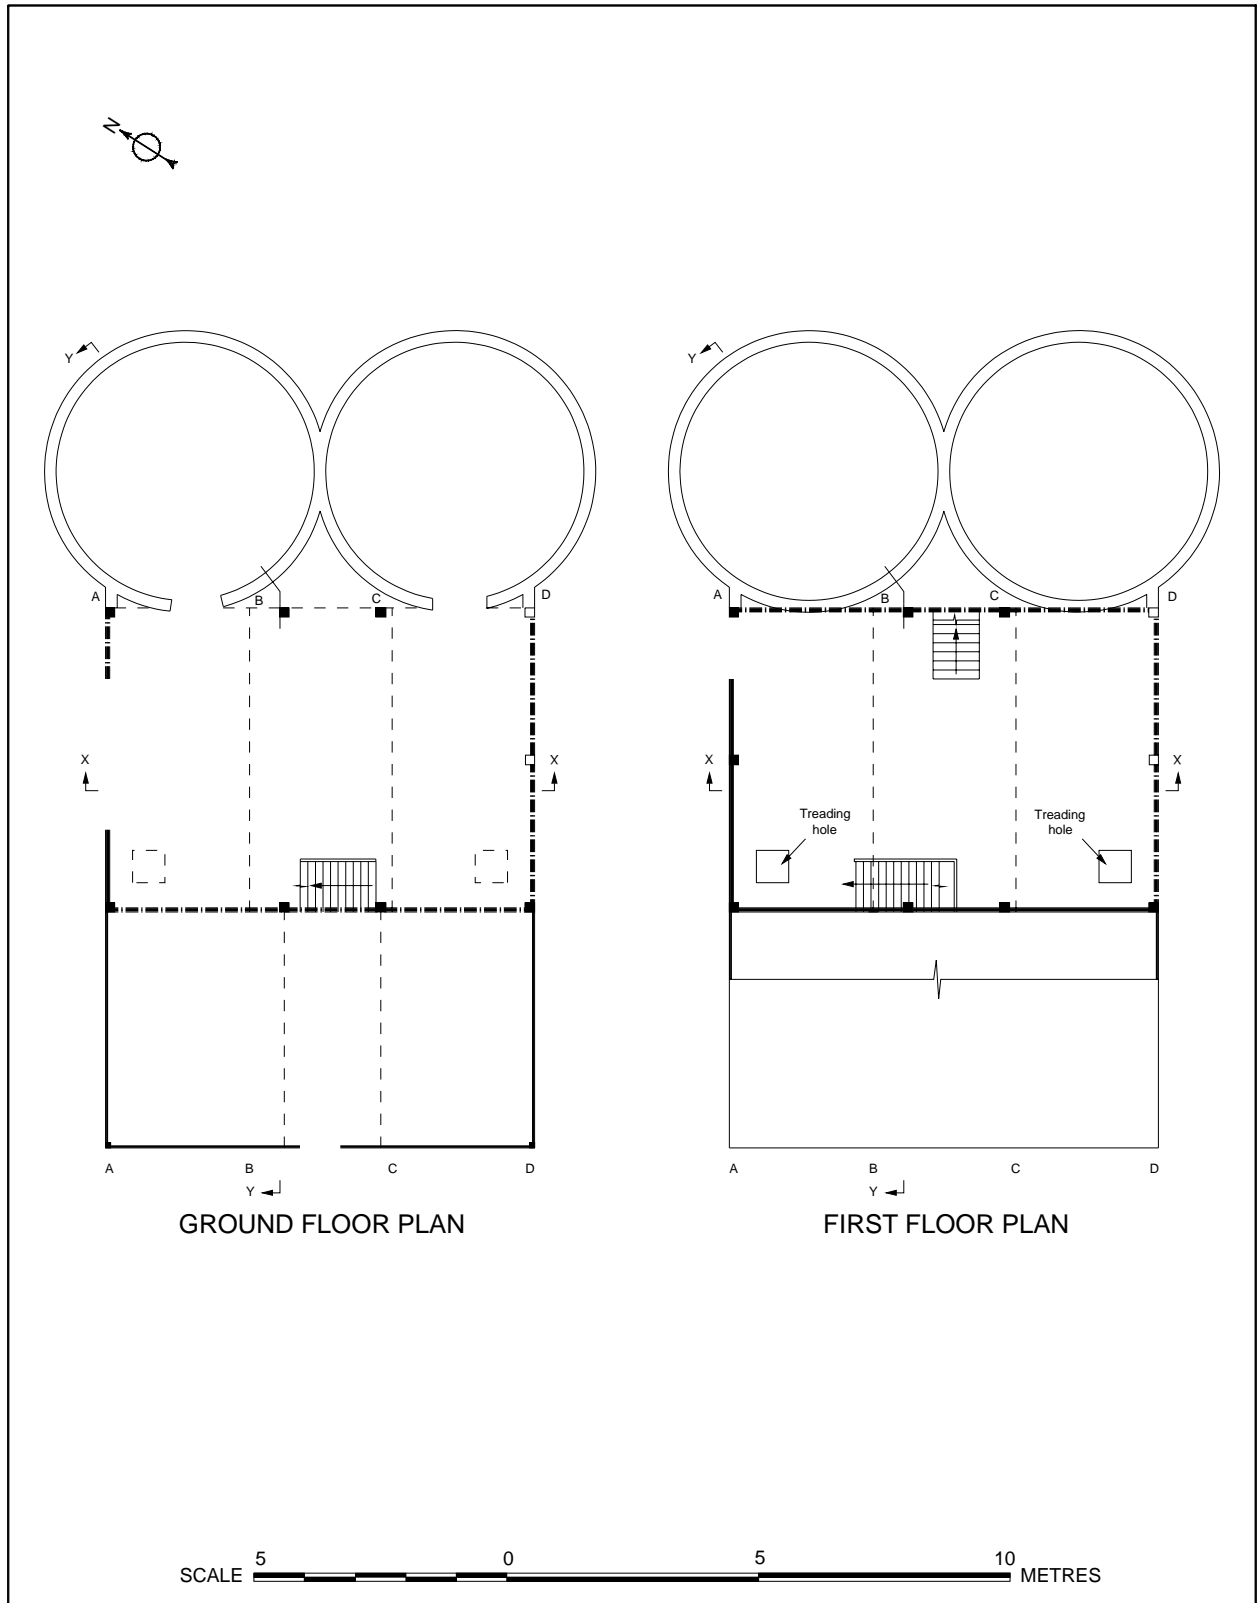
OASTHOUSE AT HAZELDEN FARM, CRANBROOK, KENT PERIOD-C RECONSTRUCTION DRAWINGS				Project Ref 3806
				Drawing No. 5
Drawn By J Clubb	Revision No -	Date of original survey 2009	Date of this revision 2009

The simpler oasthouse of the previous period was at this date enlarged by the building of two roundels on the eastern side of the structure, and the addition of a large lean-to outshut on its western side. The brick-built roundels are together wider than the original building, each having an internal diameter of 5.10 metres (16'8"), but they are set centrally, maintaining the symmetry of the building. The ground-floor area of the roundels is accessed from within the period-A structure, and in each case they have been stripped of their furnaces and associated firing tunnel. Access to the drying floors is gained via doorways which open onto a high-level landing area between the period-A/B roof void and the upper part of the roundels, which landing area is capped by a pitched roof (see Drawing No. 6).

The roundels are of brick, laid in Sussex bond, rising from a square-topped plinth and capped by a projecting, serrated-brick eaves detail. Just above the plinth are semi-circular-arched vents, with moulded, quarter-circle bricks capping the openings. Internally the vents are closed by sliding wooden shutters.

There is one doorway into each roundel on the ground floor, both openings having a segmental-arched head. The doors from these openings have been removed in order that the kilns could be fitted with gas or oil pipes. The doorway into the southern of the two kilns is taller than that into the northern kiln, but the reason for this distinction is not obvious. The wide doors giving access to the drying floor are of one-and-a-half leaves, and are 1.85 metres (6'1") high; as these doorways overlap the slope of the roundel roof, a small ceiling has been incorporated between the doorhead and the roof slope.

The period-B first floor was rebuilt at this date. The new floor is framed in three bays, not exactly respecting either the roof bays or the bays of the main frame. It is composed of north-south aligned joists jointed into the new crossbeams, approximating to the positions of trusses B-B and C-C. At the northern wall, the ends of the joists are carried on a cleat, as they are positioned too low to joint properly into the crossbeam of truss A-A. It is not known how the southernmost joists were carried at their southern end, as the crossbeam to the southern end wall was removed when the oasthouse was extended in the 20th century. Treading holes are incorporated into the new cooling floor, in the north-western and south-western corners of the period-A part of the structure. This allowed one treading hole per roundel. The drying floors within the roundels are formed of 220 mm-deep joists laid over a girder which crosses the roundel at right angles to the joists. The floors in both roundels are positioned 4.70 metres (15'5") above the modern ground-floor level.

The period-B conical flue and cowl were removed and the cut rafters were replaced at this period, the period-C timbers being fixed to a ridgeboard inserted between the period-B splinted rafters. The section of roof over the drying-floor landing likewise incorporates a ridgeboard, but has no windbracing or purlins. It rests over the period-A rafters on lay boards.
