**Allington Sluice, Maidstone, Kent
Historic Building Recording**

Project No. 3863

Report No. 2009111

July 2009

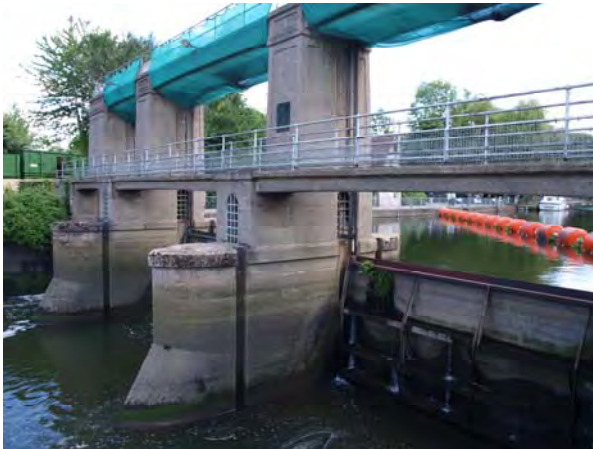
Plate 7

The southern intermediate pier, showing the projecting chamber underneath the lower walkway, taken from the south-west (18)

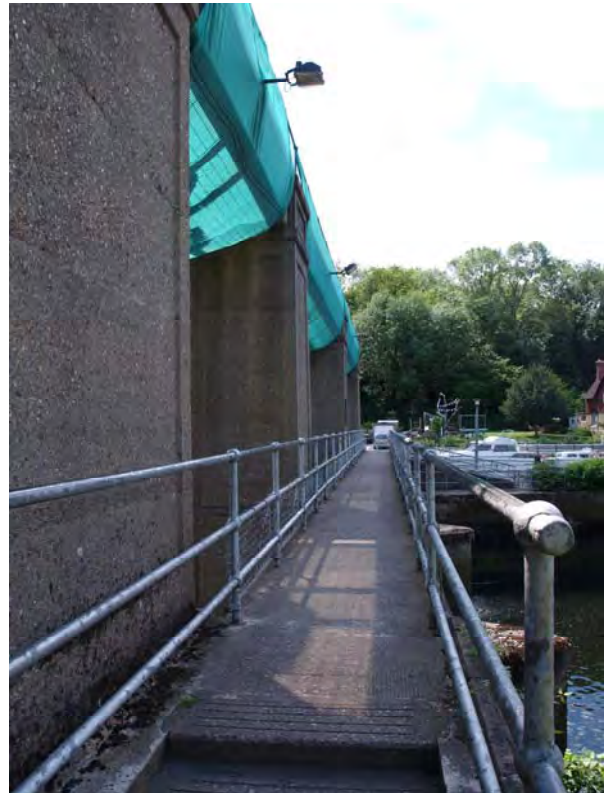
Plate 8

The lower walkway, taken from the north. Note the construction lifts in the concrete on the pier to the left (11)

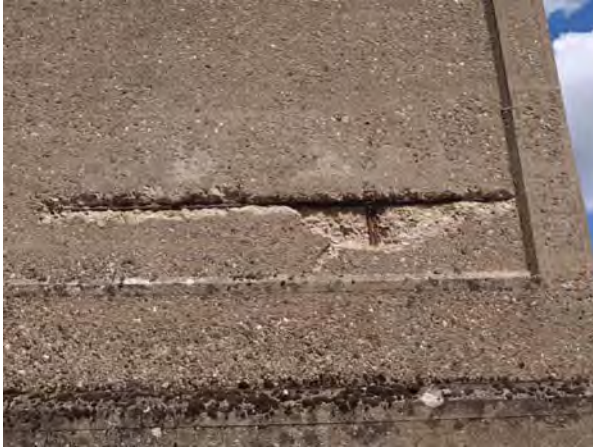
Plate 9

- 5.3 The piers, cutwaters and the lower walkway are constructed of reinforced concrete, in which the construction lifts are clearly visible (Plate 8). There are areas of weathering/damage, where fragments of concrete have fallen off (Plate 9). The north and south sides of the cutwaters are vertical, but at the lower level, the pointed ends splay towards the east and west. The concrete slab which caps these cutwaters projects slightly. The piers are in two unequal-sized sections, divided by a projecting string course: the upper section comprises only the top c.700 mm of the pier (Fig. 4). The walls of the

Area of weathering/damage on the southern pier, taken from the south (19)

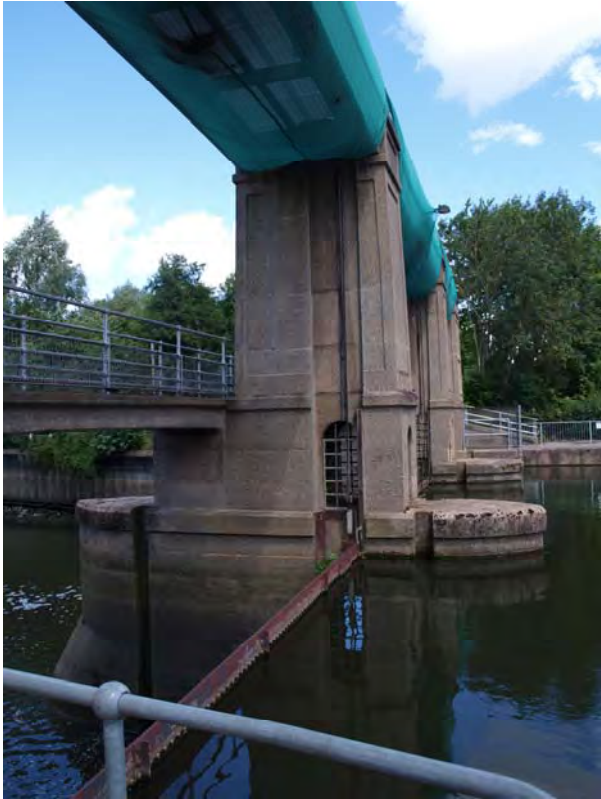
Plate 11

- 5.4 There are no window openings to any of the piers. Each of the end piers has three doorways at ground-floor level: one in the western face, one in the eastern face and one on the internal face allowing access to the gate. The two intermediate piers have doorways in all four wall faces. The door openings are all 1.40 metres tall, have semi-circular-arched heads and are plainly chamfered. These lead into the ground-floor spaces within the piers. The northern and southern doorways in the end piers are closed with wooden doors formed of vertical planks with strap hinges (Plate 10). The doors within the central piers, and those which face onto the sluice gates from the end piers, are closed by metal grilles (Plate 11).

The southern intermediate pier, taken from the south, showing the doorway in its southern face closed by a metal grille, and the top of the southern sluice gate (21)

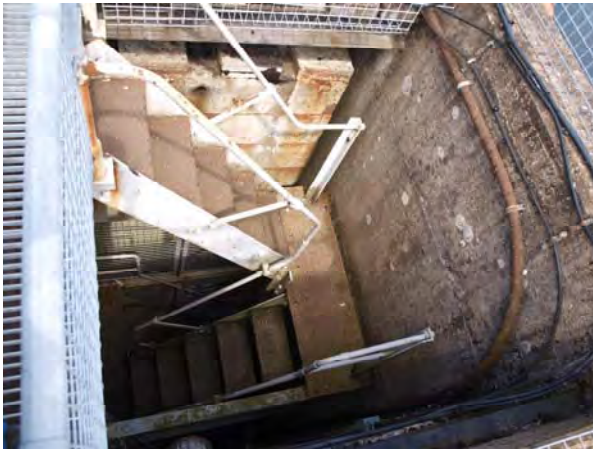
Plate 13

- 5.5 The concrete lower walkway (Plate 8) is raised approximately 2.00 metres above ground level, supported on shallow arches between the piers, and is reached by a dog-legged, shallow, closed-string stair at each end (Plate 12). The stairs which provide access to the upper walkway are of metal: they comprise four short, steep flights turning on half landings with a continuous inner handrail and short sections of outer handrail closing each flight of steps (Plates 13 & 14). The upper walkway is supported on arches between the piers on the eastern and western sides, though the top face of the concrete around the upper walkway is flat (Plate 6). Lateral support for the upper walkway floor is provided by iron 'I' beams, which are positioned either side of each piece of operating equipment, directly supporting each of the larger pieces, with intermediate beams incorporated in the centre of a wide gap. The walkway originally had timber floorboards: the 'I' beams have holes in their top faces to take bolts which secured the boards. Most of these timber boards have been removed, but some timber boards survive along the eastern edge: these may be the original boards (Plates 15 & 16). The timber floor has been replaced by a metal grid floor, supported on metal bearers resting on the ends of the 'I' beams. The handrails to the stairs and walkways are of galvanised metal (Plate 8): the style of these suggest that they are replacements, though they may approximately replicate the form of the original.

The stair rising to the upper walkway within the southern pier. Note the continuous handrail on the inside of the stairs (27)

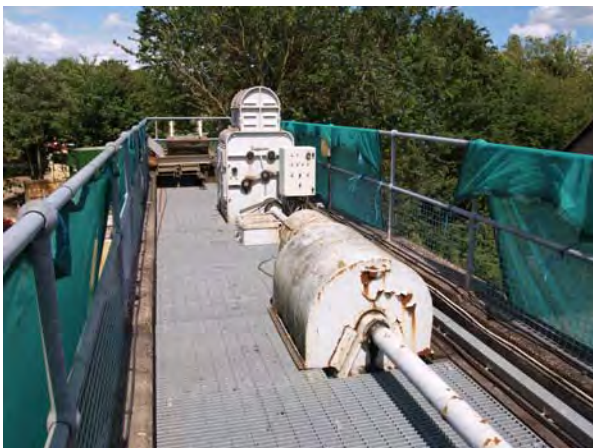
Plate 15

- 5.6 The three sluice gates are slotted into wide grooves which continue up the entire pier. The gates are formed of metal plates riveted to uprights fixed on the western (downstream) side, and have horizontal ledges at intervals, three of which are visible above the waterline (Plate 7). At the top of each gate are two top-hinged shutters which can be opened to allow varying quantities of water to pass through whilst the gates are closed (Plate 17). The gates are lifted by steel cables on each end. The operating equipment for the gates is supported by the upper walkway. There are separate motors and gearboxes for each gate, and a rope drum for each steel cable (two to each gate; Plates 15 and 21). These three pieces of equipment are connected by a single shaft. Each gate was also served by a level (Plates 18 & 19) and a control box (Plate 20). The southern and central control boxes appear to be original, but the northern control box has been replaced with a more modern version (Plate

15). Though each gate was designed to be electronically operated, there is also a manual winding handle attached to the northern face of each motor and gearbox.

The northern end of the upper walkway, taken from the south, showing the operating equipment for the northern and central sluice gates. The larger piece of equipment in the background is the motor and gearbox, whilst the smaller piece in the foreground is the rope drum. Note the cables on the right, fixed to a timber floorboard, and the modern control box against the motor and gearbox (34)

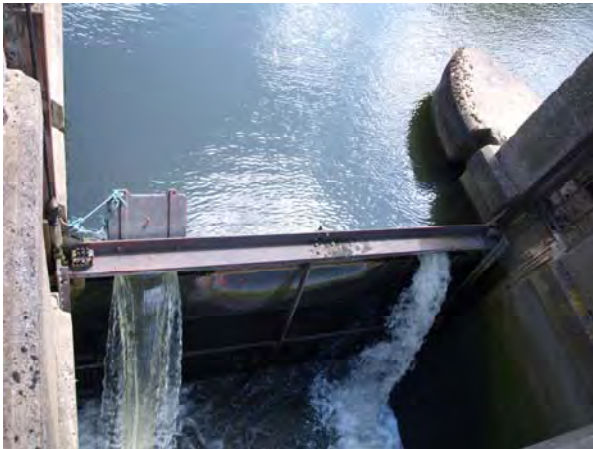
Plate 17

The smaller, northern sluice gate, taken from above. The hinged shutter is clearly visible on the left, the position of the second shutter can be seen by the stream of water on the right (12)

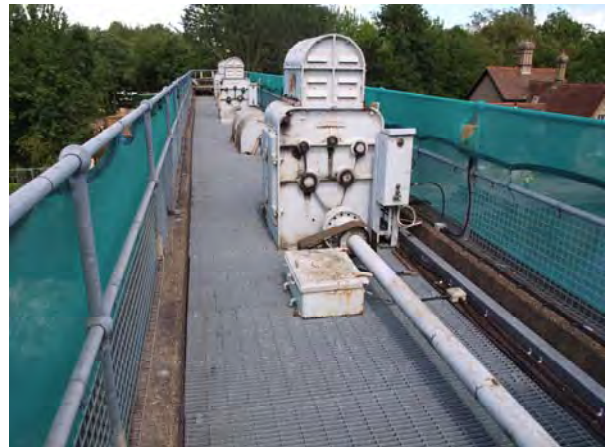
Plate 20

The upper walkway, taken from the south. All three motor and gearboxes are visible. Note the two original control boxes attached to the motor and gearbox in the foreground and background (28)
