**THE MAINTENANCE YARD, THE OLD PALACE,  
MAYFIELD, EAST SUSSEX**

**HISTORIC BUILDING RECORD**

**Report No. 2010050**

April 2010

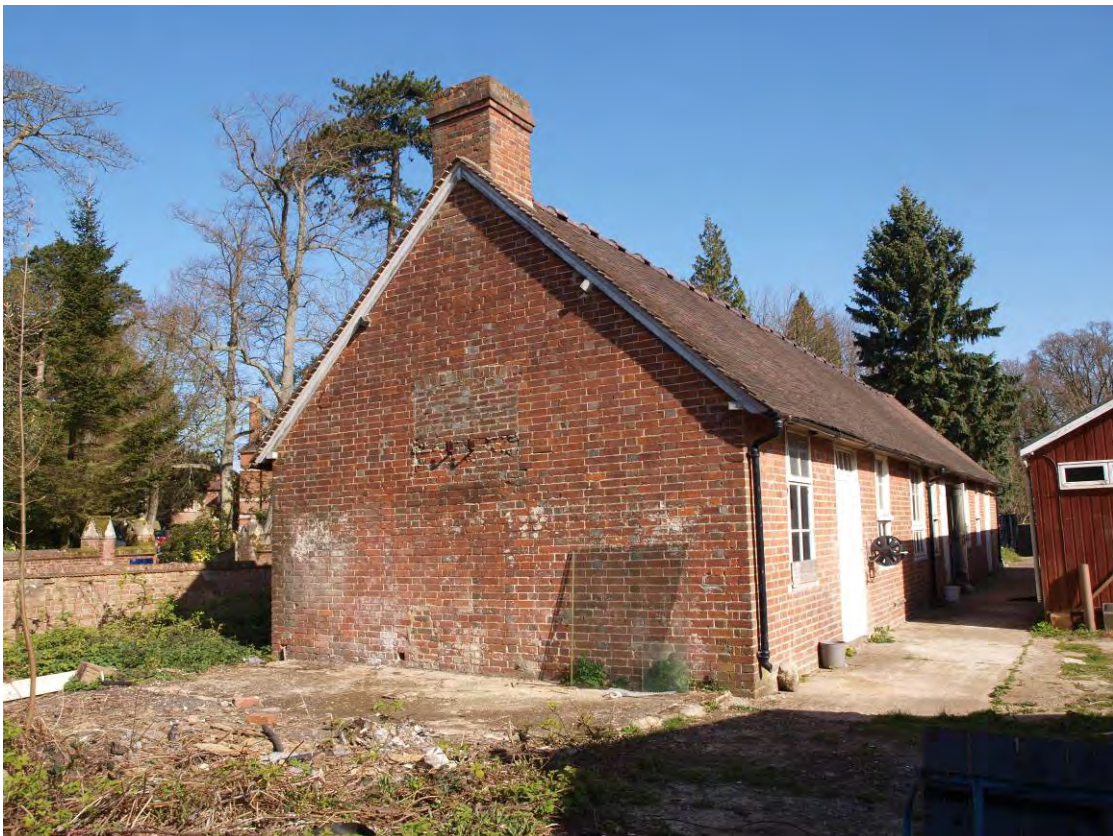
Plate 1. Building 1 from south

4.1.1 Building 1 lies on the western side of the site, adjacent and parallel to Building 2. It is a rectangular, single-storeyed, single-phase structure constructed in brick laid in Sussex bond, and is aligned upon a north-south axis. The building dates from c.1900. It has a tiled roof with equally-spaced vents in the ridge. The roof is gabled at both ends: in the south gable there is a blocked arched-headed window; in the northern gable there is a blocked high-level window with an inserted window lower down. At the southern end of the building there is an internally-projecting chimney: this chimney rises

above roof level, but internally, the stack is truncated at approximately wallplate level.

- 4.1.2 There are three doors in the east wall, but no doorways in the west wall. The fenestration is varied; the windows are timber-framed, but of different sizes and styles. There are four windows in the west wall. Some openings have queen-closed jambs, but some openings have been cut through the brickwork, indicating that some windows have been inserted after construction.

- 4.1.3 The roof is of side-purlin construction, with queen strut trusses incorporating a ridgeboard.
- 4.1.4 The interior is divided into four spaces with brick and boarded partitions. At the northern end the room is ceiled, but at the southern end the room is open to the roof. The two central rooms have high ceilings and boarded skelings. In all four rooms the walls are plastered to half-height, and they have concrete floors.

- 4.1.5 Pintles on the eastern wall at the north-eastern corner indicate that there was once a gate hung on this wall. Around the roof there is cast-iron guttering with cast-iron downpipes.

- 4.1.5 Building 1 appears to have been used for storage, as there are shelves in the rooms, and has probably been used as teaching space.

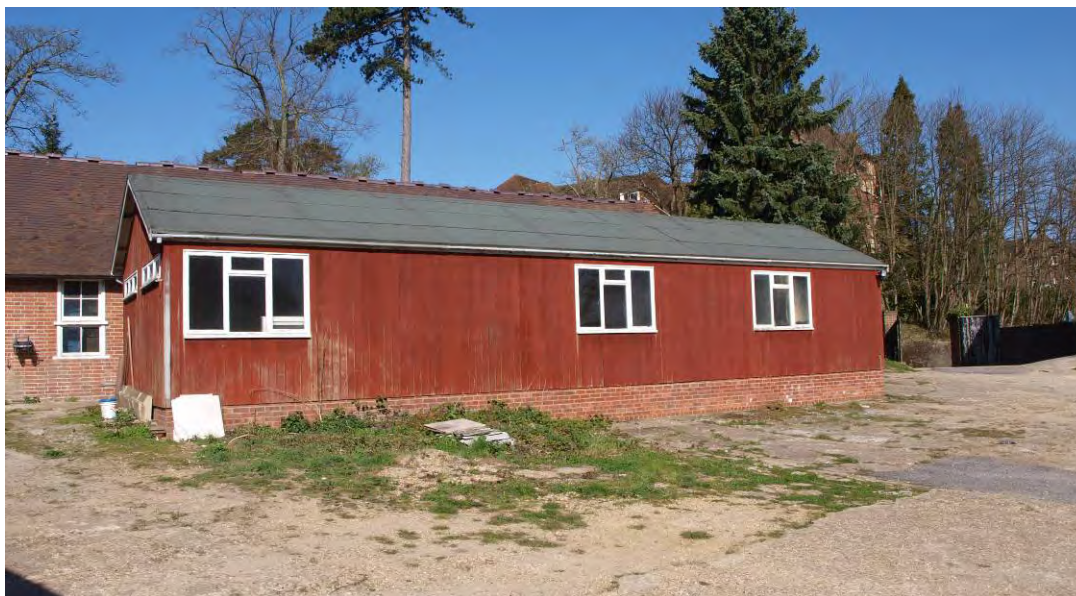
Plate 2. Building 2 from east

- 4.2.1 This building is of typical 1970s construction. It is single-storeyed, rectangular and lies upon a north-south axis. The walls are of tongue-and-groove panelling supported on a low brick wall, which is higher on the eastern side as the ground level of the yard slopes downwards from west to east. The roof is of a shallow pitch, gabled at each ends and covered with felt. Around the roof is plastic guttering with plastic downpipes.

- 4.2.2 There are two double doorways in the western wall. The timber-framed windows are arranged with two narrow, high windows in the end walls and large rectangular windows positioned off-centrally in the eastern walls. The glass in these windows is fluted, except for one pane which has been replaced. The glazing of the doors is reinforced with metal mesh.

- 4.2.3 The interior space within the building is divided into two rooms, with a two-bay room to the south, and a five-bay room to the north. The floor in the building is of concrete. The internal faces of the walls are boarded, with fibreglass insulation between the internal and external panelling. There are six approximately-equally-spaced king-post trusses supporting the roof, five of which are exposed, but one of which is enclosed within the partition between the two rooms. The rafters are hidden from view by boarding.

- 4.2.4 This building has been used as a wood workshop and possibly a wood store.

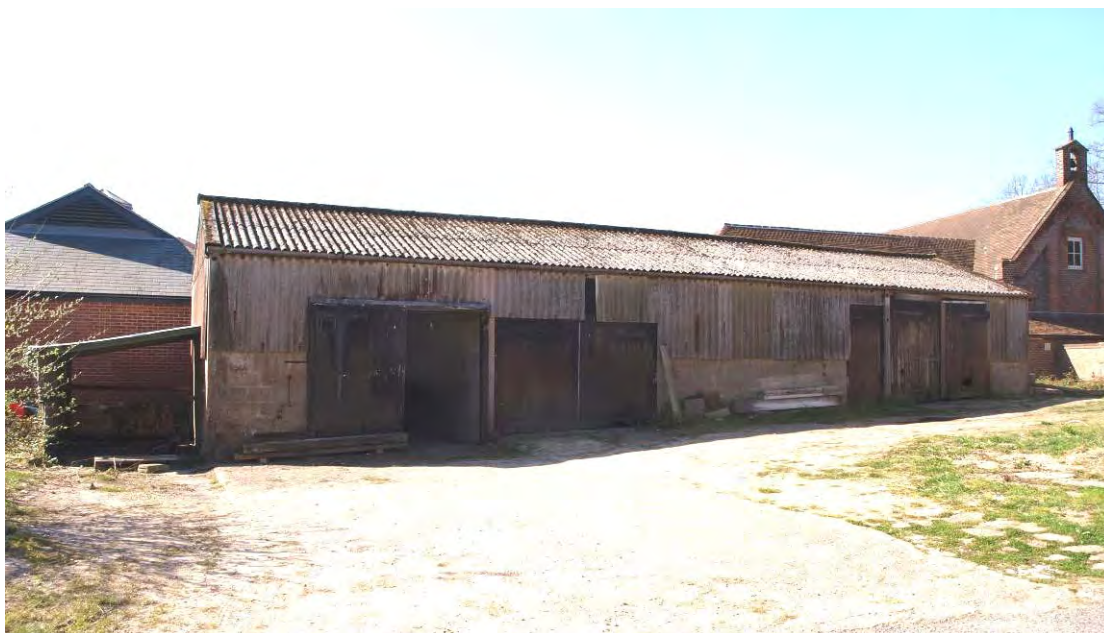
Plate 3. Building 3 from north

- 4.3.1 Building 3 is aligned upon an east-west axis on the southern side of the site. It is a tall but single-storeyed, rectangular structure with a lean-to constructed against its eastern end wall. It is constructed with half-height breeze-block

walls with corrugated asbestos sheets above. The roof and the eastern lean-to are also formed by corrugated asbestos sheets. The ground level slopes downwards along the length of the building from west to east, but the wallplate of Building 3 is horizontal, resulting in a greater wall height to the east. The roof has a very shallow pitch, and is gabled to east and west.

- 4.3.2 There are no openings in the east, south and west walls. Along the north wall there is a series of doors. The doors are of narrow planks hung on strap hinges.
- 4.3.3 This building is divided into two unequal-sized spaces by a breeze-block partition. The smaller room is to the east. This room has a floor over it, which is constructed of north-south-aligned softwood joists and planks. The trusses supporting the roof are of pre-formed concrete. There is a concrete floor which steps with the slope.
- 4.3.4 This late-20th-century building appears to have been used for storage purposes from the outset. In recent years it has been used for vehicle storage and maintenance.

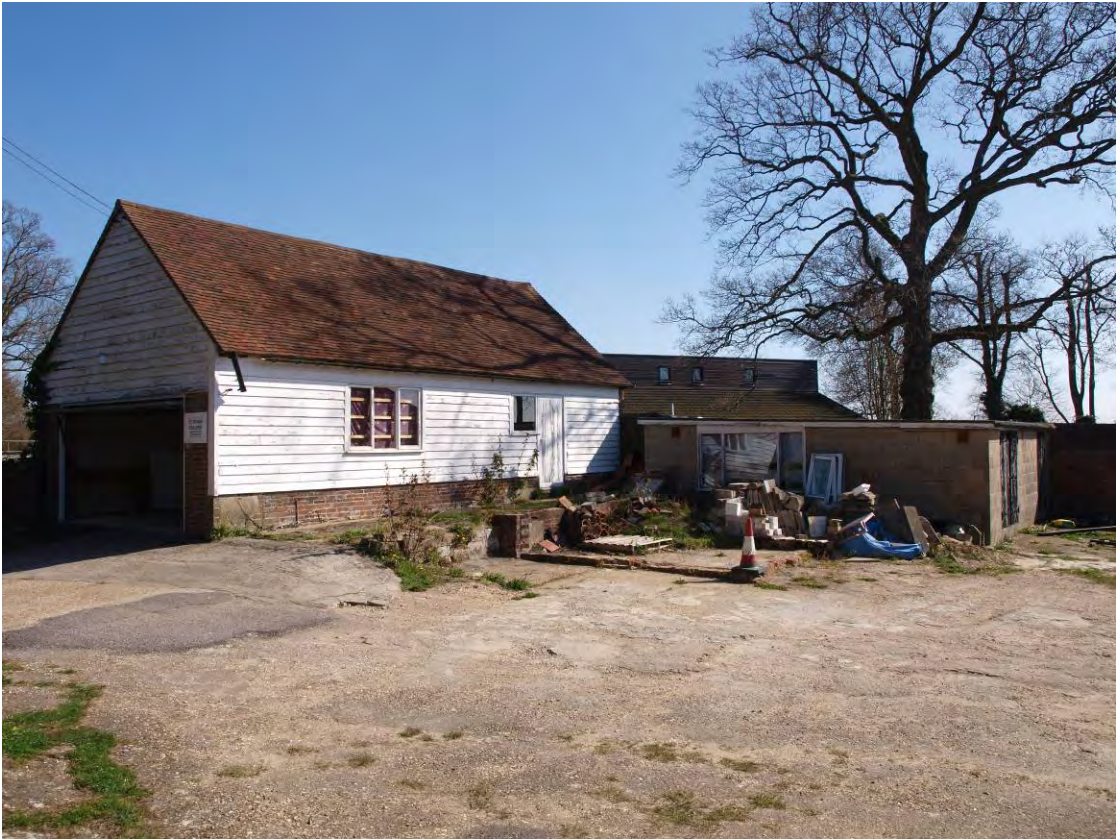
Plate 4. Building 4 and Building 5 from south-west

- 4.4.1 Building 4 lies against the northern boundary of the site. It is a small, rectangular building, aligned on an east-west axis. It has a tiled roof which is gabled at each end. The north and south walls are of timber-framed construction, weatherboarded on the exterior, supported on low brick walls. The east and west walls are of brick to wallplate level.

4.4.2 There is a window in the south wall and a large garage door in the west wall. The jambs for the garage door are formed using queen closers. There are no windows in the north or east walls.

4.4.3 On the interior, the walls and ceiling are plasterboarded. Timber tiebeams spanning the building are supported at the centre by a steel 'I' beam. The building is floored in concrete in two levels. The eastern half of the building has a slightly higher floor level than the floor to the west.

4.4.4 This building, which seems to date from the second half of the 20th century, has shelving units, but as it has no interior lighting, it is presumably used only for storage.

4.5.1 This building is the smallest on the site, and dates from after 1970. It is roughly square and constructed using breeze-block walls, though it incorporates the brick boundary wall as its eastern wall, and part of its northern wall. The building has a sloping flat roof, covered with felt, which is constructed as a grid of softwood joists.

4.5.2 There is a large, three-pane window in the western wall and two double doors in the southern wall. These doors are very similar to the doors into Building 3.

4.5.3 The floor of Building 5 is laid in concrete all of one level. There are no internal divisions, and no artificial lighting, suggesting that this building was used only for storage.

4.5.4 To the west of Building 5 there is a concrete slab with the remains of brick walls which indicates the former existence of a small structure divided into two rooms. There is also a structure to the south of Building 5, built against the dog-leg in the boundary wall.
