**St Dunstan's Church, Mayfield, East Sussex  
Report on the Blocking of the wall between the Bell Tower and Rear Nave**

**Project No. 2583**

**Prepared by Mark Samuel Ph.D MIFA**

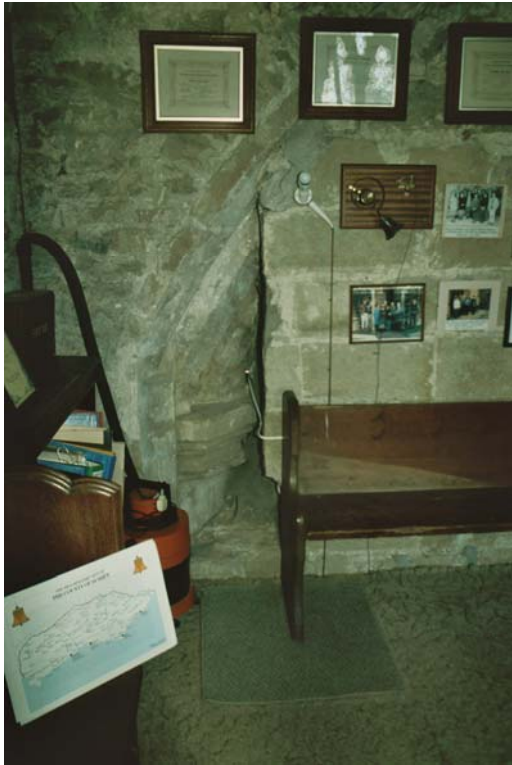
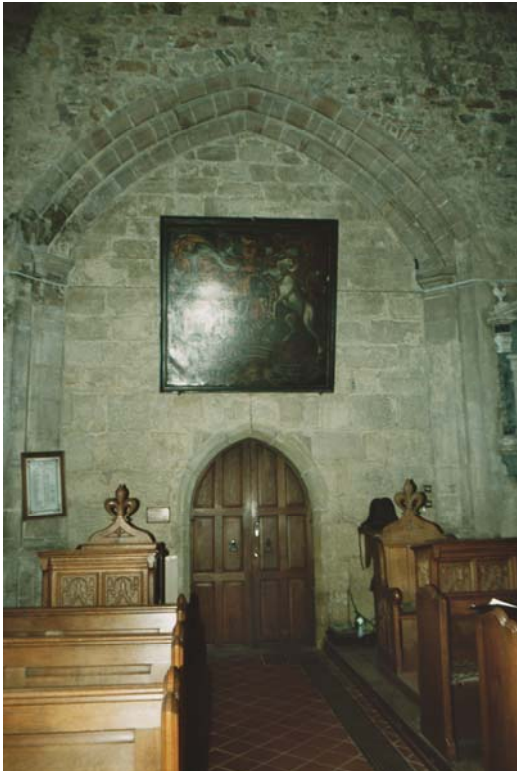
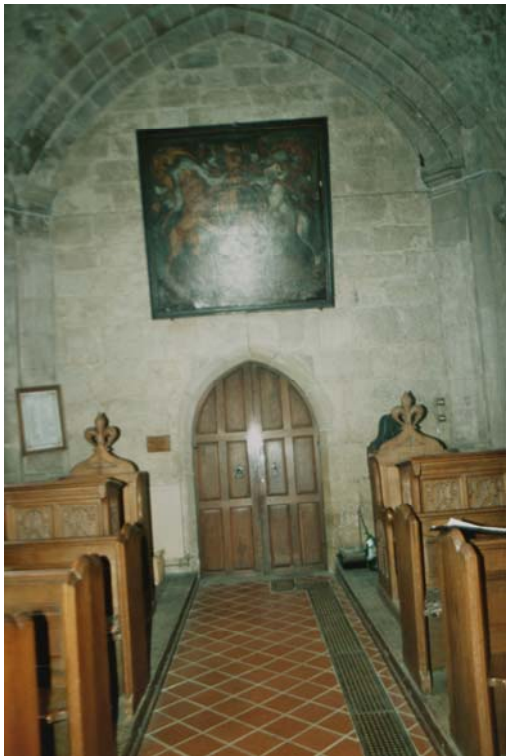
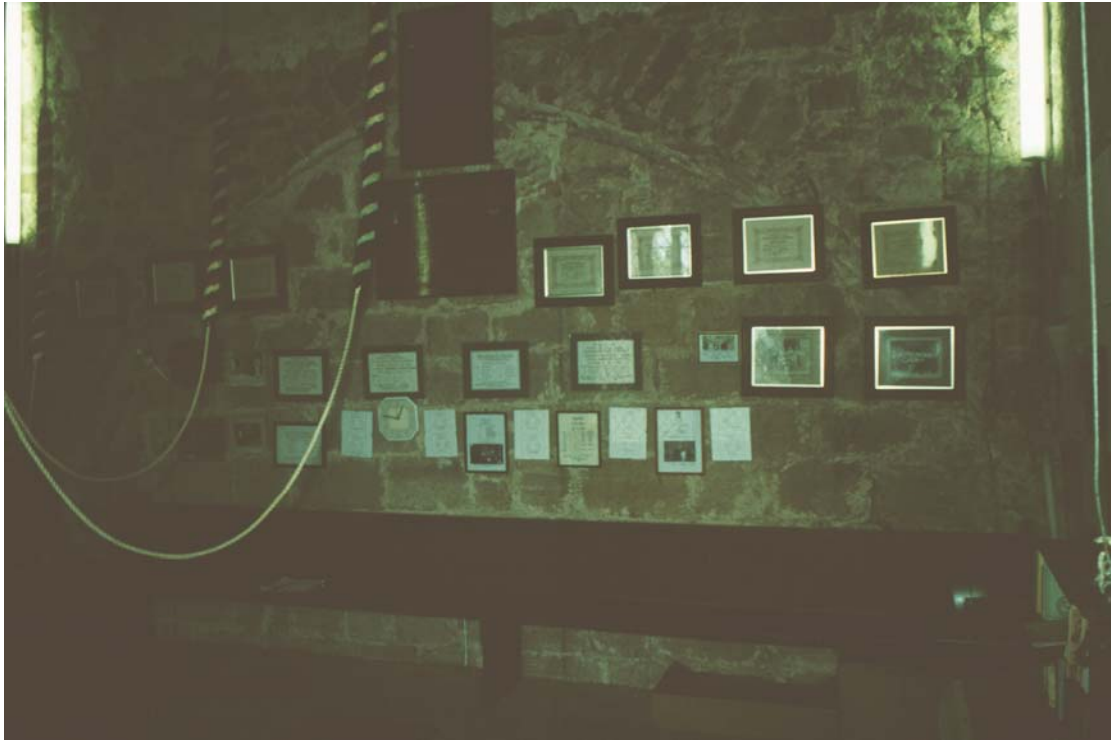
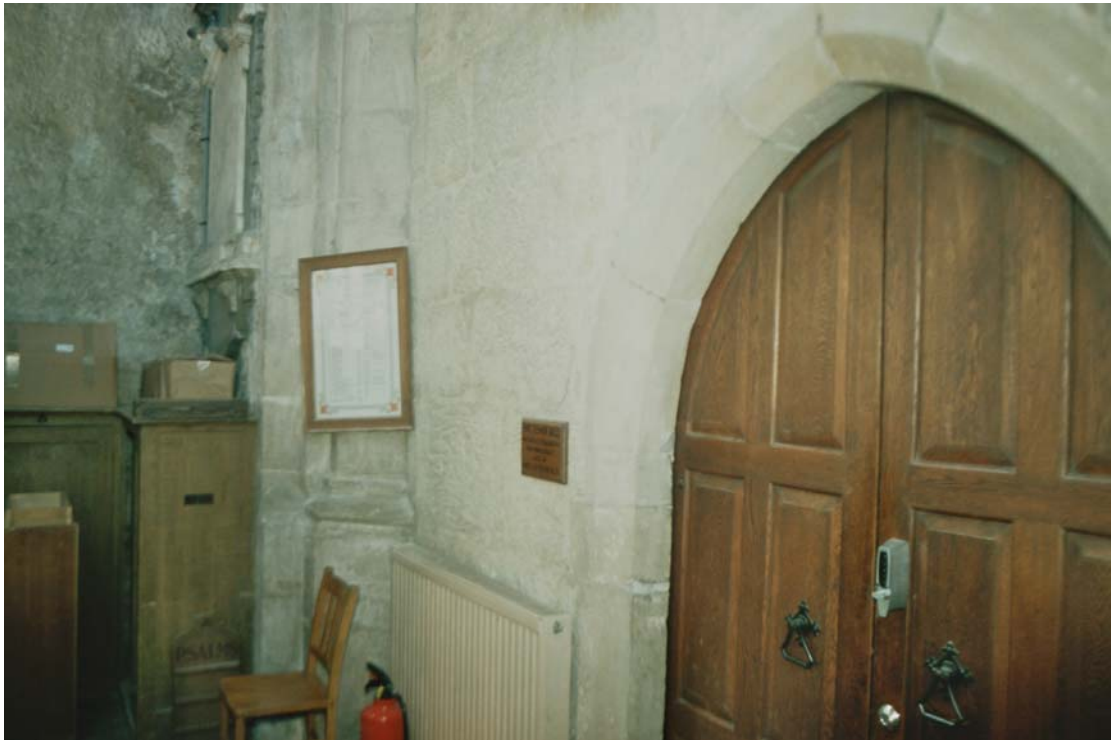
Reference photographs:

- 2.1 A two-centred arch can be seen. A small area of the blocking was removed in the past to expose one of the capitals and round responds on which the chamfered arch rests. The east bell tower face consists of very rough sandstone rubble. There is a relieving arch on the west (ringing chamber) side, but the east side shows only a peculiar 'inverted V' over the arch, perhaps a contemporary repair required to stabilise collapsing masonry when the opening was made.

- 2.2 The arch was blocked with ashlar masonry. The ashlars enclose a rubble core mixed with white lime mortar. The individual ashlars of Wealden sandstone (a Cretaceous limestone) show signs of re-use; clues being the presence of blocking pieces in awkward gaps and, where necessary, repairs to the corners of damaged ashlars.

- 2.3 A narrow blade was used to dress the ashlars which left an irregular pattern of strokes on the faces; such as would be produced by a hafted Jadd Pick or Racer; these marks are distinct from the 13th-century tooling marks visible on the ashlar interior of the Bell Tower stair. The medieval mason used a wide chisel (boaster) and mallet: This tool seems to have remained locally in use in the 15th century (to judge from the arcade piers).
