**Interpretive Historic Building Survey of
Blackford Farm House And Granary,
Herstmonceux, East Sussex**

REPORT NO. 1644

HERSTMONCEUX - BLACKFORD FARM HOUSE

REPORT NO. 1645

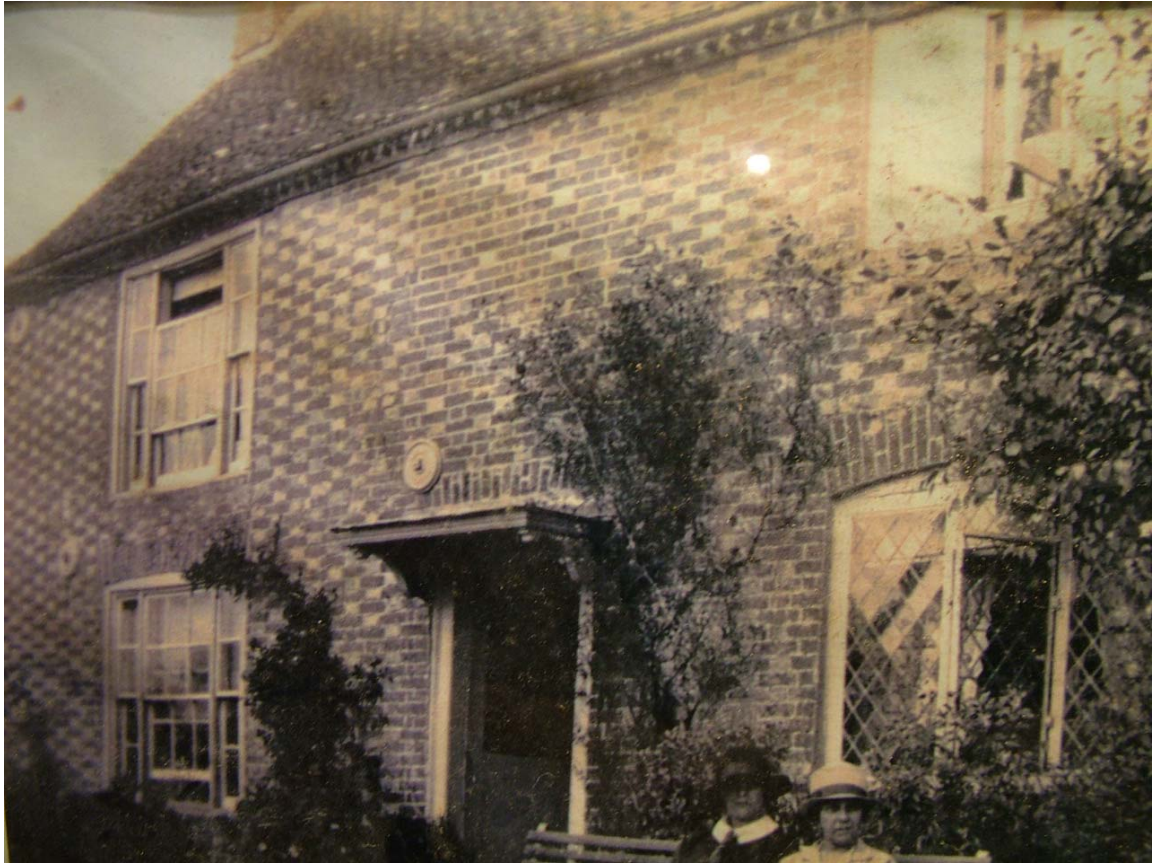
Although now replaced, the old photograph reproduced in Plate 1 indicates that the windows within the front elevation, lighting the parlour and parlour chamber, were originally of tripartite double-hung-sash type with low-level cills. In the rear wall of the period-A outshut are paired double-hung sashes replacing the earlier casements, but whether these represent period-B or period-C replacements is unclear.

Plate 1
Front elevation of the house in the early 20th century [Old Photograph]

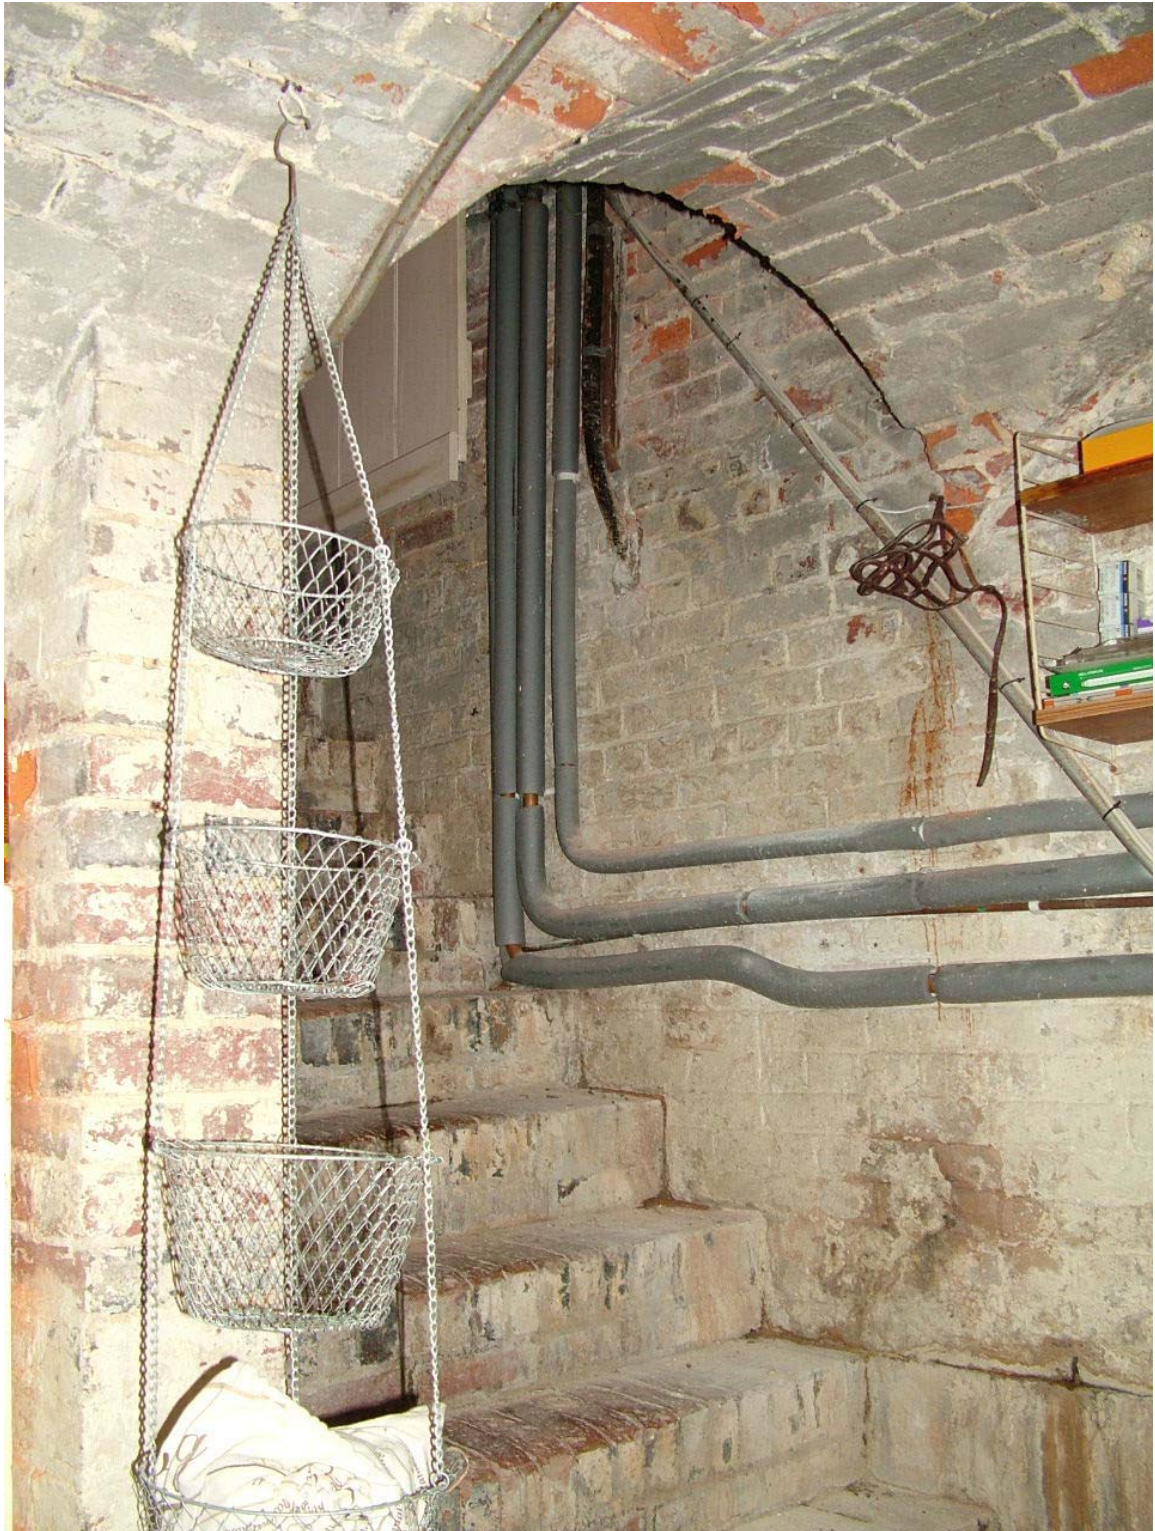
Access into the cellar is from the western end via a flight of brick steps descending within the central service room, against the rear wall of the outshut. Interestingly, a sloping barrel-vaulted ceiling supported by chamfered bricks caps the base of the steps, intersecting at right angles to the main vault of the cellar - see Plate 2. The stairs themselves were not originally enclosed by a partition at ground-floor level, but were instead protected by a dwarf brick side wall, the end of which is still evidenced by snapped bricks in the side wall of the brick bulkhead which caps the vaulted section of the passage.

Plate 2
Brick arch at base of steps leading into cellar.

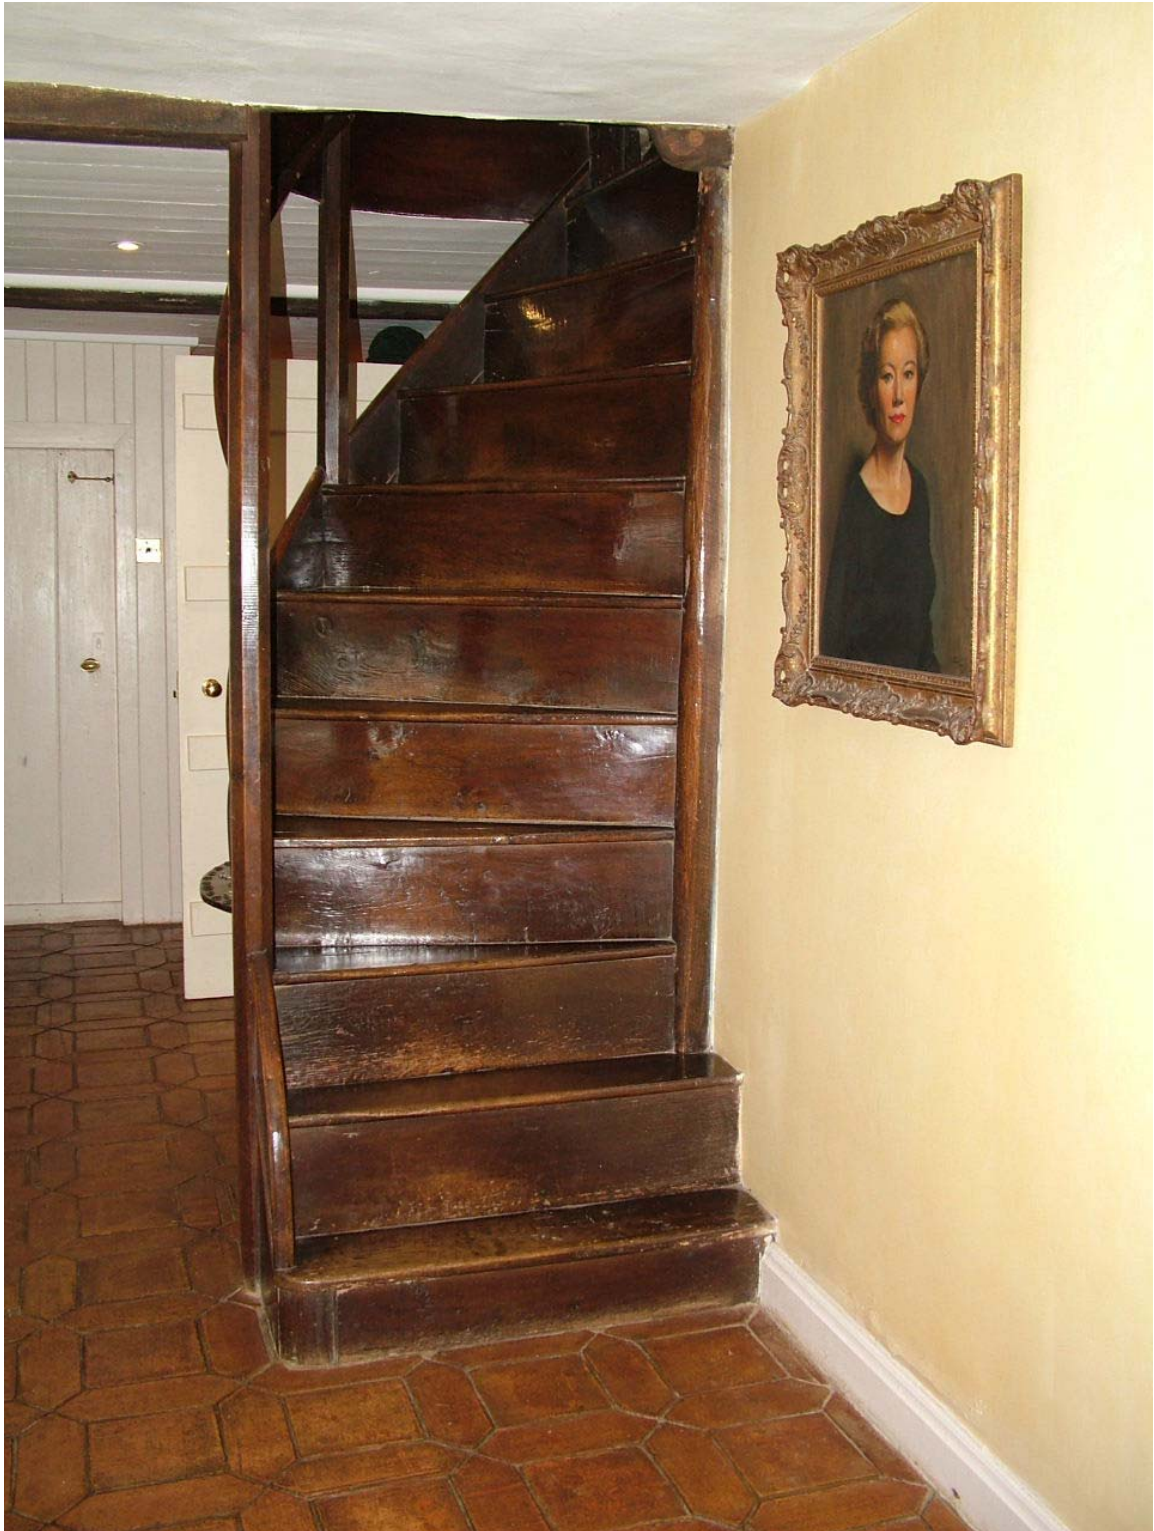
Access to the cellar has been adequately dealt with above under the heading 'Cellar'. The stairs to the period-A first floor were located to the rear of the axial chimney, being within the rear lean-to outshut. These are of unusual design in that they comprise a half turn with a curved external string. They are steep and incorporate narrow treads (see Plate 3). The top of the stairs lead through an opening located beneath the wallplate of the main range, giving onto a small landing to the west of the chimney. There is an unresolved question regarding the age of this ground-floor flight in that there is a redundant mortice in the wallplate at the top of the stairs, apparently intended to take a stud within the rear wall. If this stud were ever fitted it would have rendered the staircase inoperable. The mortice shows setting-out lines and was therefore presumably always intended, but the mortice itself is only roughly cut, perhaps suggesting that it was abandoned before completion. It is therefore possible that the mortice represents an error - if so, the staircase is original to the period-A build and the part-formed mortice should be regarded as misleading.

Plate 3
Staircase within rear outshut leading to first floor of main range.

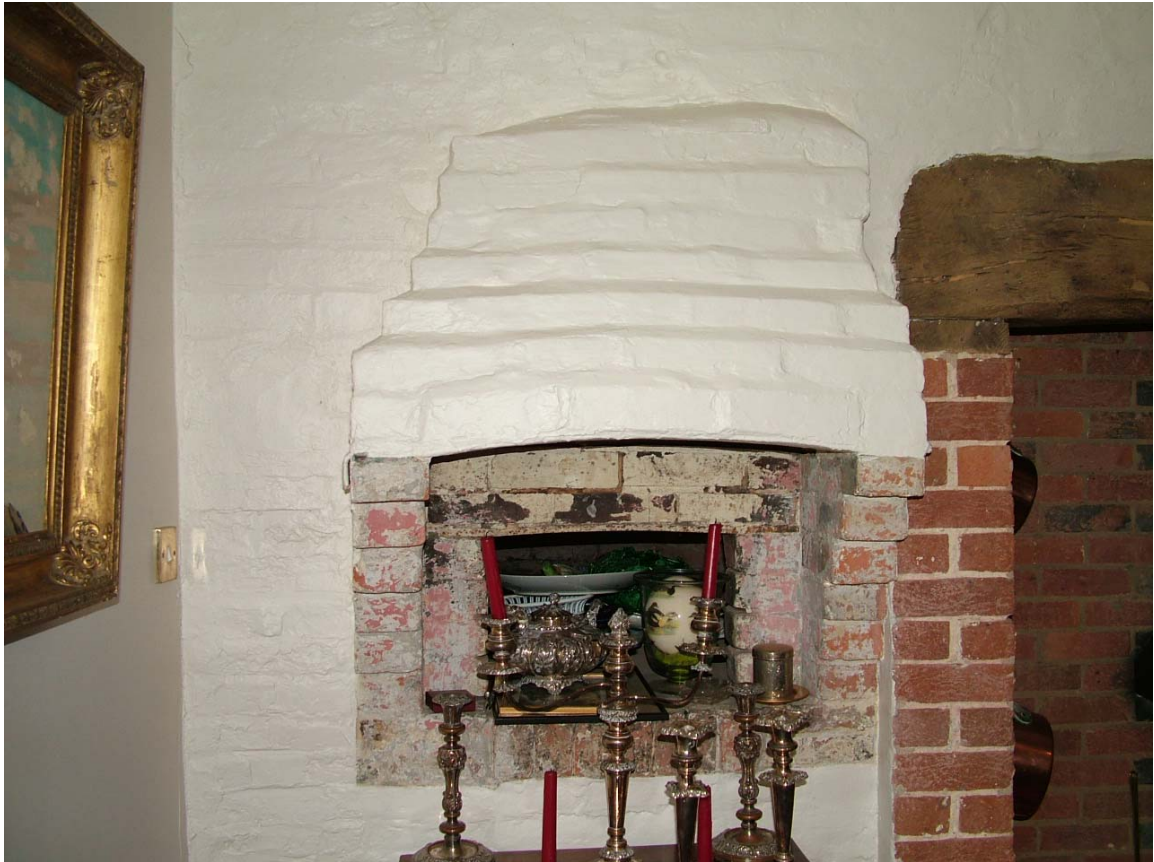
The only historical alteration recognizable within the earlier period-A chimney is the removal of the original period-A bread oven and its replacement upon the same site by a larger oven incorporating its own flue. This is built partially in front of the original external doorway leading into the room, which doorway must, therefore, have been blocked at this date. Counter to the earlier arrangement, the entrance of the new oven faces into the bakehouse, with the oven itself projecting back into the area to the side of the fireplace. The flue projects forward of the oven door in the form of a brick hood supported on plain brick corbels [Plate 4]. It is a good example of its type: all that is missing is the original removable iron door.

Plate 4
Replacement bread oven within Bakehouse.
