**AN ARCHAEOLOGICAL
INTERPRETATIVE SURVEY OF**

**OAK CROFT etc, 1-3 WEST STREET,
MAYFIELD, EAST SUSSEX**

PROJECT REF. 2725

REPORT NO. 1643

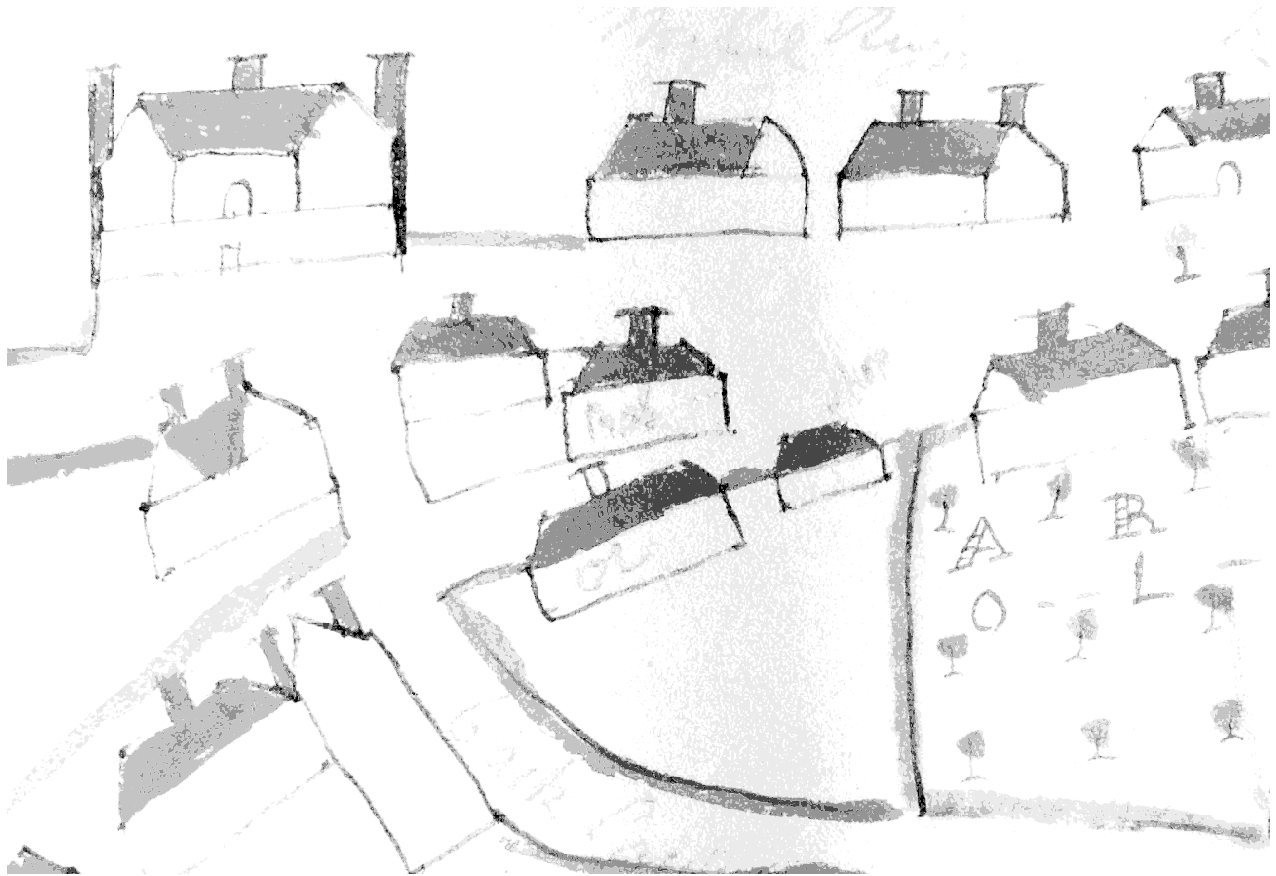
Plate 1

*Extract from a map of 1681 [ESRO Acc 4656/7) showing Oak Croft etc
 (central) with the barn to the right. North is to the top of the picture.*

A map of the town drawn in 1681 [ESRO Acc 4656/7] shows this property as a house with a barn against the street, to the east of the house (Plate 1: see also Plot 45 on Drawing No. 1643/1). Except for this, no further reference to the holding has been identified in the documentary record until the tithe award of 1843 and the Mayfield rental of 1846. By this date the manorial holding upon which the house and barn stood in 1681 had been divided into four separate ownerships (Plots 45a, 45b, 45c and 45d on Drawing No. 1643/1). The rental makes clear that the division of the holding had not occurred at a single date, but had initially involved splitting the tenement into two parts.
