**A Revised Archaeological Interpretative Survey of  
1-2 Pond Cottages, Rushlake Green,  
Warbleton, East Sussex**

**Project Ref. 2685  
ASE Report Number: 2007272**

**REPORT NO. 0518**  
**(Revised 2006)**

**WARBLETON - 1-2 POND COTTAGES, RUSHLAKE GREEN**

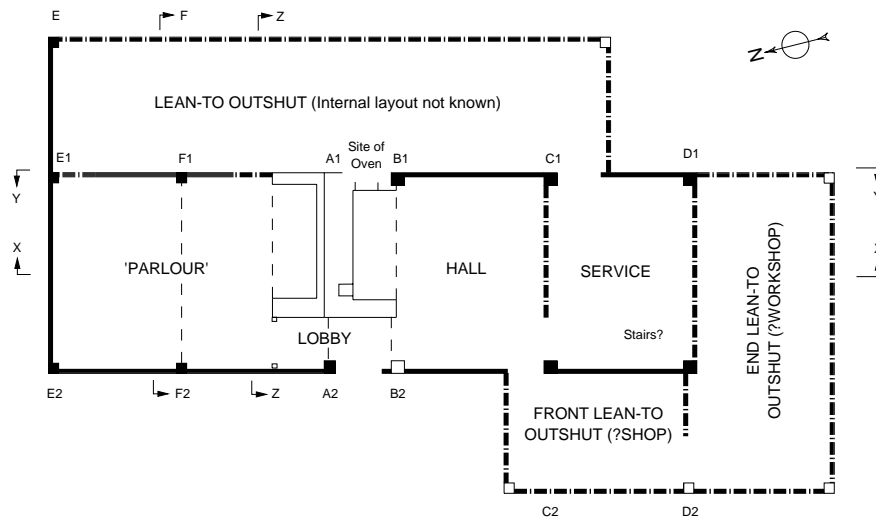
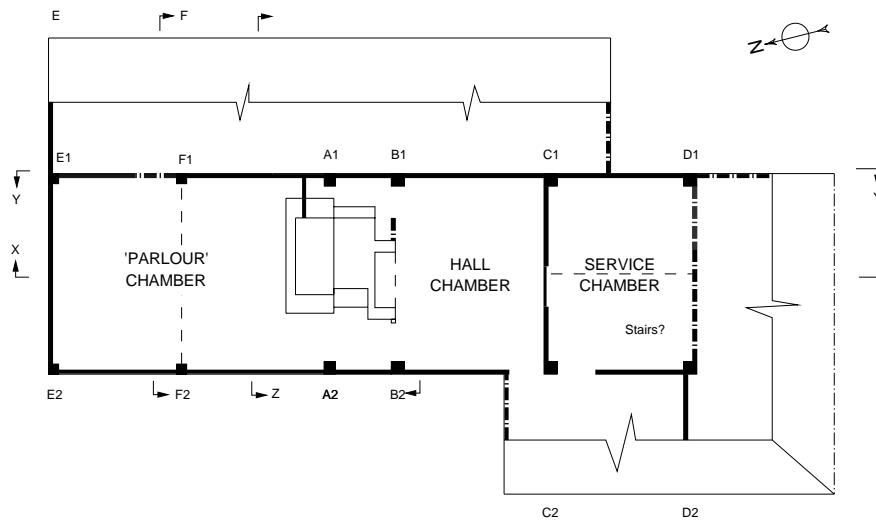
Drawing No. **518/3**

In order to increase the size of the building, lean-to outshuts were added to both the southern end of the main frame and against the southern end of the front wall, though the former has been destroyed in modern times. This end lean-to is shown partially extant in a photograph taken in 1974 (see Plate 1), whilst the southern truss of the surviving section of front lean-to has the stave holes for its daub infill set against the north face of the wall with a doorway incorporated at its western end, features which prove the destroyed end lean-to to have been contemporary with that added to the front. Why the lean-to was added to the front rather than the rear (as is usual) is not known for certain, though it probably reflects the use to which it was put. If the lean-to was utilized as a shop, such a location would be desirable, with perhaps an associated workshop located within the inter-linked southern end lean-to.

Late in the 17th century the main range of the house was extended northwards by two bays in order to give a heated 'parlour' with unheated chamber above and, above that, a storage garret. This new extension is the same width and height as the period-A house, has a 2.85 metre (9'4") wide rear lean-to outshut, and measures 5.50 metres (17'11") long, giving a revised overall length for the house of 15.55 metres (51'0") measured overall the southern end outshut.

**GROUND-FLOOR PLAN**

**FIRST-FLOOR PLAN**

**1-2 POND COTTAGES, RUSHLAKE GREEN, WARBLETON, EAST SUSSEX  
PERIOD-C RECONSTRUCTION DRAWINGS**

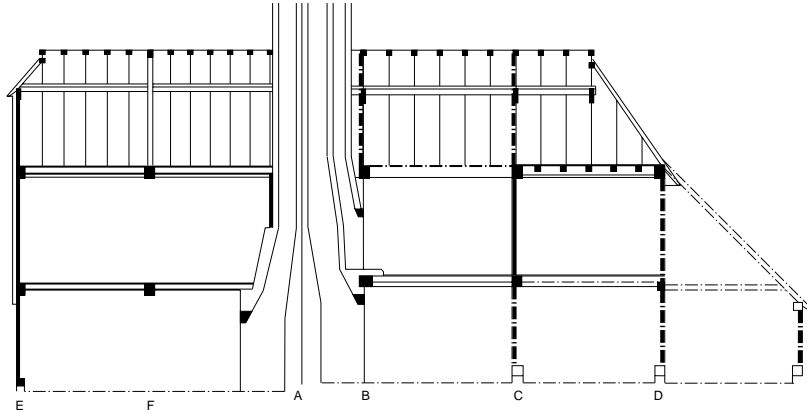
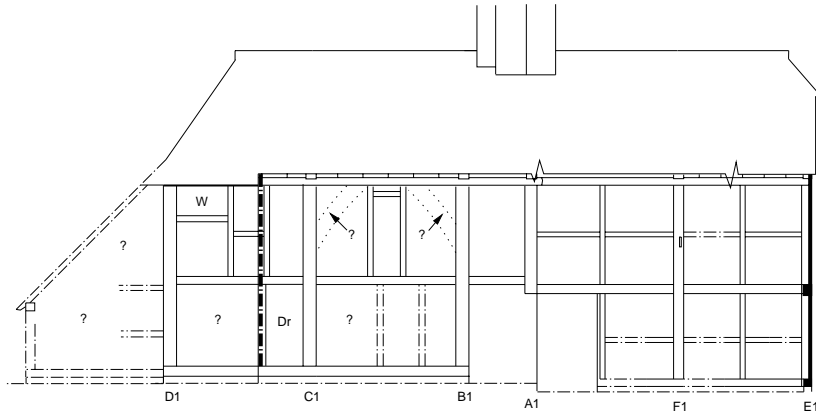
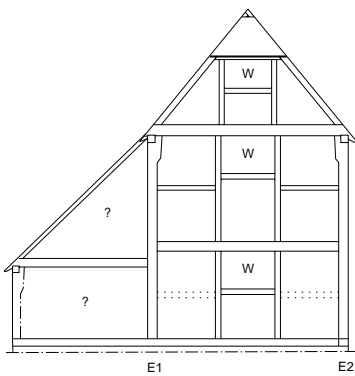
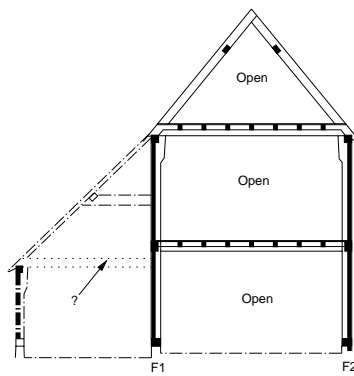
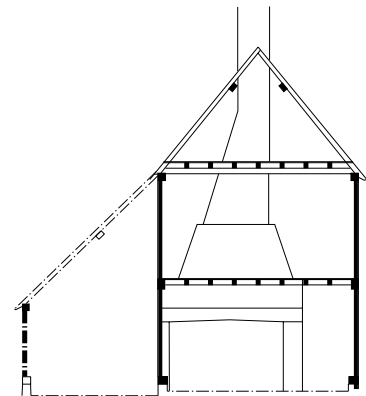
Drawing No. **518/4**

As shown in Drawing No. 518/4, the frame of the northern two-storeyed extension is constructed using standard techniques of timber framing with infill of small-panel design, the midrails of which are interrupted by the studs. The timbers generally are relatively spindly (*ie* principal posts 200 mm wide; studs 100-150 mm wide; midrails mostly 90 mm deep) and the principal posts have small, splay-cut jowls at their heads.

LONGITUDINAL SECTION X-X

SECTION Y-Y SHOWING REAR WALL OF MAIN FRAME

NORTH ELEVATION

TRUSS F-F

SECTION Z-Z

**1-2 POND COTTAGES, RUSHLAKE GREEN, WARBLETON, EAST SUSSEX  
PERIOD-C RECONSTRUCTION DRAWINGS**

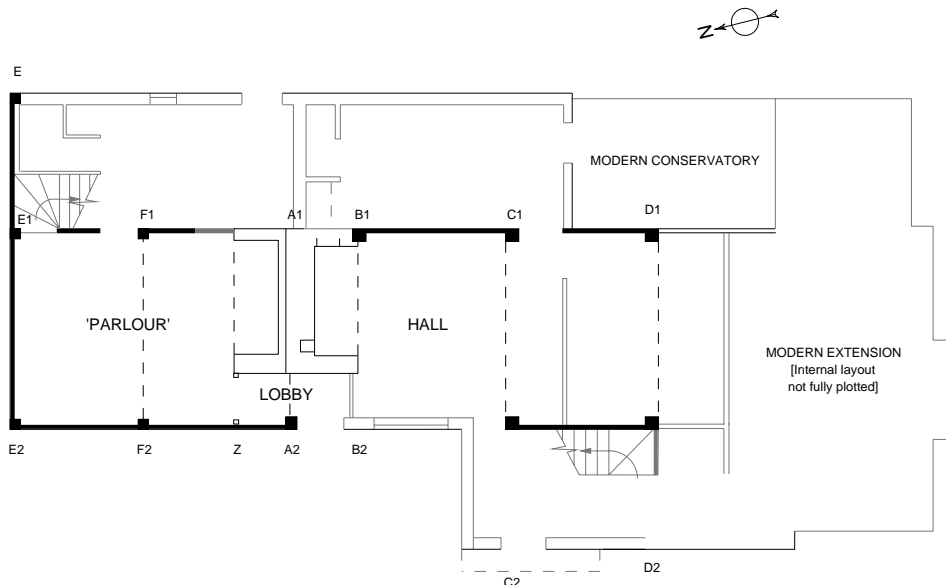
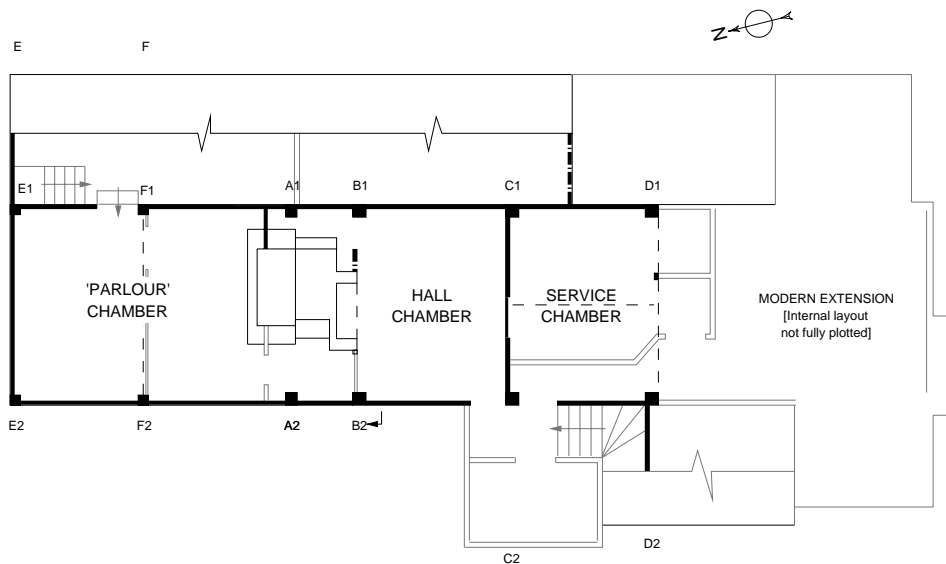
In modern times a two-storeyed porch has been intruded into the northern end of the front outshut and a single-storeyed extension added to the south. These alterations had already been undertaken by 1974 (Plate 1). Between that date and 1980 the remains of the southern lean-to outshut were destroyed by the addition of an extra storey over the modern single-storeyed part, and extensions were made to the rear at the southern end (see Drawing Nos. 518/5 and 6).

APPROXIMATE GROUND-FLOOR PLAN

APPROXIMATE FIRST-FLOOR PLAN

<b>1-2 POND COTTAGES, RUSHLAKE GREEN, WARBLETON, EAST SUSSEX PLANS OF BUILDING AS IN 2006 [Modern details shown approximately]</b>				Site Ref <b>P45/05</b>
Drawn By <b>D Martin</b>	Revision No 1	Date of original survey <b>1980</b>	Date of this revision <b>2006</b>	Drawing No. <b>518/5</b>

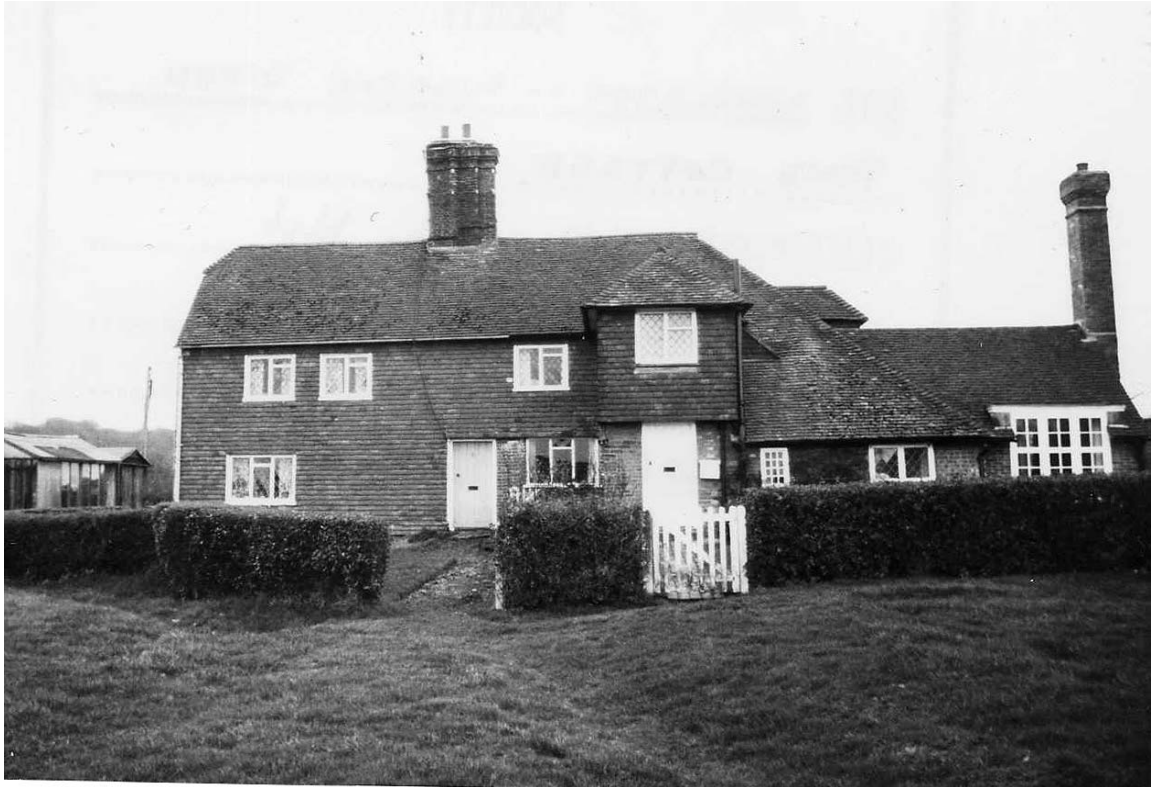
Plate 1  
Exterior of the house in 1974 showing initial single-storeyed 20<sup>th</sup> century extension on right.
