**An Archaeological Interpretative Survey of  
199 Preston Road, Preston, Brighton, Sussex**

**Project Ref. 2792  
ASE Report No. 2007185**

### **PRESTON - 199 PRESTON ROAD, BRIGHTON**

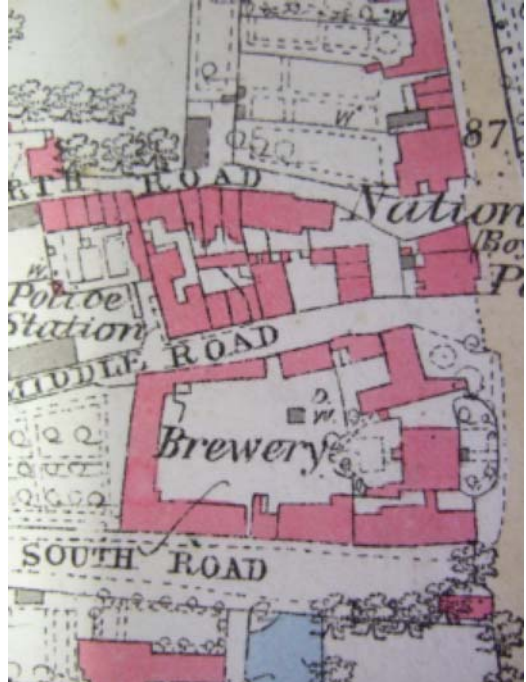
<b>199 PRESTON ROAD, PRESTON, BRIGHTON, SUSSEX HISTORICAL MAPS</b>				Site Ref <b>P143/2</b>
Drawn By <b>D Martin</b>	Revision No -	Date of original survey <b>2007</b>	Date of this revision -	Drawing No. <b>1653/2</b>

The historical map evidence reproduced in Drawing No. 1653/2 indicates that already by 1875 a small, narrow, range of attached outhouses had been built projecting from the southwestern corner of the building, and by this date a rear porch had also been constructed. The structural evidence indicates that both represent additions, rather than being part of the period-B work. Already by 1896 the rear porch had been removed, but it was subsequently replaced by a two-storeyed, flat-roofed structure.

EXTRACT FROM TITHE MAP, 1838  
 [ESRO TDE 28]

EXTRACT FROM 1st EDITION 1:2500 O.S. MAP,  
 1875 [O.S. SUSSEX, Sheet 66/5]

EXTRACT FROM 2nd EDITION 1:2500 O.S. MAP,  
 1896 [O.S. SUSSEX, Sheet 66/5]

EXTRACT FROM 3rd EDITION 1:2500 O.S. MAP,  
 1911 [O.S. SUSSEX, Sheet 66/5]

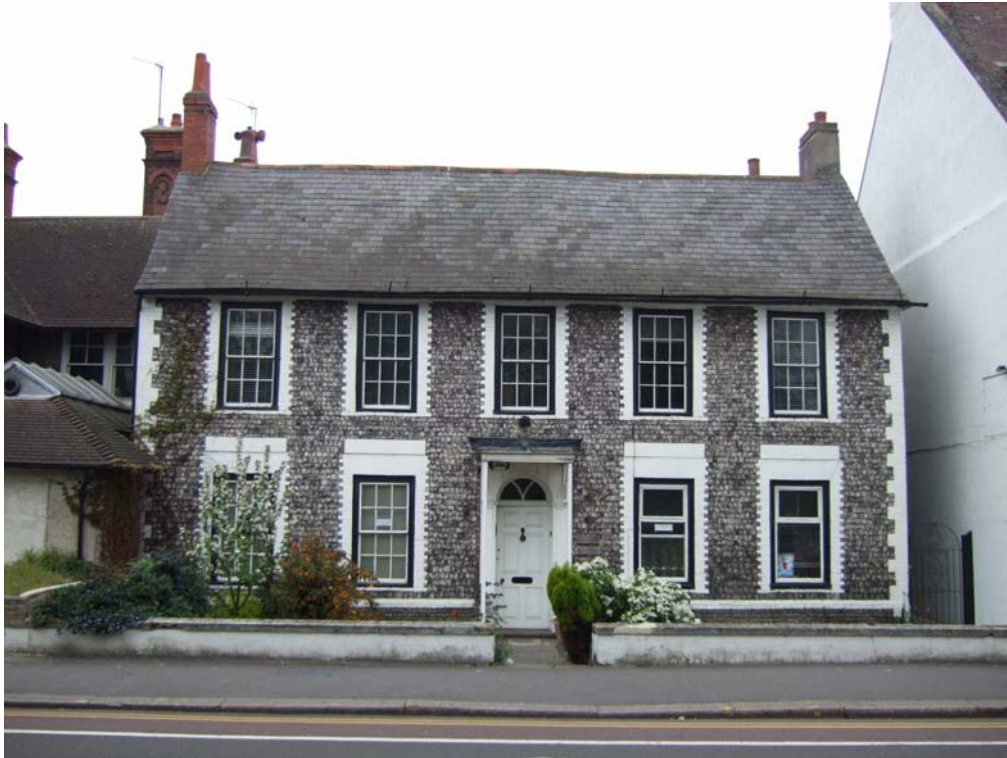
Given the building's age and its downland location, it is no surprise that the external walls are faced in flint with brick dressings to the quoins, openings and square-topped plinth. The dressings within the front facade are now painted white, but they remain natural brick colour elsewhere. Unfortunately the details of the southern end wall are masked from view, whilst even within the north elevation most of the facing was rebuilt when the large projecting chimney was removed (see Period B). Even so, enough period-A facing remains within this latter wall to show irregular, mostly knapped flint nodules bedded in copious amounts of lime mortar. In contrast, within the front facade, above plinth level, the flints have been carefully selected, knapped square, and laid with tight joints so as to give a regularly coursed, black, shiny surface. For the region, the work is of high quality and very effective.

Plate 1 - Front elevation.

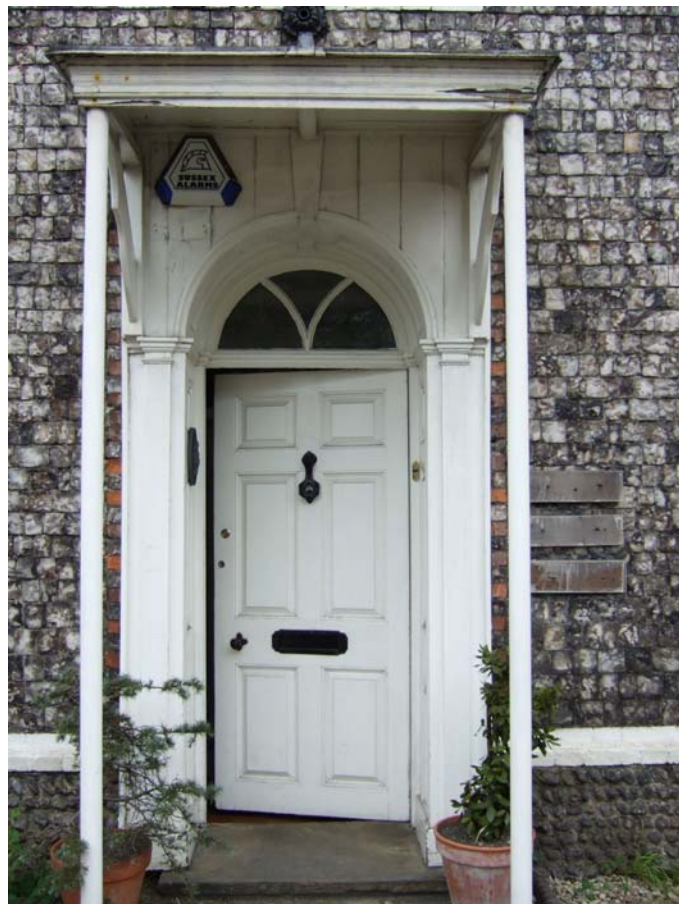
Located centrally within the main facade is the front entrance, recessed deeply back within a semi-circular-headed opening flanked by simple pilasters of timber. A porch has been added later, and to this later period belongs the flush boarding over the arched head, though the projecting key stone could be original. The six-panel front door survives, capped by a simple fanlight (Plate 2). Flanking the opening are two pairs of double-hung sash windows with slender glazing bars: the pair of frames lighting the hall have been replaced without glazing bars. This design is repeated above, with a fifth window over the main entrance, lighting the closet.

Plate 2 - Detail of front door.

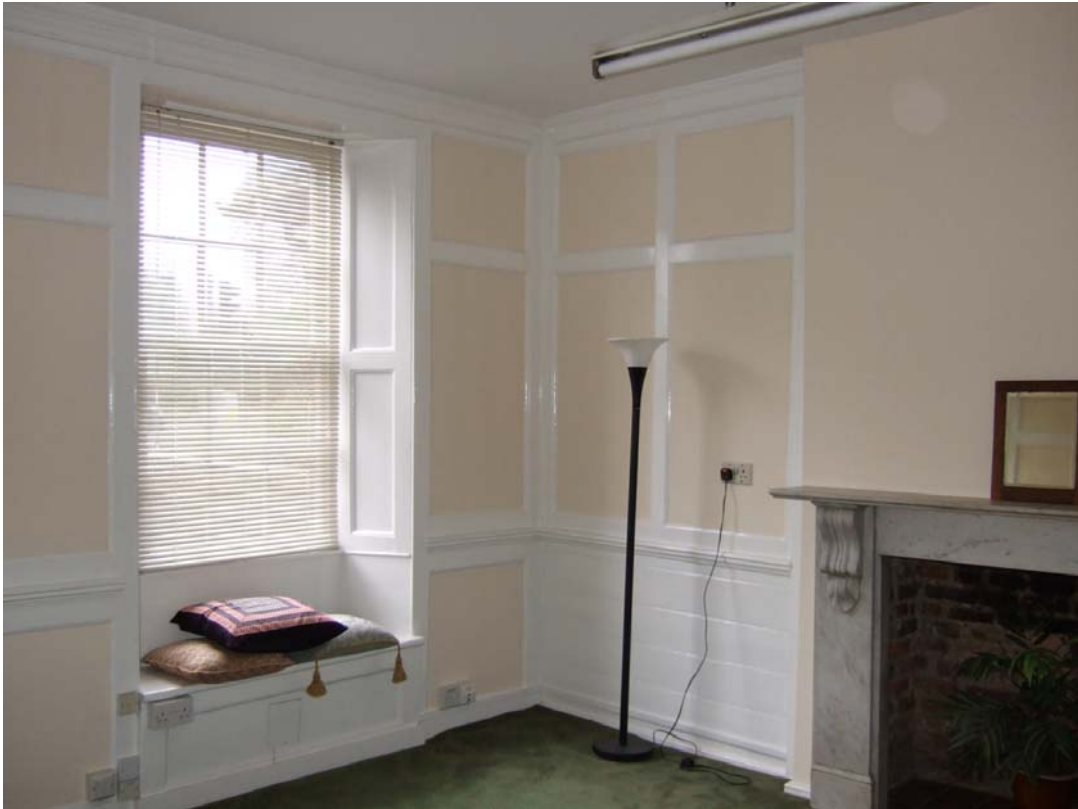
Plate 3 - Panelling, window seat and shutters in ParLOUR.

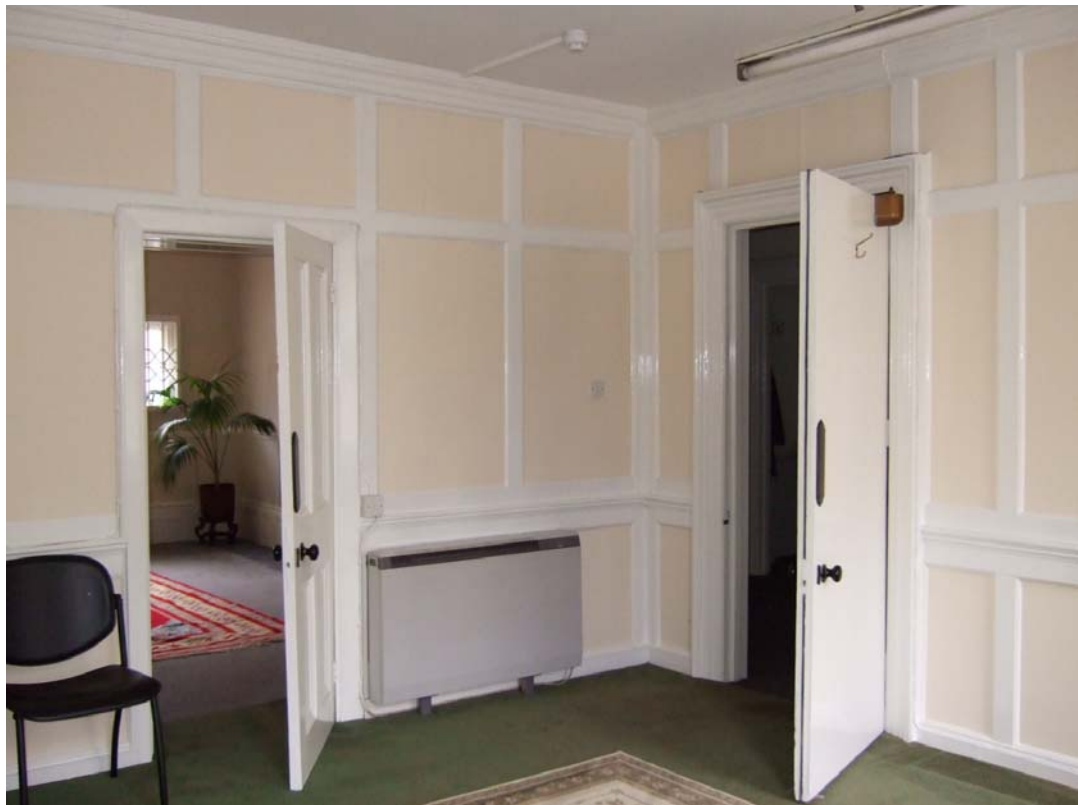
Plate 4 - Panelling in ParLOUR showing intruded doorway (left).

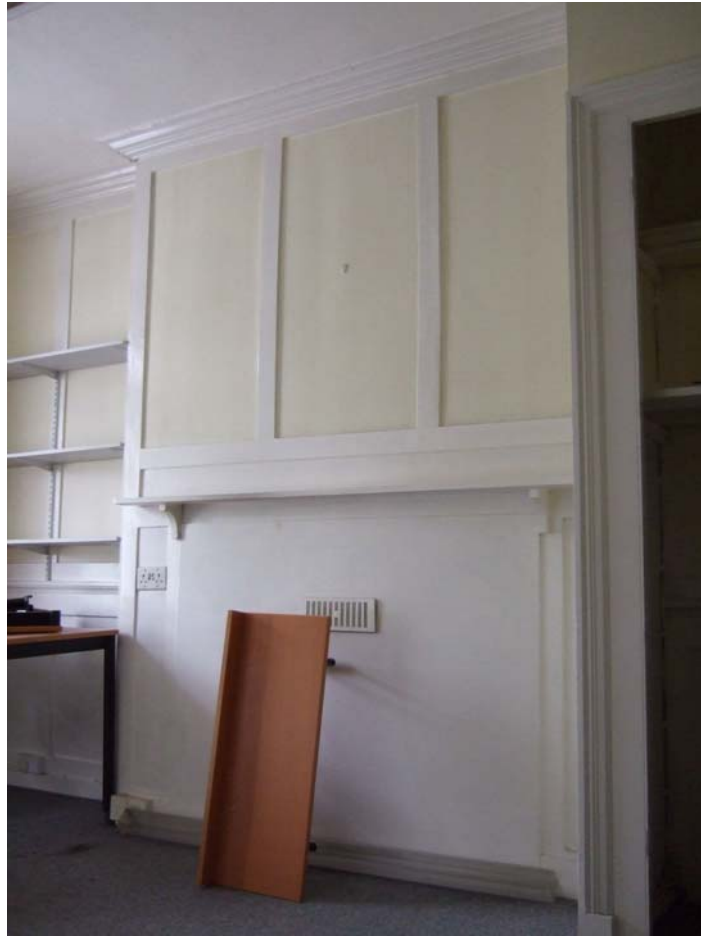
Plate 5 - Fireplace and panelling within Parlour Chamber.

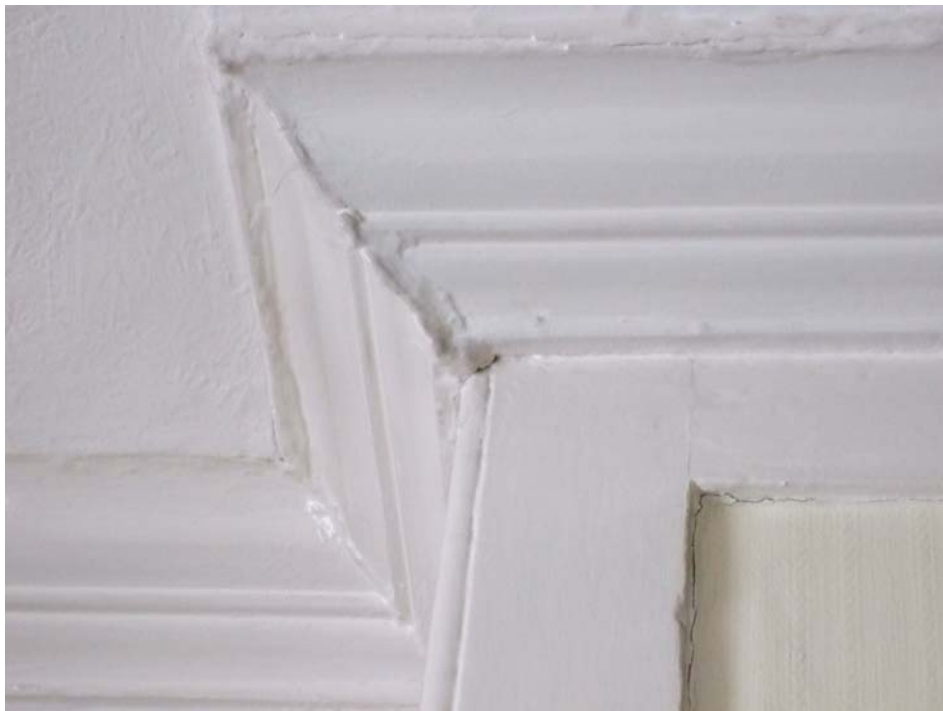
Plate 6 - Cornice within Parlour Chamber.

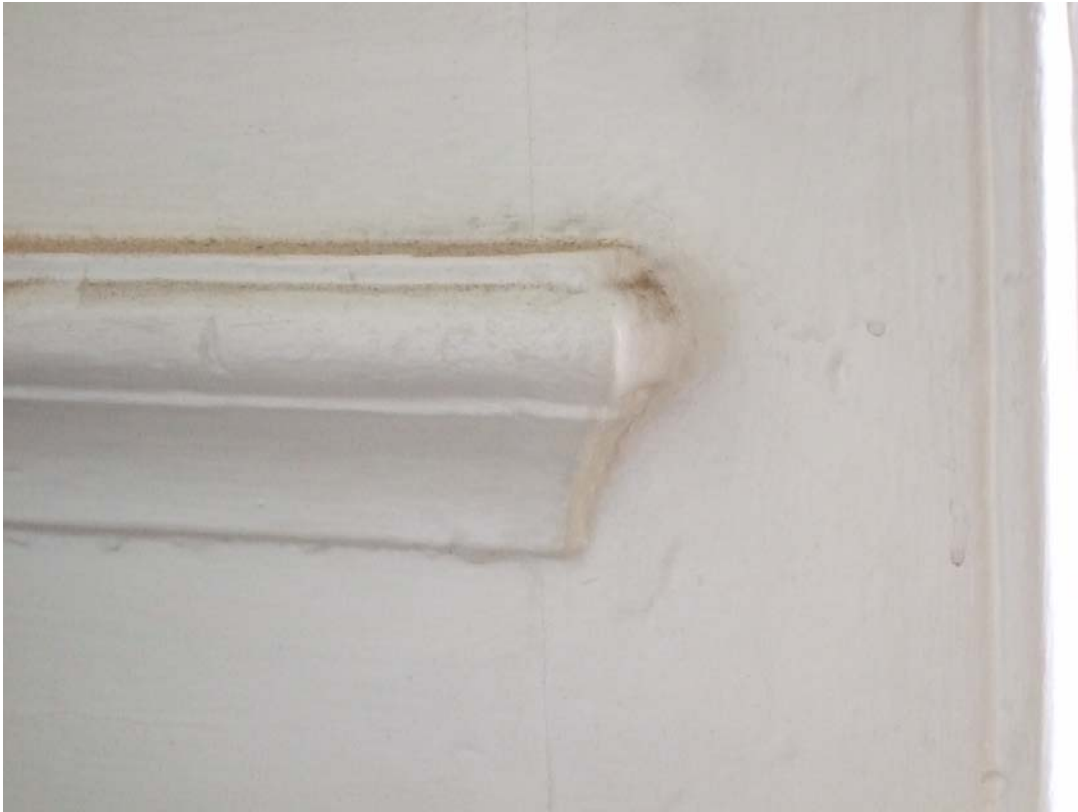
Plate 7 - Dado rail within Parlour Chamber.

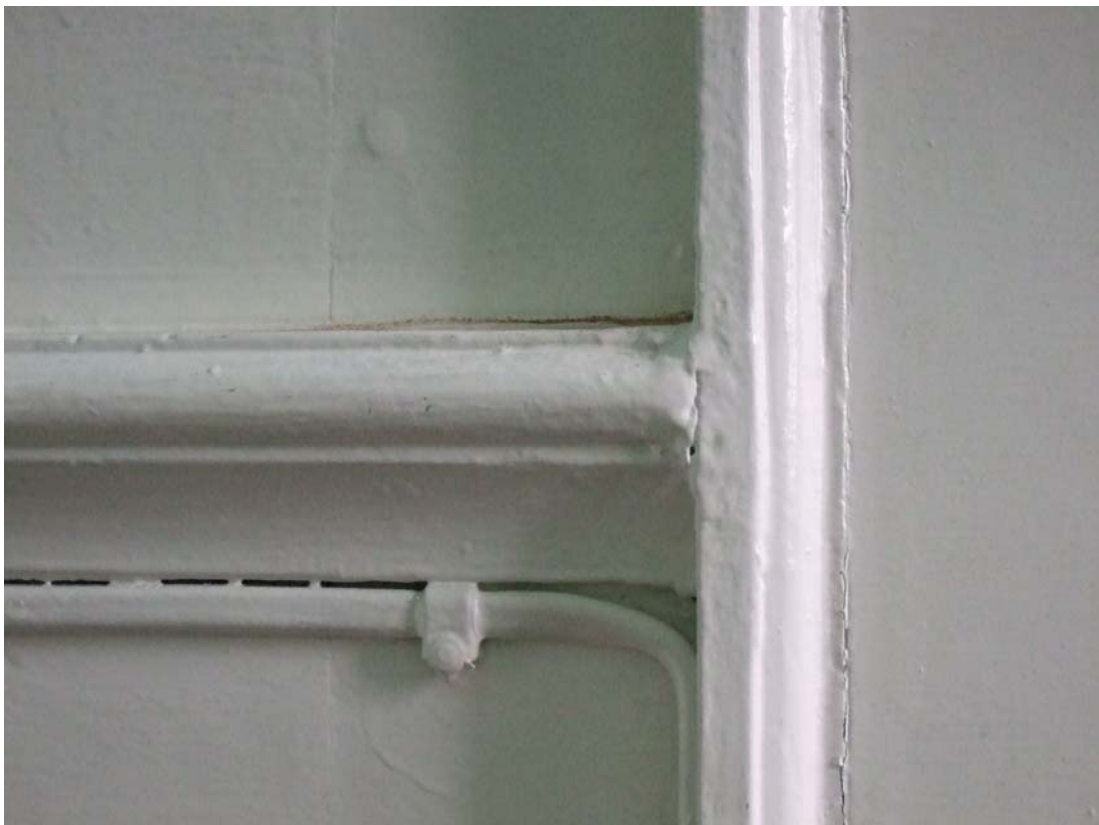
Plate 8 - Dado rail and architrave to closet doorway within Parlour Chamber.

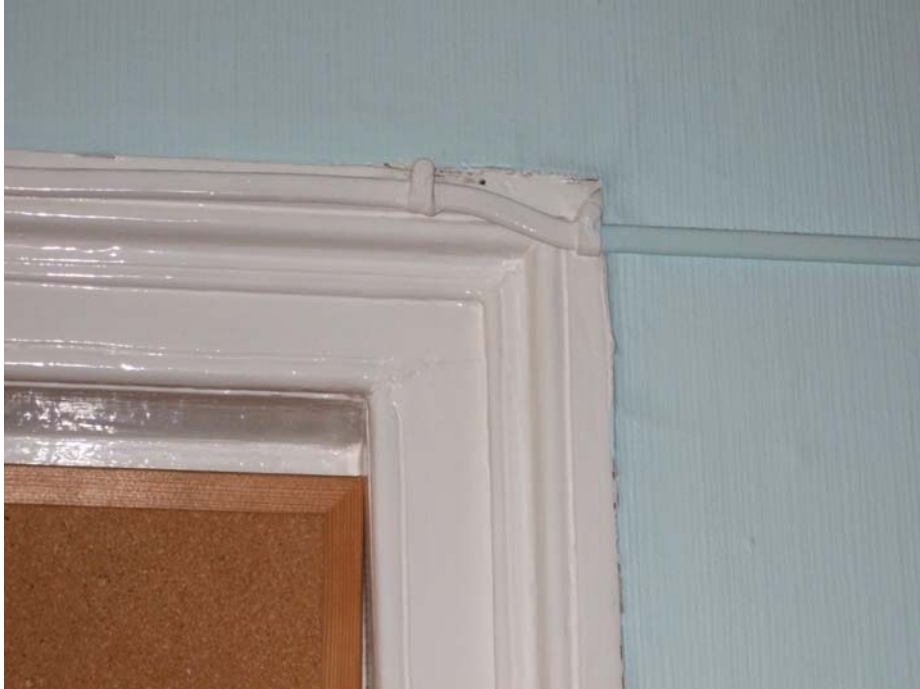
Plate 9 - Door frame and architrave to closet doorway.

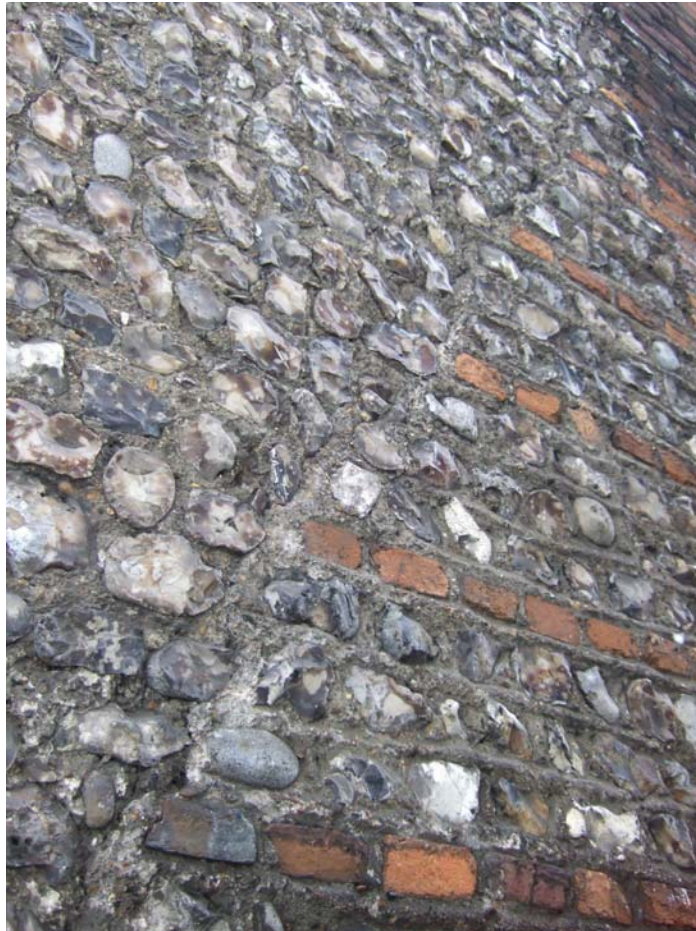
At the northern end of the house both the fireplace and chimney which formerly served the hall/kitchen has been removed. The stack's outline is still visible in the northern external face, marked by a large area of period-B re-facing (Plate 10). Visible is the outline of a large inglenook fireplace which formerly projected from the wall face - the scar suggests that the fireplace measured approximately 3.60 metres (11'10") wide overall its jambs. Above it can be seen the scars left by the sloping side walls of the tumbling. Their asymmetrical outline are more consistent with a 16th- or 17th-century chimney than one of mid 18th-century date, perhaps suggesting that the chimney was retained from the earlier house. Further evidence of the chimney's large size is visible in the roof where the end rafters are cut to abut against a much larger chimney than that which exists today - the rafters were roughly extended upwards when the present

Both fireplaces within the rear northern room and chamber are currently masked from view. It was probably at this date that the marble surround was added to the parlour fireplace and at this date too that the hall/kitchen inglenook fireplace and projecting chimney were removed and replaced by a new chimney incorporated into the thickness of the wall. The repair in the end gable, where the chimney has been removed, is faced with brick-banded flintwork typical of that used within the period-B addition (see Plate 10)

Plate 10 - Scar left by chimney removed from northern wall, with period-B making good (left) incorporating brick banding.

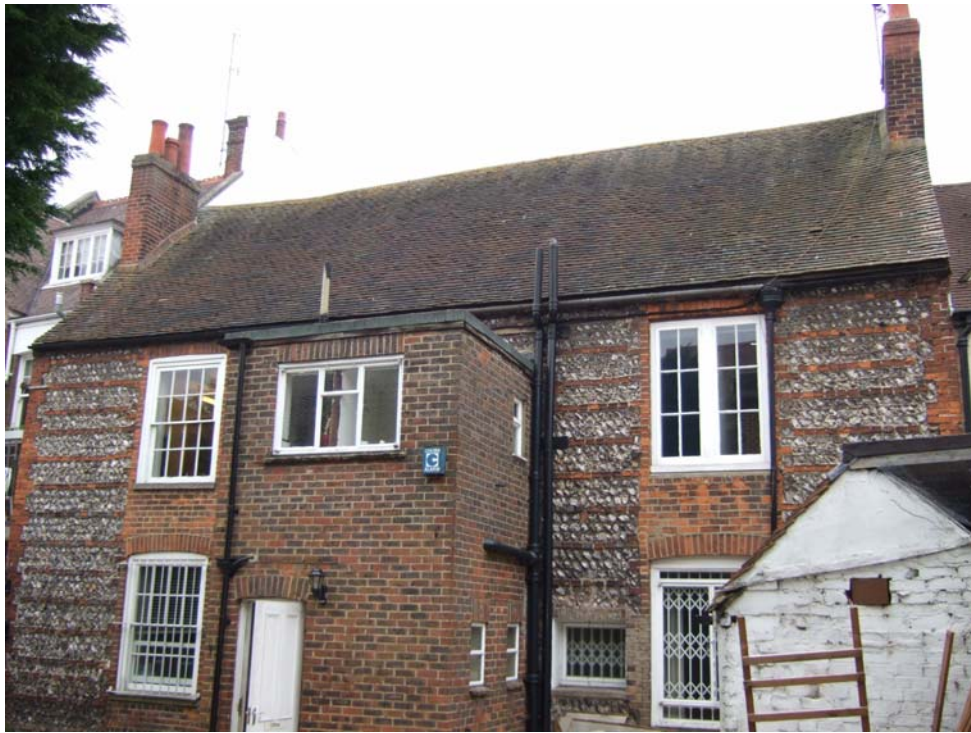
As plate 11 shows, the new external walls are faced in flint laid in courses with brick bands at every fourth course - a very distinctive feature. The quoins are laid in blocked brickwork, the bricks being three courses deep and of one-and-a-half bricks and one brick in width. The brick dressings to the window openings consist of three courses half brick wide, alternating with a single course one brick in width, whilst brickwork faces the panels between the ground-floor openings and those on the first floor. The windows are of double-hung sash type, capped by one-brick deep ring arches. Located centrally within the west elevation, the stair area was lit by a window capped by a semi-circular-headed arch. When the 20th-century flat-roofed projection was constructed this was converted into a first-floor doorway. Beneath it survives a flush six-panel door giving access to the rear yard. Its design is similar to that within the front elevation, perhaps suggesting that it is the period-A back door reused.

Plate 11 - Period-B west elevation.

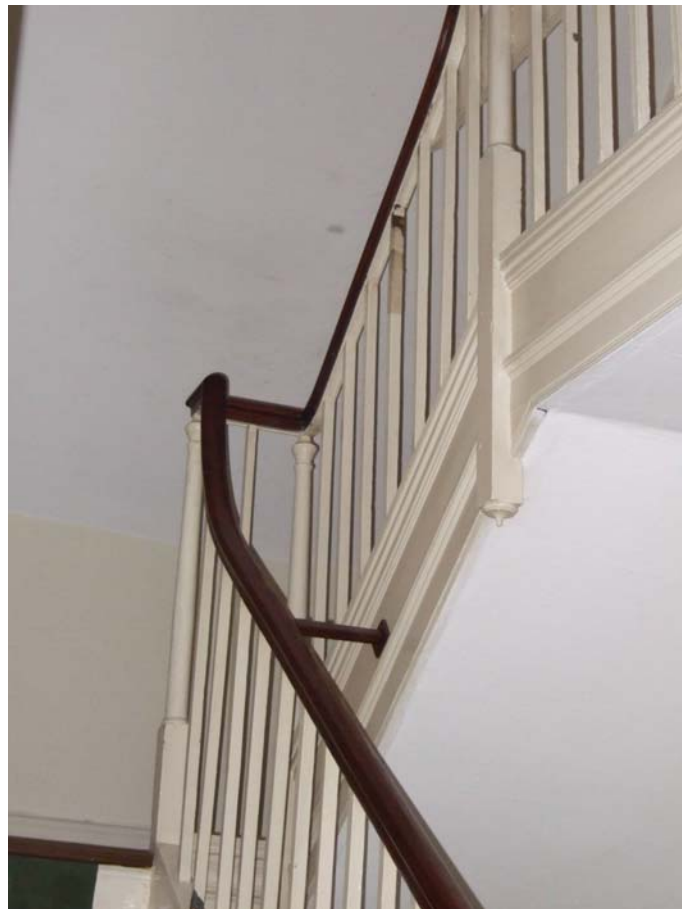
Plate 12 - Garret flight of period-B staircase.

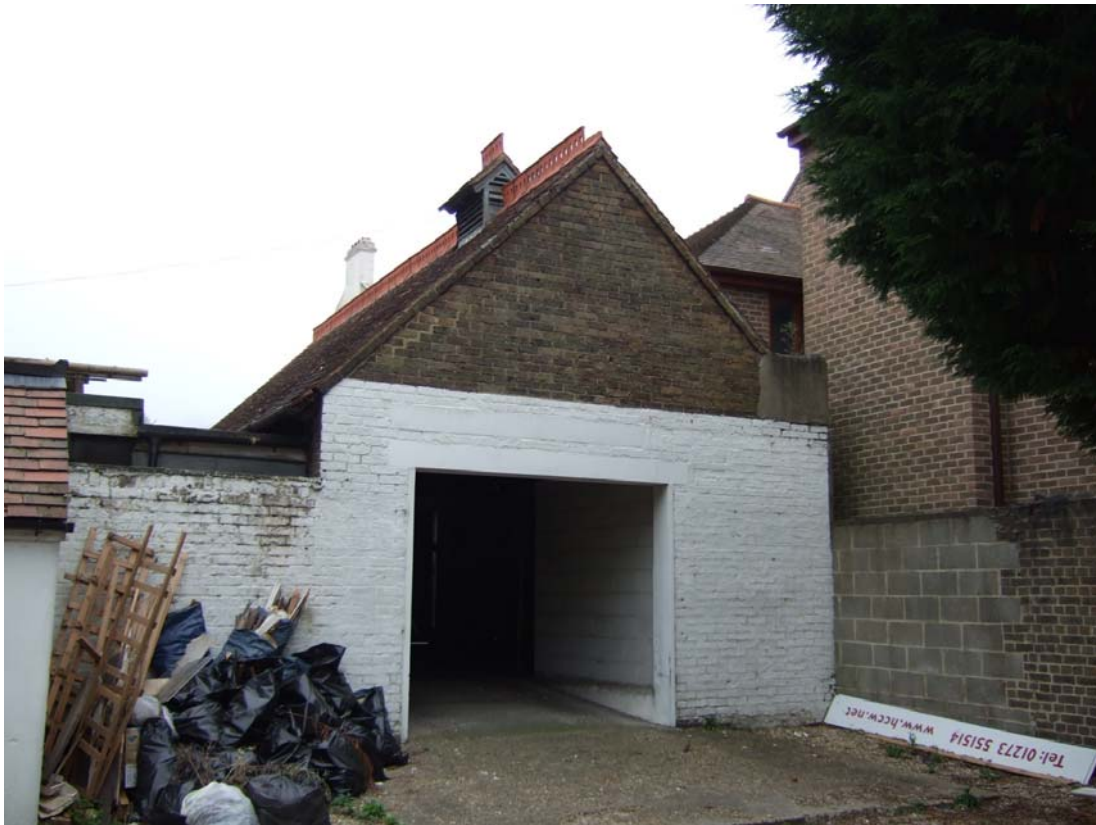
The rear yard is today accessed from South Road via a covered entrance located within the extreme southwestern corner of the sized-down yard (Plates 13 and 14). The building which contains the entrance is a rectangular structure constructed at right angles to South Road with wide doors off the street. Incorporated into the western wall is an earlier boundary of flint, but otherwise the building has brick walls and a gabled softwood roof of modified 'kingpost' construction formed by nailed-on planks. There is a continuous ridge board. The roof covering is slate and has pierced, crested ridge tiles to the apex. The site of this building was occupied by part of the farmyard/brewery complex in 1875. According to the map evidence, the present structure was built between 1875 and 1896 (which concurs with the architectural evidence) but was not at that time in use as an access way, but was probably a 'coach house' associated with the public house, built 1875x1896, occupying the corner of South Road and Preston Road. This was still the building's use in 1911, at which time access to the rear yard was from the north, via a track which entered the yard at the northwestern corner (see Drawing No. 1653/2). Only subsequently was the wide rear doorway punched though in order to give revised access to the rear yard.

Plate 13 - Coach house viewed from north showing intruded entrance.
