**An Archaeological Interpretative Survey of  
Peelings Manor, Westham, East Sussex**

**Commissioned by The Trustees of Peeling Manor**

**Project Reference: 2567  
ASE Report Number: 2007226**

### **WESTHAM - PEELINGS MANOR**

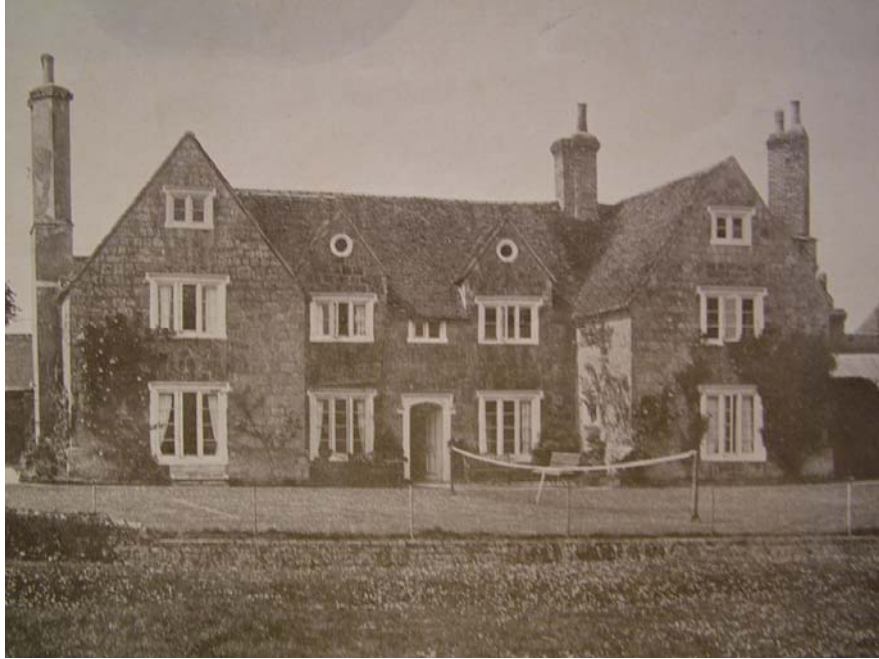
flanking a centrally-placed stone doorway with four-centred arched head beneath a square hood with return stops. The facade was still in its unaltered state in 1952 when the house was listed. The list description records that the initials M E were carved into the spandrels of the door head. The initial 'M' probably relates to Miles, but the significance of the 'E' is unknown (unless it is a misreading of 'H' for Hodgson!). Above the doorway was a two-pane window squeezed below the medieval eaves, whereas the three-pane windows on either side pierced through the medieval eaves into gable-fronted face dormers, each with a central bulls-eye window.

The photograph incorporated within the 1921 sale particulars shows a further chimney rising through the ridge at the northern end of the main range. From the design of its cap this appears to have been of two flues serving ground- and first-floor fireplaces facing south, heating the kitchen and kitchen chamber, though it is possible that a third flue was included, serving the service chamber. The only part of this stack to survive is the brick back wall of the kitchen fireplace, the top part of which is tumbled back as it

Plate 1  
Front elevation of Peelings in 1921

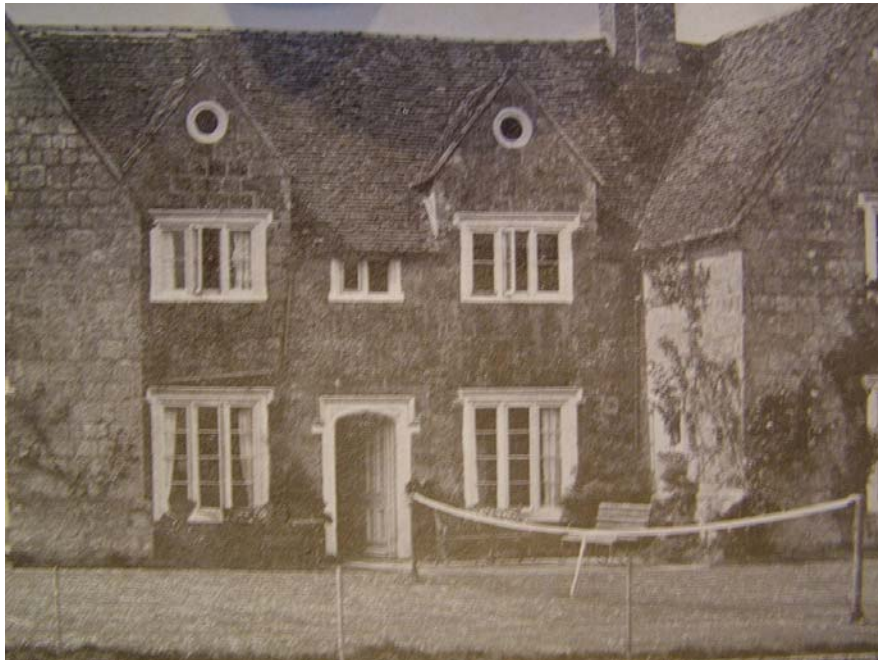
Plate 2  
Detail of front wall of main range as in 1921
