**An Archaeological Interpretative Survey of
Brocketts, Whitemans Green, Cuckfield, West Sussex**

**Commissioned by
Gould and Company on behalf of
John and Rosie McNamara
Project Ref. 2681**

REPORT NO. 1641

CUCKFIELD - BROCKETTS, WHITEMANS GREEN.

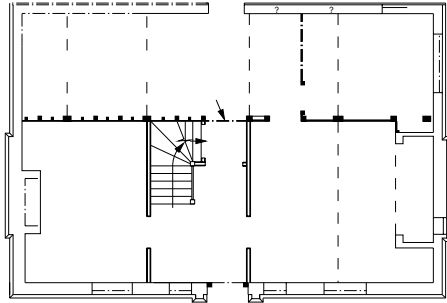
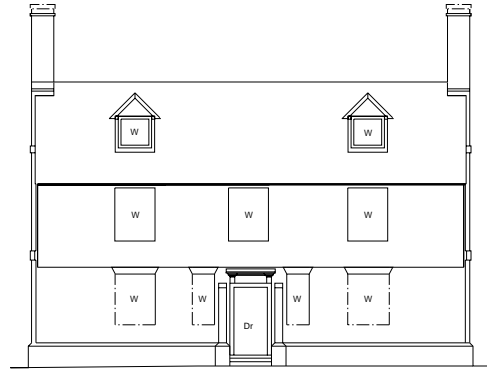
1. THE LIKELY DESIGN MODEL USED FOR THE HOUSE

GROUND-FLOOR PLAN

FRONT (EAST) ELEVATION

A major feature of the classic 'central-entry, terminal-chimney house which became so popular during the 18th century was its adoption of a symmetrical facade, even in those quite common instances where the parlour was designed to be of lesser length than the kitchen/hall and thus, in plan, the entrance area was located off centre. In these latter instances symmetry was usually achieved by positioning the front door eccentric to the entrance area, as shown in illustration 1, Drawing No. 1641/6. At Brocketts the front door is off centred to the entry in this way, but in this instance the parlour and kitchen/hall are of similar length to one another and therefore there seems no logic behind the design, especially as three windows were incorporated to the south of the front door, but only two to the north, resulting in an unbalanced elevation (Illustration 2 in Drawing No. 1641/6). With the adoption at Brocketts of a symmetrical plan it would have been so simple to incorporate a symmetrical elevation of the type shown in illustration 3, Drawing No. 1641/6, so why was such a design not used? Given the observations mentioned above, the positioning of the openings at Brocketts only makes sense if the parlour was intended to be shorter (as in illustration 1, Drawing No. 1641/6). With this in mind, it would be logical to suggest that the parlour was initially built small and was subsequently extended. As attractive as this seems, sufficient of the structure was visible in 2006 to confirm beyond all doubt that the entire front range is of one build, so this cannot, in this instance, be used as an explanation for the anomaly.

It is known that clients often commissioned their new buildings by reference to another example they had seen, listing variations they required to be incorporated. This raises

the possibility that in this instance the client commissioned a building similar to that shown in illustration 1, but stipulated that he/she required a larger parlour. If this were so, perhaps the builder merely incorporated into his given design an extra ground- and first-floor window at the parlour end of the house! If so, it shows a surprising low level of aptitude on the part of the builder! Despite this, this suggestion may not be as unlikely as it seems, for the builder demonstrates poor design skills elsewhere within the structure, in particular with regards to the design of the end walls. Within these, the levels of the projecting string courses are wrong and the endings of the projections are poorly conceived. Furthermore, although a slight external projection on an end chimney was a feature which was becoming increasingly common at this date, usually the projection was designed to suggest the presence of a narrow internal fireplace even where an inglenook was incorporated. However, the designer of Brocketts incorporated wide, off-centred projections at both ends of the house, implying the use of wide fireplaces throughout and giving a somewhat cumbersome and unbalanced appearance to the end walls.

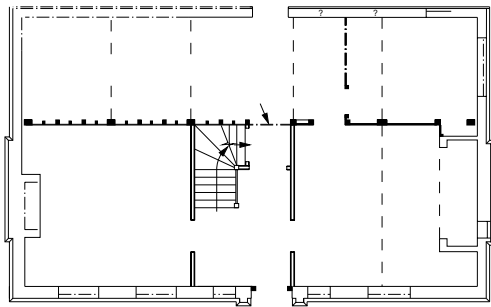
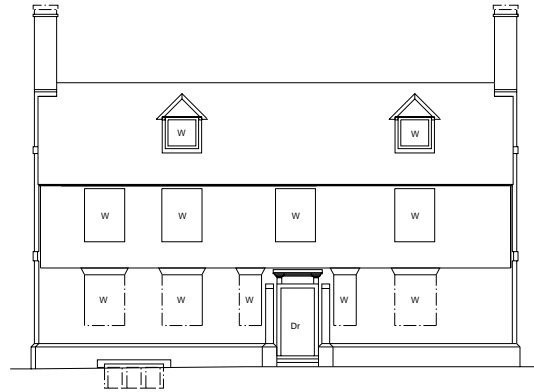
2. BROCKETTS AS BUILT, WITH LARGE PARLOUR

GROUND-FLOOR PLAN

FRONT (EAST) ELEVATION

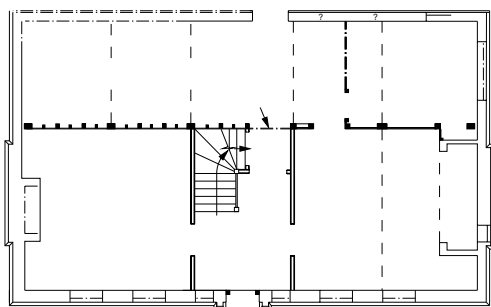
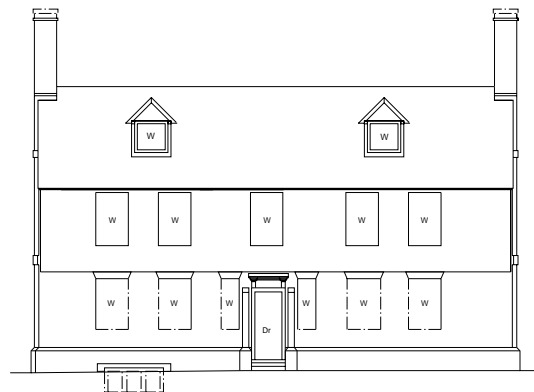
3. THE LOGICAL DESIGN SOLUTION (NOT ADOPTED)

GROUND-FLOOR PLAN

FRONT (EAST) ELEVATION

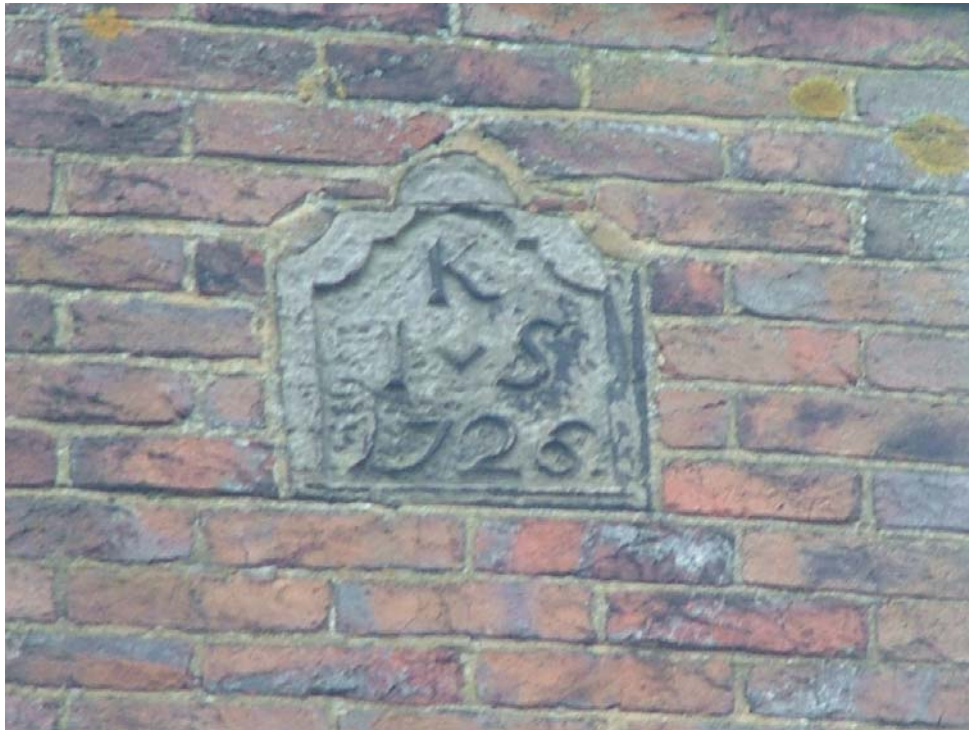
Plate 1
Date stone built into southern chimney cap.

The main range and rear lean-to outshut were constructed during the early 18th century [**Period A**], the date (1726) being commemorated by a plaque built into the southern end chimney cap. It is a central entry, terminal chimney house of textbook type, though curiously (and somewhat unnecessarily) designed with an asymmetrical facade. Except for the first-floor section of the front facade and part of the southern end wall (which are of tile-hung timber framing) the external walls are of brick. All internal partitions are timber framed. A canopy-capped entrance doorway leads into the central entry, which also contains the stairs. To the north is the kitchen/hall and to the south a large parlour with cellar beneath. Running along the rear of the house was a service lean-to (now partly destroyed and much modified) the southern half of which was open to the roof whilst a storage garret was incorporated over the northern part. The layout within the main range is repeated at first-floor level. There have always been rooms within the roof.

As discussed under the heading 'Listed Status and Age of the Building' above, based upon the layout, constructional details, and original window arrangement a typological date in the early 18th century can be given for the building. Built into the southern face of the southern end chimney is a stone slab which incorporates a rectangular panel with a shaped head. On this panel are the initials $I^K S$ and the date 1726 (see Plate 1). Ordinarily, given the date suggested by the architecture, there would be no reason for doubting that the plaque commemorates the construction of the house, but, as already noted, the list description for the building suggests that the plaque is reset, but gives no source/evidence for this statement. Bearing this in mind, although the early 18th-century date for the building should be regarded as secure, a question mark remains as to whether the precise date for the work is 1726.

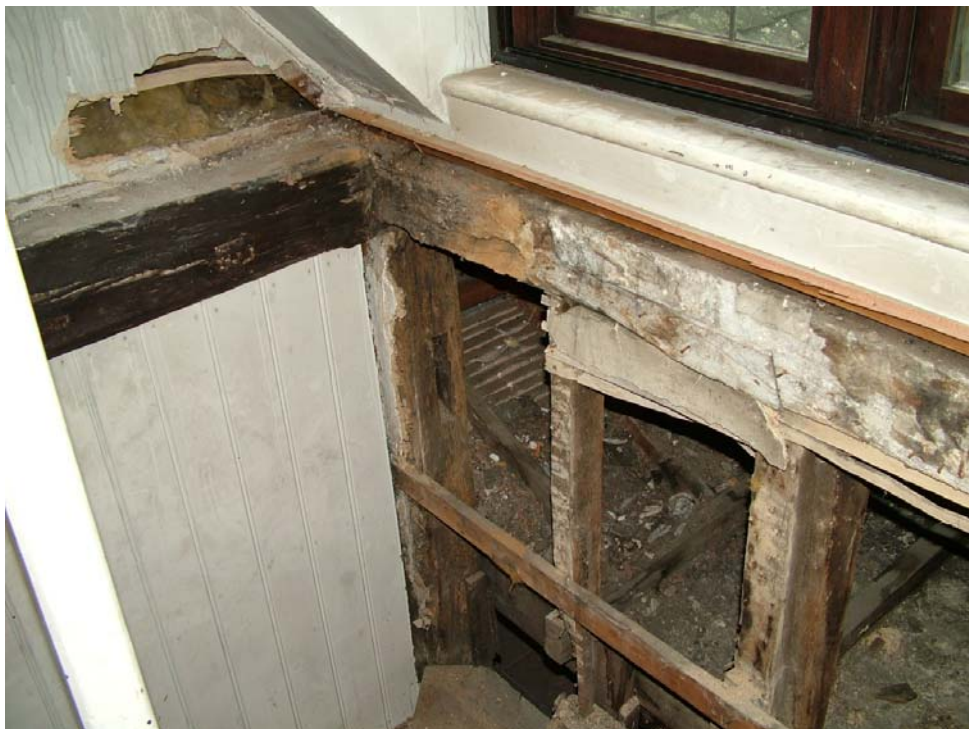
Plate 2
Attic stairs showing tiebeam jointed to wallplate in level assembly.

Rising from the first-floor landing, immediately above the ground-floor flight, are the stairs giving access to the attic areas. As indicated by blocked mortices in the side of the adjacent tiebeam, these have been replaced, probably to a more convenient, lesser pitch, for the removed joist indicates that the original trimmed opening was considerably smaller than that which now exists. As the headroom would have been limited, it is assumed that the present modern dormer replaces a predecessor: this would not only have lit the stairs, but would also have provided extra headroom, thereby giving easier access to the garret rooms.

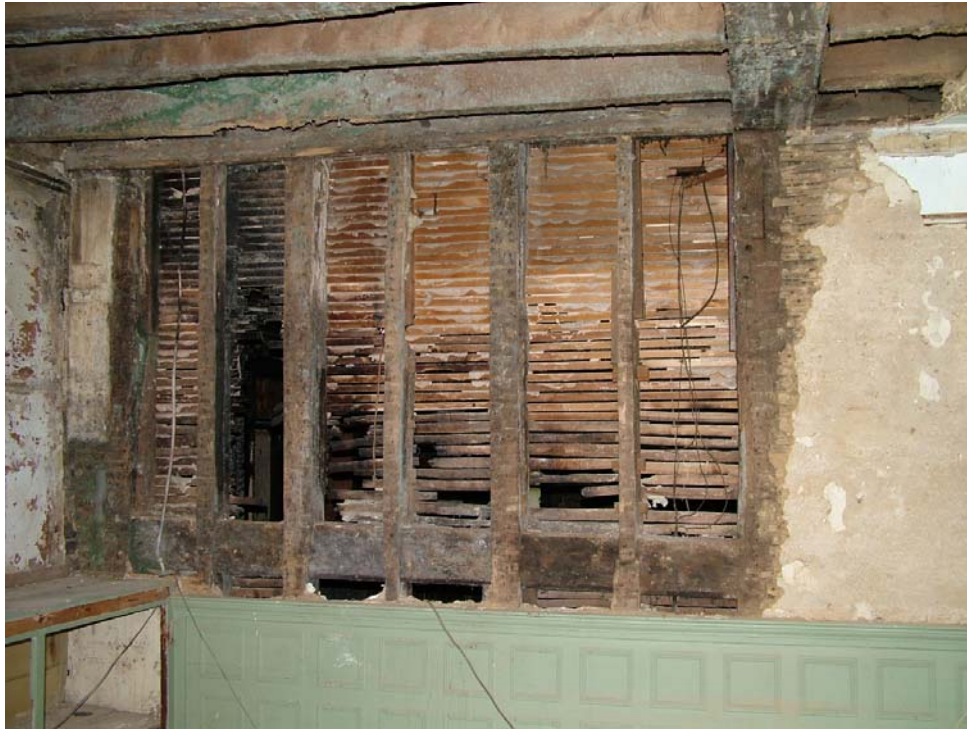
Plate 3

Wall framing within rear wall of parlour exposed by removal of original lath and plaster following fire damage. Note the midrail of the small-panel framing and the extra nailed-in secondary studs (two of which are nailed against the face of jointed-in primary studs), all fitted in order to support the laths.

In contrast to the mostly brick external walls, all internal walls and partitions are of timber-framed construction. In the main rooms and chambers all the framing was intended to be masked from view from the outset whereas, in contrast, within the rear service areas it was left exposed to view - it has been covered by lath and plaster subsequently. Following the fire in 2006 these later coverings were partially removed from the southern end of the wall which separates the main range from the lean-to outshut. The wall is constructed using heavy-scantling wall posts at the bay divisions, giving a wall five bays long (see 'Rear Wall of Main Frame (Y-Y)' in Drawing 1641/5). Most of the timber has been reused from an earlier building, explaining the presence of illogically placed redundant mortices and wattle grooves. A further effect of this use of secondhand material is to be seen in the main wall posts themselves, at least some of which are made up of two timbers spliced together part way up the walls, the splices being strengthened (perhaps at a later date) by extra timbers fixed to the western face of the posts, just above the level of the rear lean-to outshut's tiebeams. The design of the infill framing is typical of the transitional period from standard post-medieval timber framing to the new techniques which were introduced late in the 17th and early in the 18th centuries. Some elements are very traditional. For instance, as indicated in Drawing No. 1641/5, side girts (at the level of the first floor) and midrails (half way up the storey heights) span between the bay posts, with 100 mm x 90 mm studs jointed into them by means of pegged mortice-and-tenon joints. The result is typical small-panel framing of the type commonly found during the 17th and into the 18th century. However, despite this use of traditional elements, the main bay posts are absent of jowls at their heads and support the wallplates and tiebeam in level (as opposed to normal) assembly - typical 18th-century features (see Plate 2). There are no dragon ties to triangulate the ends of the wall. It is traditional for small-panel framing to be infilled using solid daub panels supported by staves, but in this instance there are neither stave holes nor grooves for fixing traditional staves. Instead, notched and nailed to the midrails are 'extra' studs of 55-65 mm x 100 mm section which support on their eastern face a lath and plaster covering. This covering continues across the faces of the main posts, midrails and side girts to give a flush plaster surface within the principal rooms and chambers. These nailed-in secondary studs were fixed during the 'fitting-out' stage of the construction process and are shown in grey outline in section Y-Y, Drawing No. 1641/5. At that same time as this was undertaken it was necessary to apply extra studs to the eastern face of the framed-in structural studs in order to pack these out to the same alignment as the secondary studs.

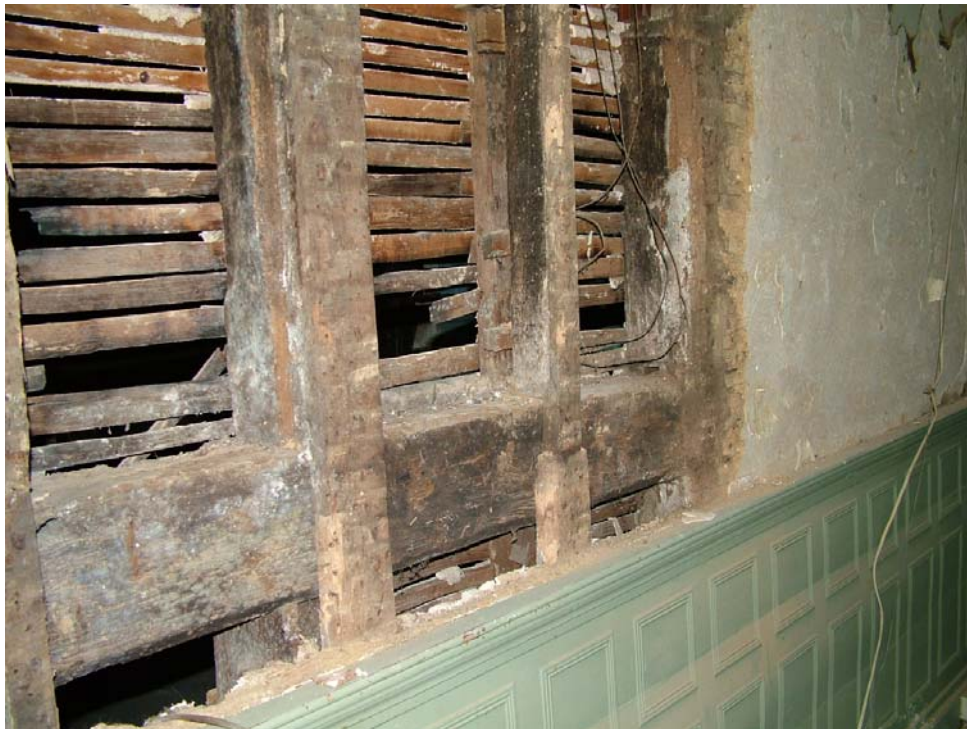
Plate 4.

Detail showing section of wall illustrated in Plate 3

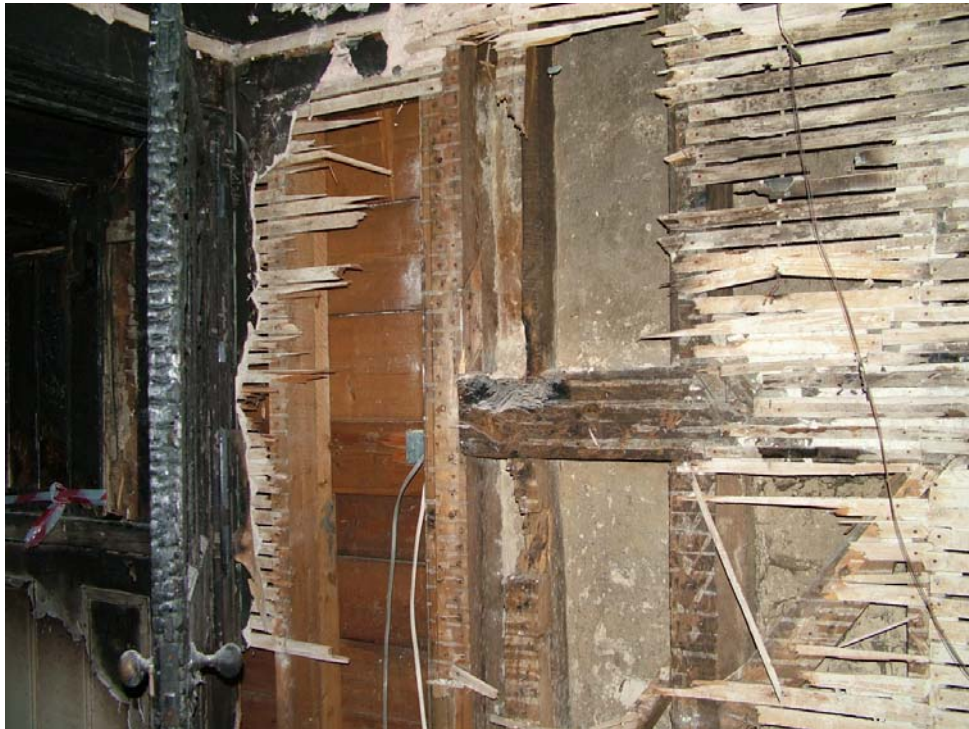
Plate 5

Wall framing temporarily exposed within area of former rear outshut where modern lath and plaster removed following fire. The original lath and plaster is clearly visible within the core of the partition, smoothed to a finish between the projecting studs which support the laths. Note the intruded modern doorway within this wall, now blocked by a wall and doorway within the later extension (left).

In contrast to the main face of the wall, in the rear lean-to outshut the timbers were left exposed, the plaster surface applied to this side of the laths being smoothed flat between the studs. All this timberwork and plaster had subsequently been masked from view by modern plaster coverings, but areas of both the plaster and studwork were temporarily exposed to view following the fire (see Plates 3-5). Similar framework is exposed to view within the northern end of the same wall, within the lean-to outshut: it is detailed in Drawing No. 1641/5, Section Y-Y).

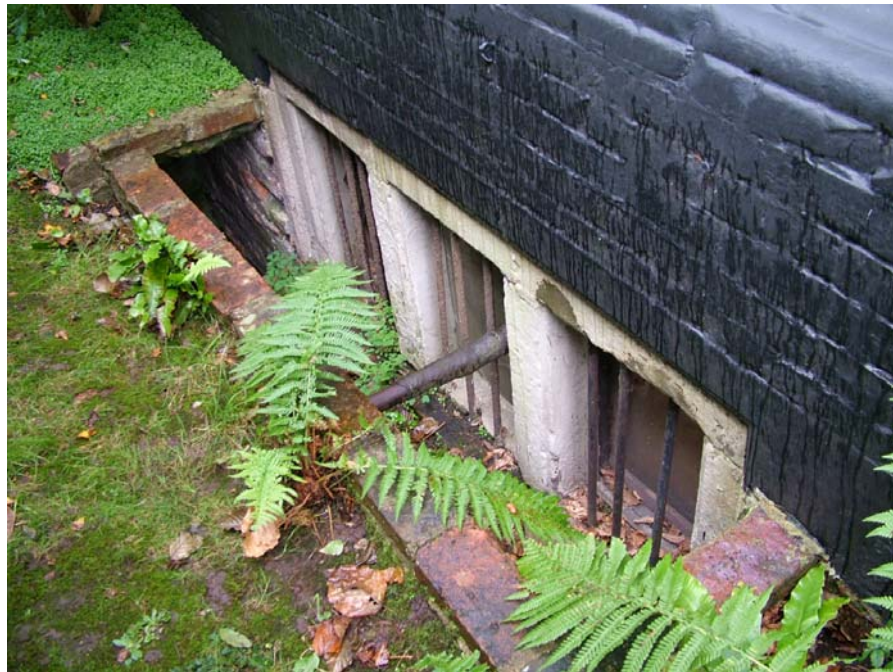
Plate 6

Stone surround of cellar window

floor (but with a single window over the front door) though externally the northern of the two openings serving the parlour chamber is now blocked by tile hanging: on the interior its position is today indicated by a recess filled by book shelves. Despite the use of timber window frames at ground- and first-floor levels, the cellar was lit by a three-pane stone-mullioned window with plain, rebated external leading edges. In front of it is an open area allowing extra light into the cellar (see Plate 6).

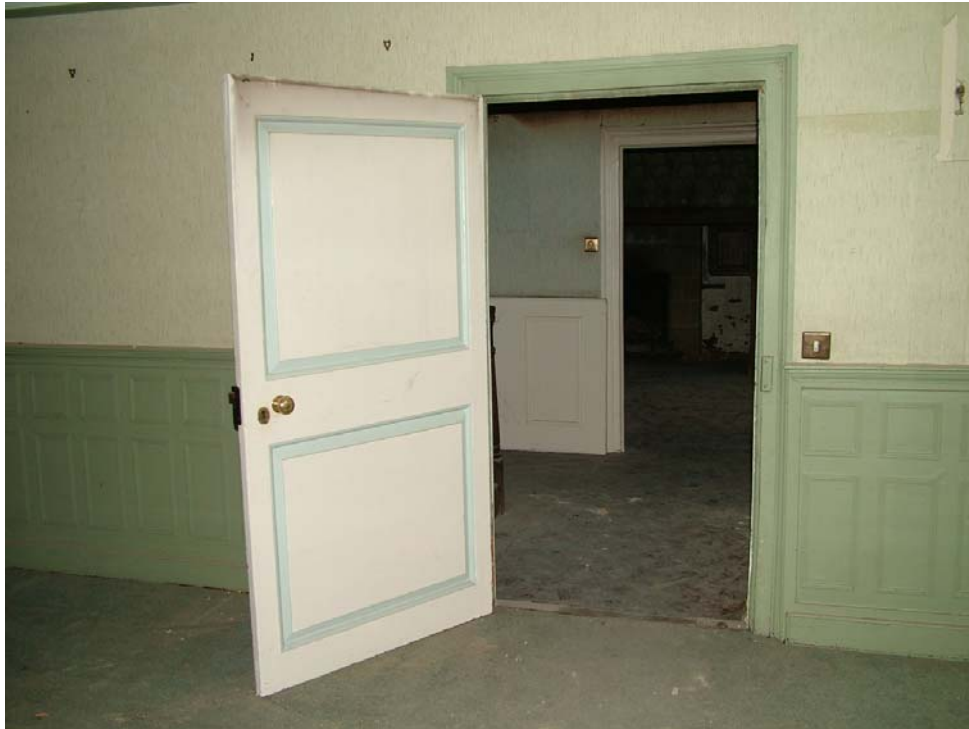
Plate 7

Doorway leading from entry to parlour. The other principal doors and doorways similar.

Internally the doors leading off both the entrance hall and the first-floor landing are of two-panel type and incorporate raised-and-fielded panels (see Plate 7). The door frames have cyma moulded architraves and the doors themselves are hung on 'H-L' hinges.

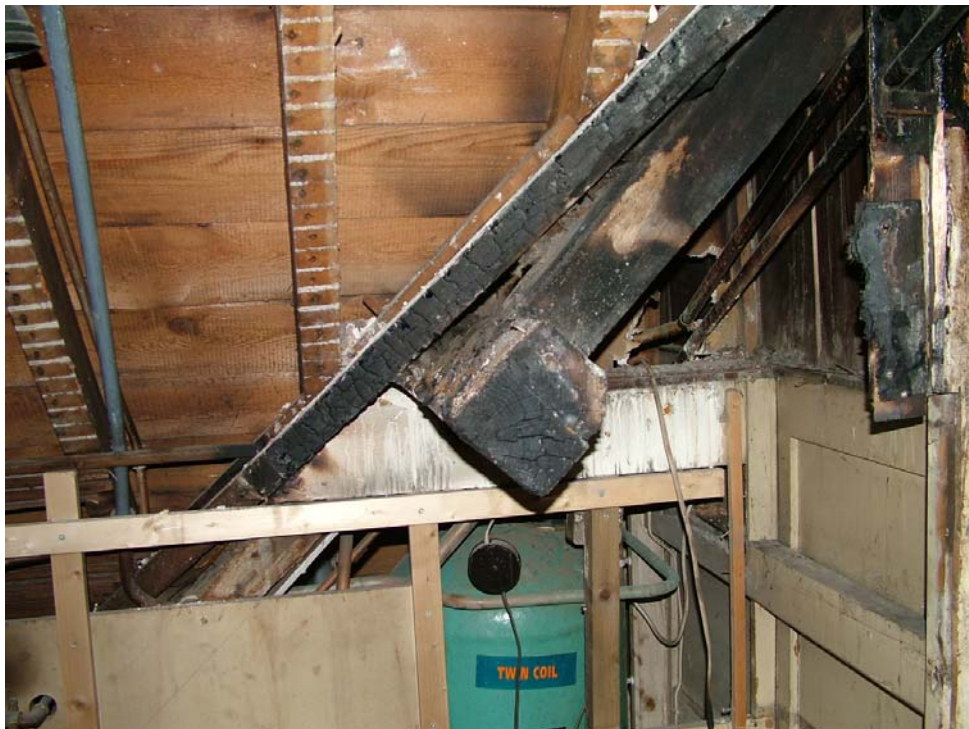
Plate 8

Fragmentary remains of roof over rear lean-to outshut, trapped between added southern rear range and added storey over northern end.

Although very little of it survived the later alterations, staggered-butt-purlin construction was also utilized for the roof over the lean-to outshut. A short surviving section of this roof was revealed by the fire in a cupboard squeezed between the later southern rear range and the upper storey added over the northern part of the outshut (Plate 8). The butt purlins measure 125 mm x 140 mm with 110 mm x 90 mm common rafters jointed into them at 480 mm centres. The sawn-off heads of the rafters of the former rear lean-to are still visible within the roof of the added two-storeyed range, proving that the lean-to outshut originally ran the full length of the house.

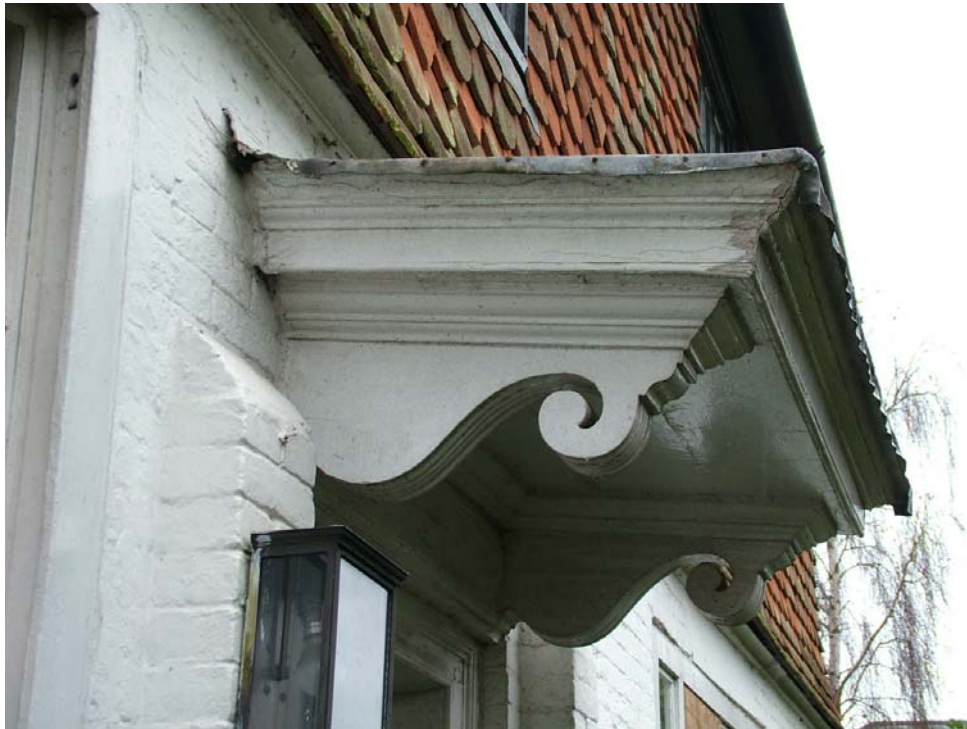
Plate 9
Detail of hood over entrance doorway.

The front door is capped by an original flat canopy supported on shaped brackets set above narrow brick piers which flank and emphasize the front entrance. The doorway itself is raised above the surrounding ground and is reached by steps. The frame

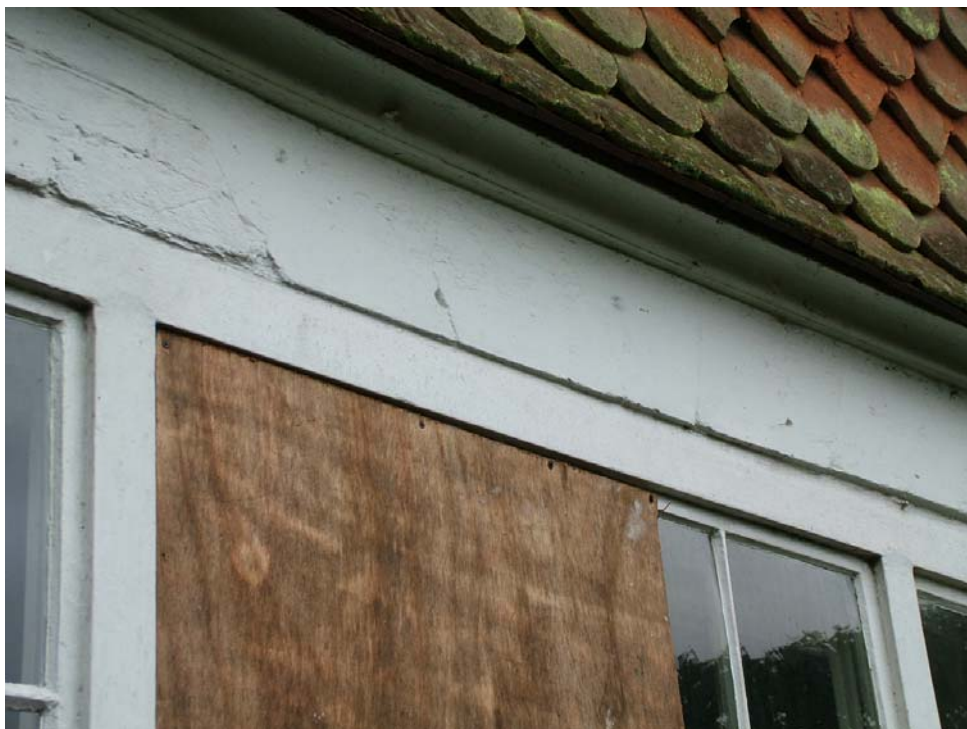
Plate 10
Head of former window exposed above inserted tripartite double-hung sash in front elevation.

As Drawing No. 1641/4 illustrates, the front elevation originally incorporated a very different window layout from that which exists today. The original ground-floor layout of the openings is not only indicated by straight joints in the brickwork but, even more convincingly, by the original rendered and lined-out flat window heads visible in the brickwork immediately beneath the moulded timber cornice which runs along the base of the first-floor tile hanging. This original scheme of windows was superseded in the 19th century by the present arrangement of wider tri-partite double-hung sash windows.

From the surviving window heads and straight joints it is possible to reconstruct the original window design with complete confidence. Viewed from the exterior, there were a pair of tall, narrow, windows flanking the front door, from which they were divided by applied brick pilasters. Viewed from the exterior these openings would have given the impression of lighting the entrance area, though, given the width and position of the entrance hall, in truth that to the north of the doorway actually lit the southern end of the kitchen/hall. The kitchen/hall itself was primarily lit by a single tall window. This contrasted with the arrangement at the southern (parlour) end which had two (rather than one) identical-sized openings. From the exterior this 'extra' southern window totally upset the symmetry of the house. It is not known whether these windows were of crossed-transom-and-mullioned type or whether they were new-style double-hung sashes, but given the design of the extant window in the north elevation (see below) and the fact that the elevation was later 'improved' to incorporate double-hung sashes, the former seems the more likely. Originally this window scheme was repeated on the first
