**An Archaeological Evaluation on
Winton House, Alfriston,
East Sussex**

**Commissioned by
Juliet Nicolson**

Project Ref. 3138

REPORT NO. 1667

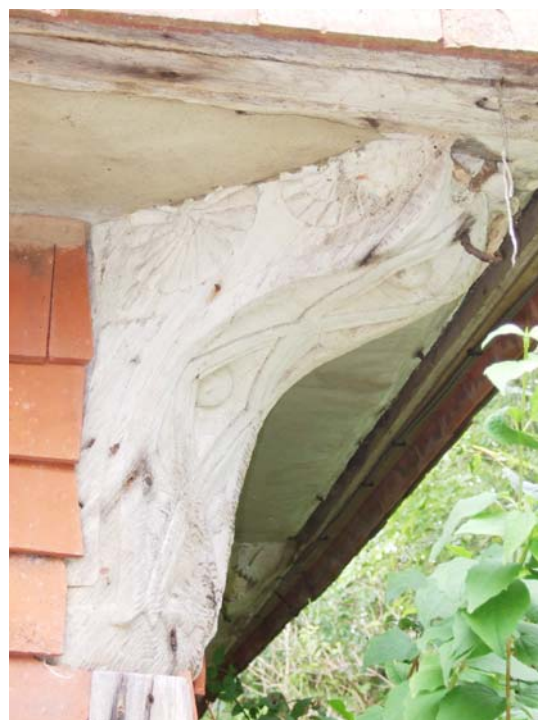
Plate 1

roughly finished. At the south-western corner, beneath the end of the dragon beam, survives the jetty bracket which, unlike those of the period-A2 range, is decorated with geometric designs (Plate 1). Here too the joist ends are masked by an ovolo-moulded fascia, designed to match that on the adjacent range.
