**An Archaeological Interpretive Survey  
of  
Stone House, High Street, Mayfield, East Sussex**

**Project Ref 3131**

## **REPORT NO. 1665**

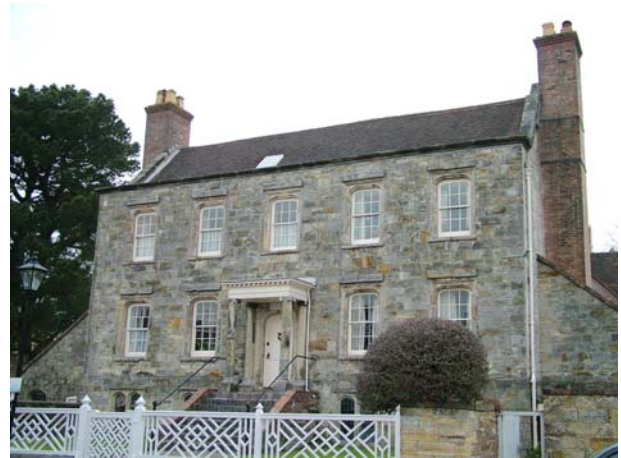
*Plate 1  
Street Elevation*

The symmetrical front wall (Plate 1) is divided into five bays by two tiers of regularly-spaced openings, all with reused stone surrounds. The front doorway, which has a plainly-chamfered four-centred arched head and vase stops, is approached by a flight of (rebuilt) steps and is protected by a flat-roofed canopied porch. This is carried by four columns supported on low pedestals and sporting Ionic caps and bases. The timber fascia to the flat hood is moulded and incorporates square dentils (see Plate 2). The door itself is of four panels and has a spring latch and two flat-bar locking bolts (see Plate 3).

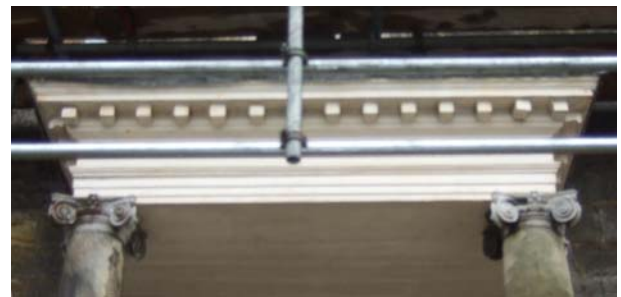
*Plate 2  
Hood to porch*

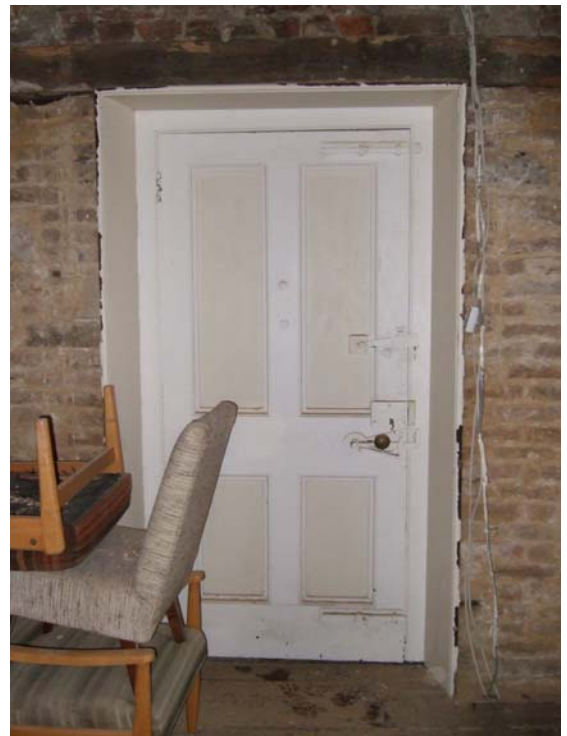
*Plate 3  
Interior of front door*

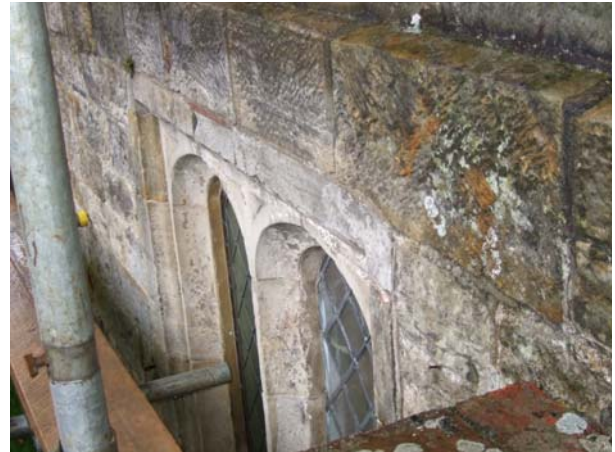
*Plate 4*  
*Window at basement level*

This layout of windows is repeated beneath the plinth at basement level, where the cills are positioned only just above ground level. Here the windows retain their original form – two lights with a central stone mullion and four-centred arched heads (Plate 4). These may have been reused in this form in order to reflect the lower status of the basement rooms, or equally (for the same reasons) could have escaped modification during the 19th century. The lobby at the bottom of the cellar steps was lit by borrowed light from a square-headed window in the eastern side wall of the barrel-vaulted area beneath the entrance stairs.

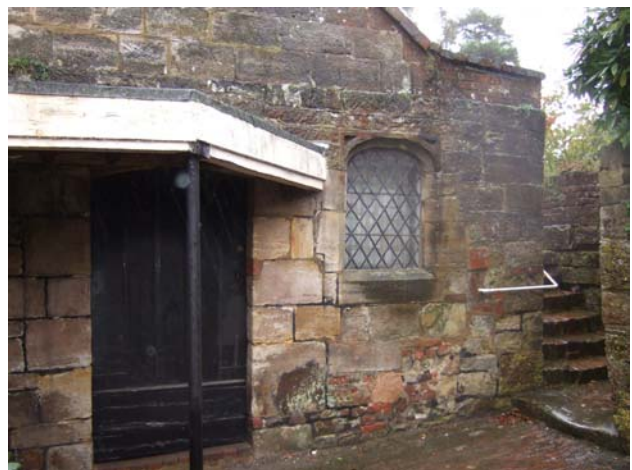
The two lean-to outshuts which flank the house are each entered by a stone doorway in their southern walls. That to the eastern outshut has plain jambs and a segmental arched head, whilst the single-light window to the east has a stone surround with semi-elliptical arched head and sunk spandrels, all of reused material (Plate 5). These doorways and adjacent windows are the only openings serving the outshuts: their other external walls act as retaining walls.

*Plate 5*  
*South wall of eastern outshut*

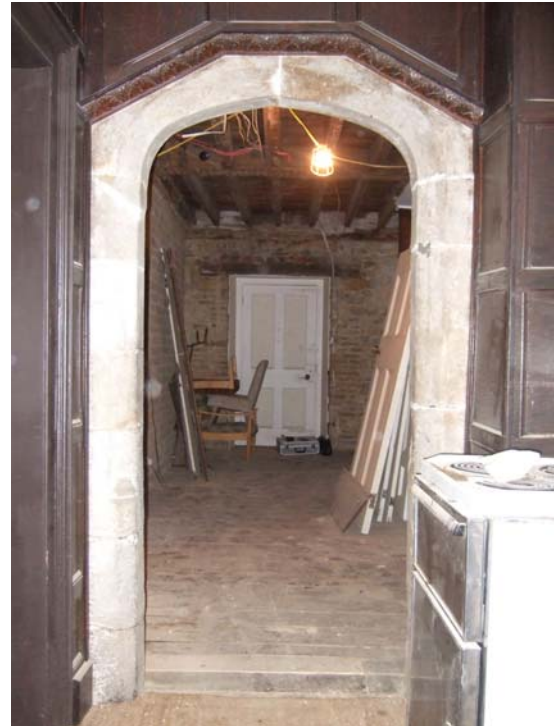
Although the point is not now obvious due to later alterations, despite its secondary nature the rear (north) elevation is nonetheless designed to be symmetrical when viewed from the exterior (see Drawing No. 1665/4). This is despite the fact that compromises had to be made with regards the internal layout. The reason why symmetry was considered important appears to have been that this elevation was easily visible from the palace. The reused central doorway, approached by a short flight of steps supported on a barrel vault, has chamfered stone jambs, the chamfer being carried around the otherwise plain four-centred arched head (Plate 6). Internally a massive timber lintel supports the wall above. Within this elevation each of the two ground-floor rooms and two first-floor chambers was lit by a single opening. As with the doorway and the windows within the front elevation, the surrounds are reused from the palace. They are of two chamfered lights with four-centred arched heads having sunk spandrels, all set within a cyma-moulded square-headed surround (Plate 7). Originally the rear doorway was flanked by narrow rectangular window openings with plain jambs and square heads, the lintels of which are each formed by a single stone block. That to the west of the doorway (now partially blocked)

*Plate 6*  
*Rear doorway (now within added porch)*

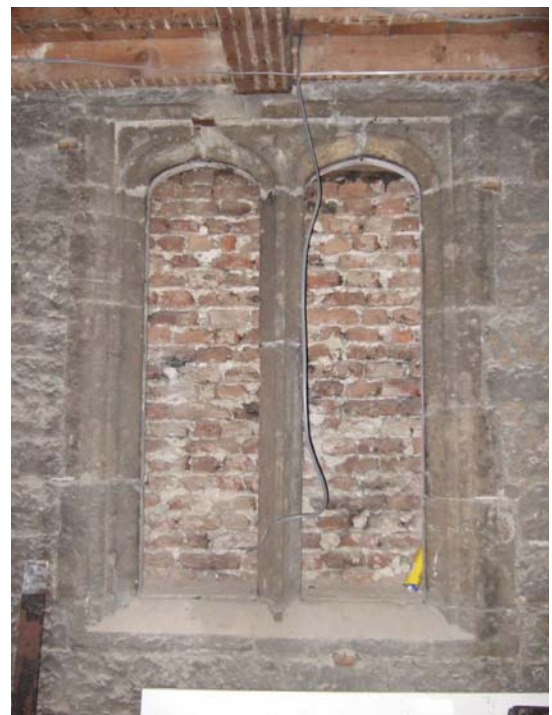
*Plate 7*  
*Blocked rear window serving hall*

is fitted with an original (possible reused) double-hung sash window having heavy ovolo-moulded glazing bars. The eastern opening clashes with the alignment of the entry/hall

partition and is in fact blind, its brick jambs being returned across the internal face of the wall in fully-bonded brickwork. Now internalized by the addition of the later rear wing, the opening was originally fitted with a double-hung sash which matched that to the west: presumably its glass was painted out to disguise the fact that it was a dummy. Over the doorway, on the first floor, one of the splayed jambs of a destroyed window survives behind a later timber surround, where a doorway has been cut through subsequently. Whether this window, which lit the first-floor landing, was fitted with a stone surround or a double-hung sash is not known.

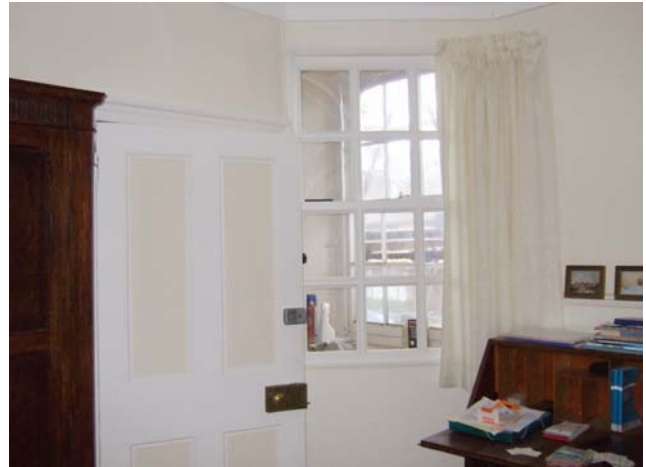
*Plate 8  
Borrowed light in parlour*

A double-hung sash similar to that beside the rear doorway, also with heavy glazing bars, exists internally as a borrowed light where an angled partition divides the parlour from the entrance area (Plate 8). This partition is angled in order to avoid a clash between its alignment and the symmetrically placed windows in the front facade, though the borrowed light may also have served the additional function of allowing Richard Owen Stone to observe clients approaching the front door.

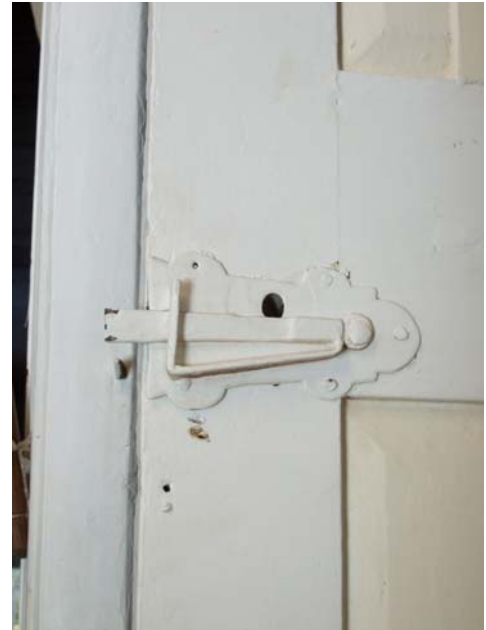
*Plate 9*

this same reason, the door serving the eastern attic room is a three-plank ledged door: its top corner is angle-cut to suit the roof slope. The door giving access to the bottom of the attic stairs retains a good spring lock (Plate 9).

*Latch to door at base of attic stair*

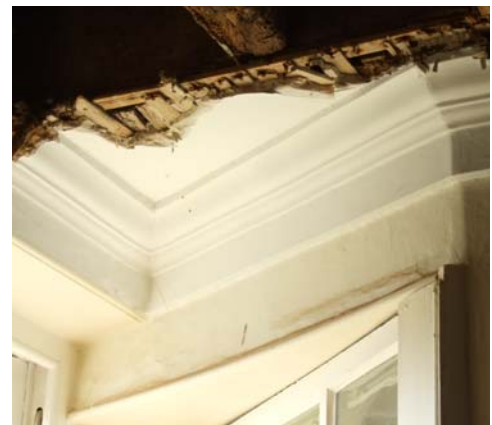
*Plate 10*

*Surviving cornice in the entry*

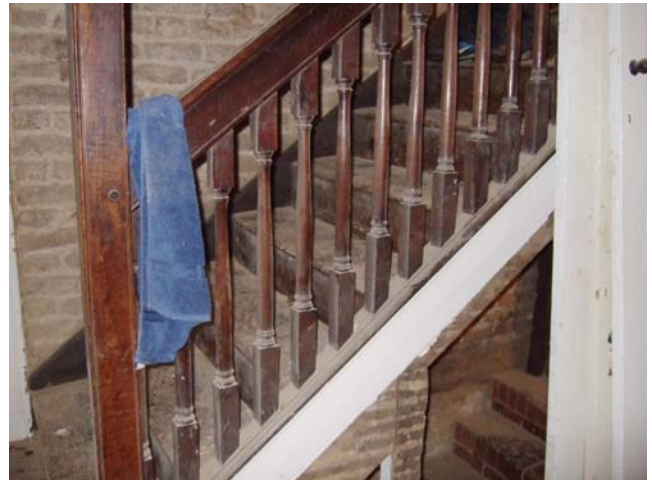
typical of the period (Plate 11). Access to the enclosed attics stairs is via a doorway off the landing. Winders at the head allow sufficient headroom beneath the slope of the roof. At this point the stairs are today protected by a modern handrail: the original balustrade arrangement (if any) is uncertain.

*Plate 11*  
*Balustrade to main staircase*

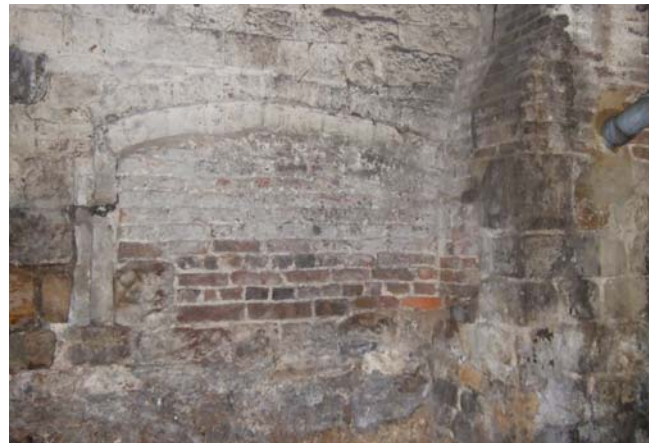
At the western end in the basement is a large working fireplace which also served a large bread oven (now removed). The bread oven was sited mainly within the western end lean-to, but because of its location it also projected through the gable wall of the main house. Within this wall can be seen an arched opening which carried the masonry over the vulnerable, non-structural dome of the oven (Plate 12). Because of the internal room configuration, on the ground floor the chimney incorporated not one but two small fireplaces: these served the parlour (front) and ?butler's pantry (rear). The parlour fireplace is currently blocked but retains its simple moulded timber surround and mantle shelf. Within the ?butler's pantry is a simple stone surround with segmental head. Within the opening is a very complete cast iron grate (Plate 13). This fireplace sits over the bread

*Plate 12*  
*Arch carrying wall over site of former oven*

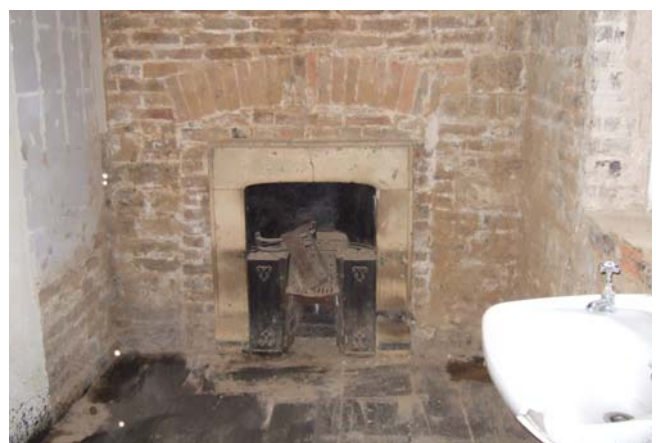
*Plate 13*  
*Fireplace within ?butler's pantry*

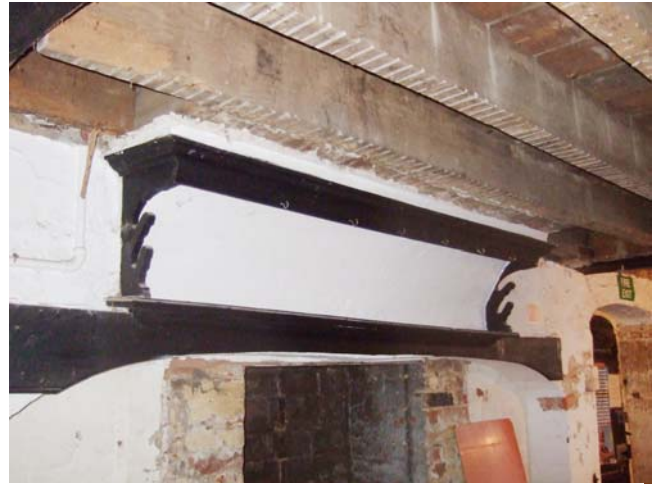
Like the chimney serving the western end of the house, the eastern stack incorporates a large cooking hearth at basement level. The hearth is exceptionally deep. Above is a timber spit rack (Plate 14). To the north of the fireplace are three courses of bricks which project forward into the room, above which is a blocked arched opening. The likelihood is that this was once associated with a water-boiling furnace, or similar fixture. Within the flue, above the brick arch which forms the lintel, are two arches crossing the flue, preventing the tumbling from collapsing in on itself. (A similar arrangement of arches probably exists within the western chimney, but the flue has been blocked.) On the ground floor, within the hall, the fireplace surround has been removed. At the time of the site visit the two-ring brick-on-edge segmental arch which spans the earlier opening was exposed for repair: this had dropped and was being supported by timber props. Both eastern chambers on the first floor were served by fireplaces, though that in the front hall chamber has had its surround removed. That serving the rear chamber has an original timber surround with projecting moulded shelf and mantle board, all typical of the period (Plate 15).

*Plate 14*  
*Spit rack over kitchen fireplace*

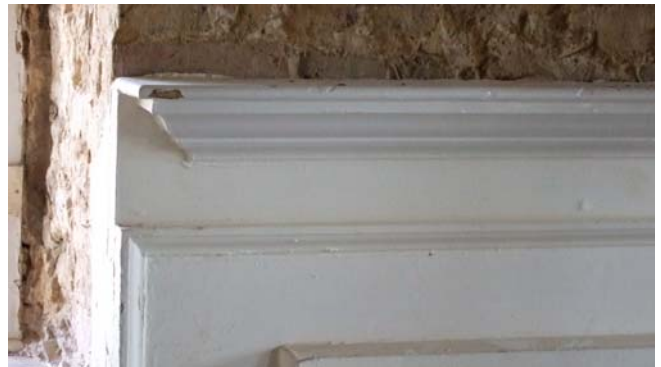
*Plate 15*  
*Surround and mantle board to fireplace,  
rear hall chamber*
