**AN ARCHAEOLOGICAL
INTERPRETATIVE SURVEY
OF
BUNCES, BLACKBOYS,
FRAMFIELD, EAST SUSSEX**

**Commissioned by
AVRIL & NOEL MANSLEY**

PROJECT REF. 2941

REPORT NO. 1654

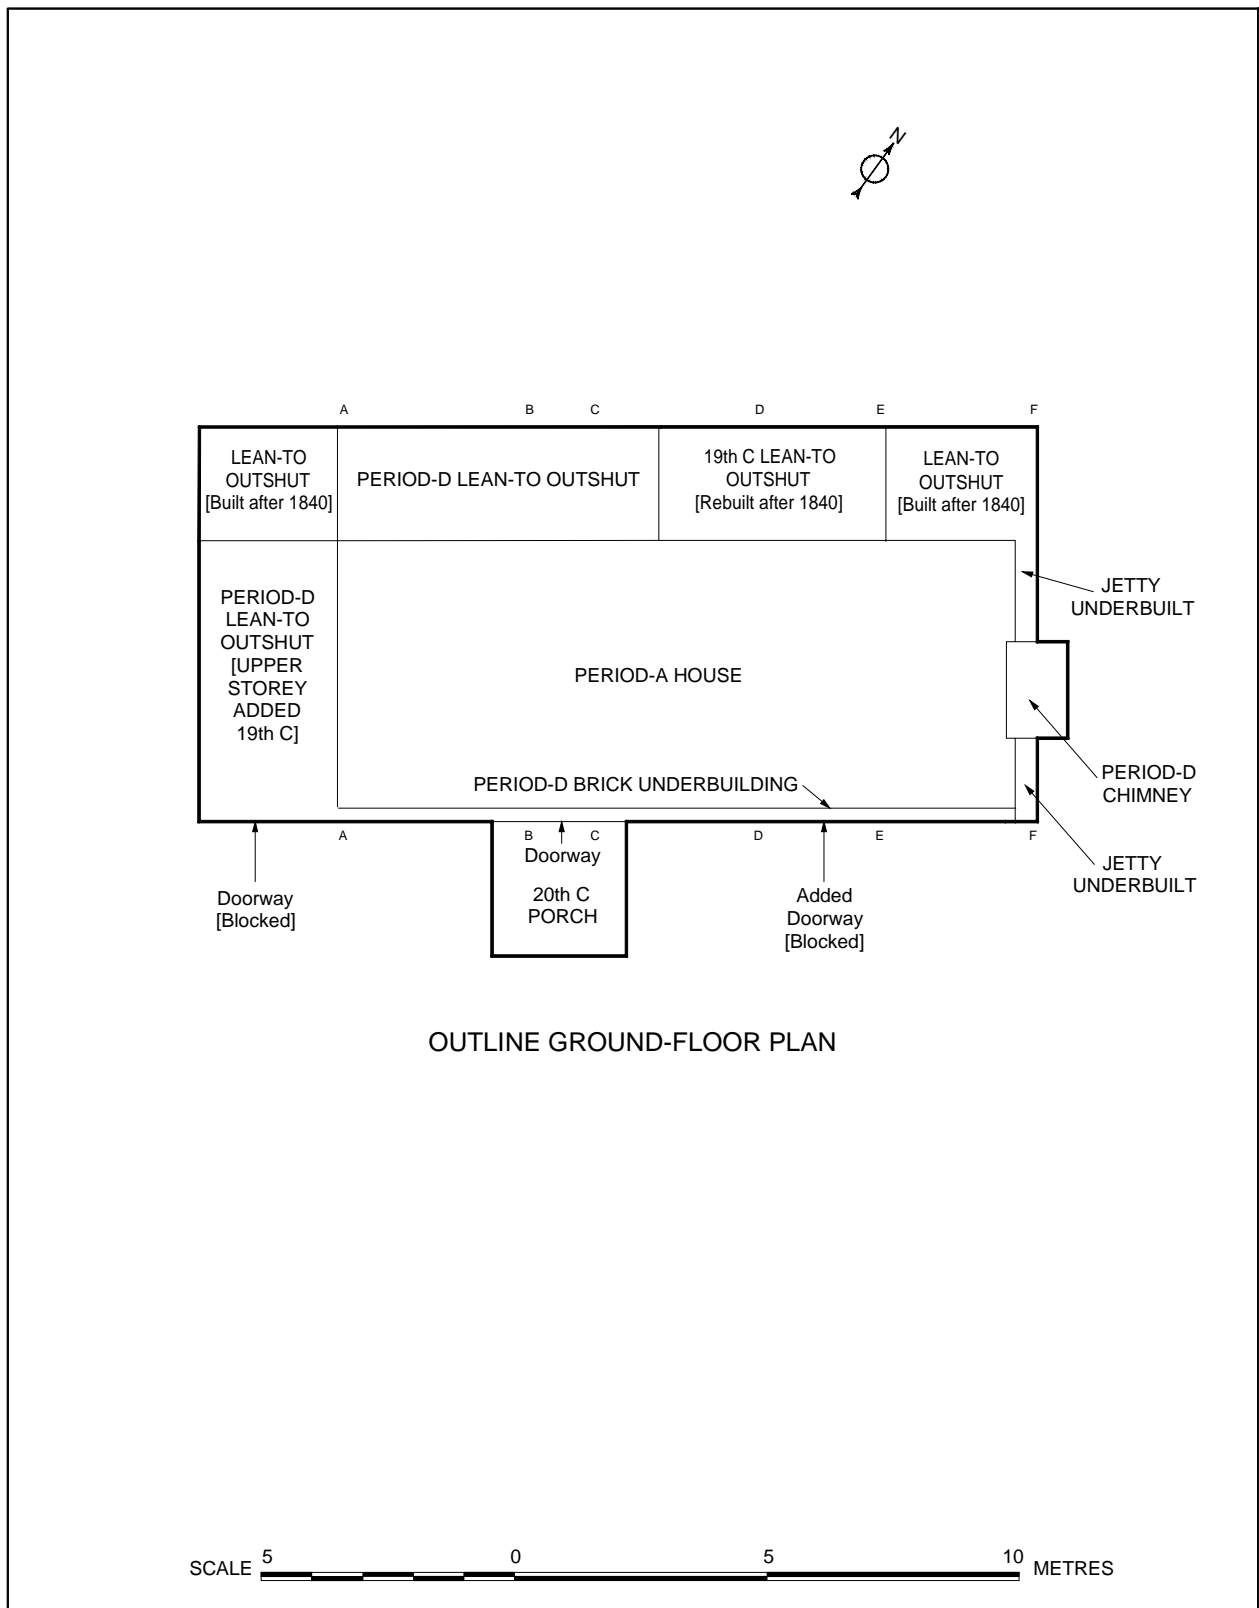
BUNCES, BLACKBOYS, FRAMFIELD, EAST SUSSEX OUTLINE PLAN SHOWING SEQUENCE OF DEVELOPMENT				Site Ref	P69/18
				Drawing No.	1654/1
Drawn By	D Martin	Revision No	-	Date of original survey	2007
				Date of this revision	-

The house dates from the mid 16th century [**Period A**] and incorporated a floored-over hall from the outset. At the western end, in the location usually reserved for the service rooms, was a kitchen. The house also differed from the usual plan in that it incorporated two inner rooms (or parlours) beyond the high end of the hall: the first of these contained the stairs giving access to three chambers on the first floor. The house illustrates well the experimentation which occurred during the medieval/early modern transition in that it incorporates a mixture of features from both eras. The hall was initially heated by an unrestricted smoke cavity, but it also incorporated high-end dais panelling. All three of the first-floor chambers had ceilings from the outset, allowing attic storage within the roof, yet both the smoke cavity and the adjacent kitchen area were open from ground floor to roof. All windows were of unglazed type.

It seems likely that at a date quite soon after the house was constructed [**Period B**] the smoke cavity was upgraded by the insertion of a more sophisticated heating system (perhaps either a timber-framed chimney with an enclosed fireplace or a single-flue brick stack). This possible modification is hinted at by the reuse of a once moulded 16th-century fireplace lintel within the present chimney. There is also inconclusive evidence which suggests that part of the open kitchen bay may have been floored over and partitioned off in order to form an additional first-floor chamber. It should be stressed that both of these possible alterations remain unproven.

Not until the mid/late 17th century [**Period C**] was the earlier heating systems within the hall and kitchen replaced by the present brick four-flue stack. The stack is noteworthy because its western ground- and first-floor fireplaces are aligned at right angles to those heating the hall and hall chamber and serve a room and chamber occupying the front half of the western bay. This arrangement could have been influenced by the (assumed) period-B alterations within this bay. Excepting this, the house otherwise continued to utilize its earlier plan form. Almost certainly already by this date the windows had been upgraded from unglazed to glazed type, a modernization which entailed inserting a new, larger window into the eastern end wall at first-floor level.

It was not until the second half of the 18th century [**Period D**] that two brick-built lean-to outshuts were added: one at the western end, the other extending along the western half of the rear wall. The ground-floor part of the front wall was at this time rebuilt in Flemish-bonded brickwork, the upper part was tile hung, and a two-flue chimney was added to the eastern end, heating the eastern parlour. Despite the new chimney, the eastern end jetty was retained *in situ* at this time. It may have been at this date too that dormer windows were inserted into the front slope of the roof, though this could have occurred subsequently.

OVERVIEW OF THE BUILDING [Drawing No. 1654/1]

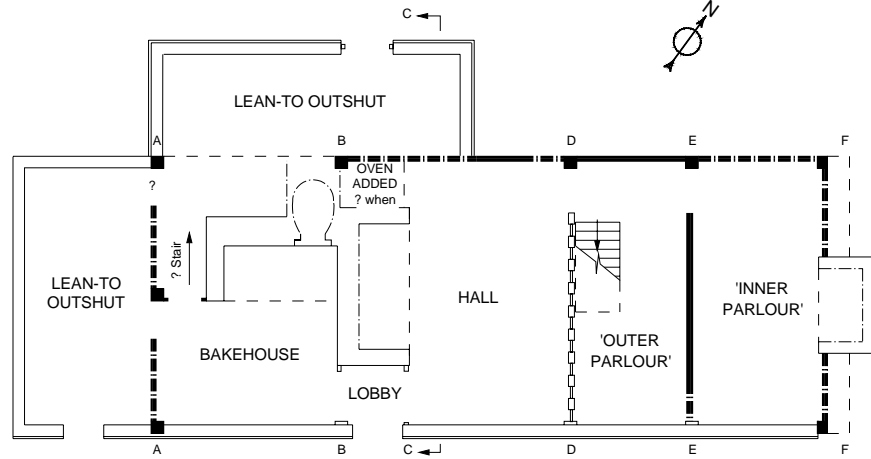
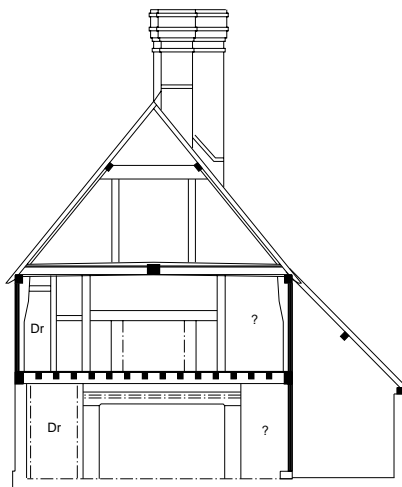
BUNCES, BLACKBOYS, FRAMFIELD, EAST SUSSEX PERIOD-D RECONSTRUCTION DRAWINGS				Site Ref	P69/18
				Drawing No.	1654/5
Drawn By	D Martin	Revision No	-	Date of original survey	2007
				Date of this revision	-

brick-built lean-to outshuts were constructed - one against the western end wall and the other extending along the western end of the north wall. The end lean-to was presumably built to provide additional service accommodation, whilst the rear lean-to served as a much needed extension to the area behind the brewhouse fireplace. Within it was sited the new back door. It is possible that at this date a staircase was inserted to the west of the bakehouse fireplace, leading to the upper chambers at this end of the house. Alternatively, the staircase in this location may not have been added until the house was divided into cottages.

As part of the modernization the ground-floor front wall was brick underbuilt at this date and the first-floor framing above clad with tile hanging, but the first-floor eastern end jetty was retained, as evidenced by the extant brick quoin, the *in situ* headplate of the ground-floor wall, and the design of the eastern end chimney which was added to heat the parlour. Here the framing was left exposed - presumably it was not easily visible from the road.

GROUND-FLOOR PLAN [Windows not shown]

TRUSS C-C FROM EAST

PERIOD D (Late 18th C) [Drawing No. 1654/5]

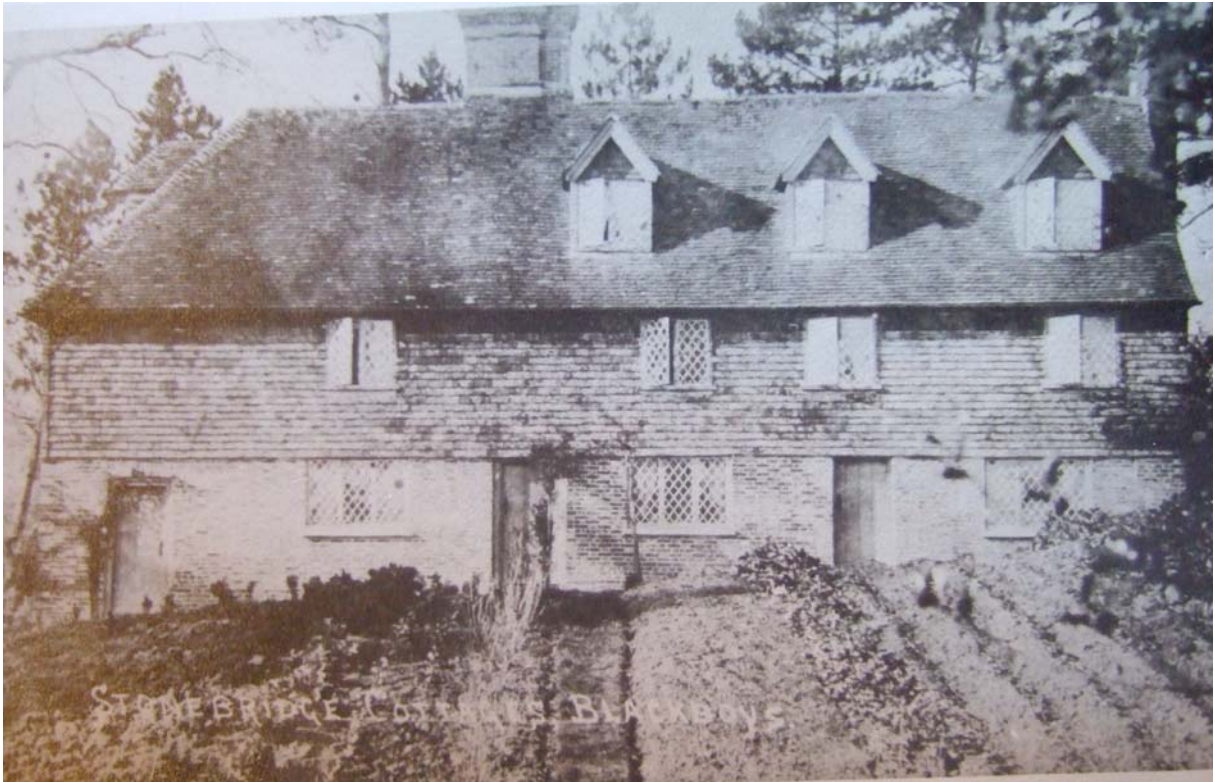
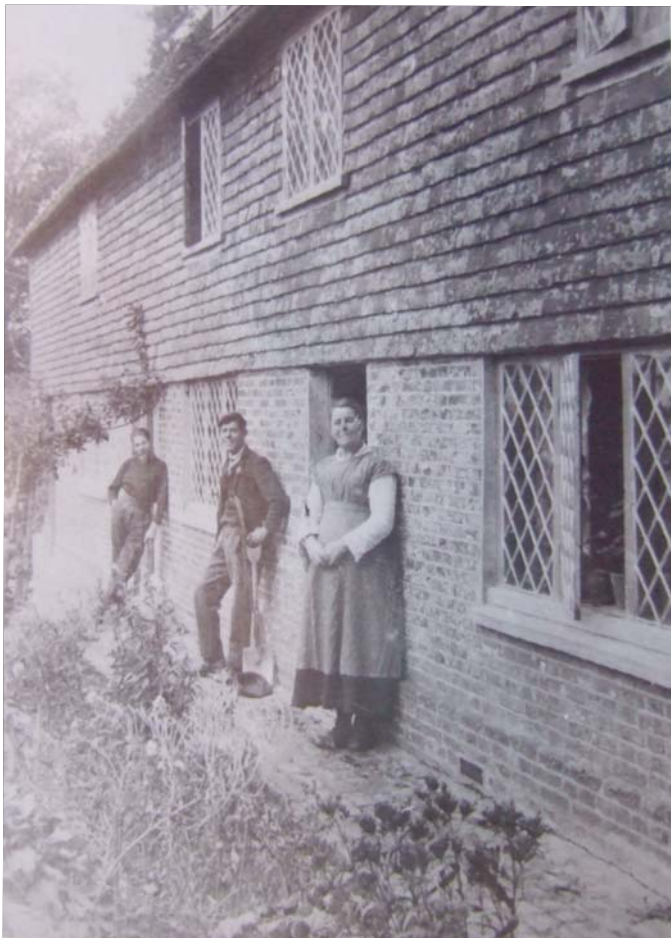
Plates 1 and 2
Old photographs of Bunces when in
use as cottages.

outshut was converted to two full storeys, capped by a westward extension of the main roof, complete with hipped end. The new roof is of sawn softwood with ridgeboard and is cradled over the backs of the former hip rafters (which are utilized as lay boards). Lean-to outhouses have been added in the angle between the western end extension and the earlier rear outshut. Two photographs survive showing the building in its cottage configuration (Plates 1 and 2).
