An Archaeological Watching Brief at Brushings Farmhouse, Broad Street, Hollingbourne, Kent

**Planning Reference MA/05/1807
Listed Building Consent MA/05/1816**

**ASE Project No. 2439
Site Code: BFH07**

January 2008

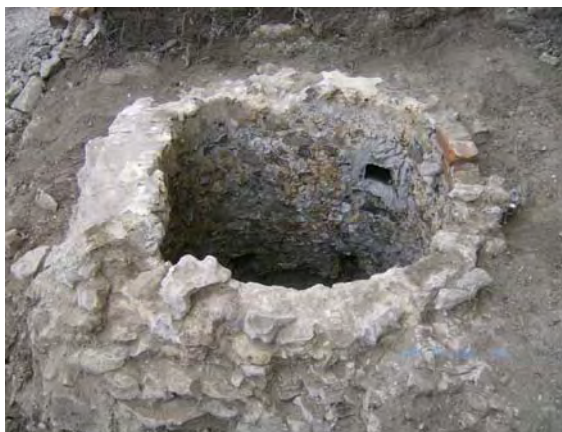
Plate 1: The well 3/006

- 4.3.2 No archaeological features or deposits were observed within Trench 3 however a well was encountered during landscaping associated with the excavation of Trench 3. This was situated to the immediate north of Trench 3 indeed the position of Trench 3 was adjusted slightly to allow for the total preservation of the stone structure of the well. The well [3/004] measured 1.19- 1.23m across in diameter inside the stone structure (3/006) and was over 5.50m deep from the surface. The full profile was not visible; the sides sloped sharply appearing to taper slightly towards the base [3/004]. Some infilling was evident from observations made from the surface. This material (3/005) was not examined and could represent intentional infilling after the well had gone out of use or natural infilling over a period of time or most likely a combination of the two processes. The stone wall structure of the well (3/006) comprised of flints bonded with mortar and there was evidence of various repairs to this structure overtime. The top of the well wall had been damaged by the c.1960's construction of an extension to the side of the farmhouse and part of the structure had been altered with modern brickwork. The diameter across the outer edge of the stone wall was 1.60m-1.80m and the wall was up to 0.50m thick.

Number	Type	Description	Max. Length	Max. Width	Max. Depth
3/001	Layer	Concrete Slab Surface	Tr.	Tr.	50mm
3/002	Layer	Mixed topsoil/ Made Ground	Tr.	Tr.	0.30m
3/003	Deposit	Natural	Tr.	Tr.	N/A
3/004	Cut	Cut of Well	1.23m Diameter inside stone structure of well		5.50m+
3/005	Fill	Fill of [3/004]	N/A not excavated	N/A not excavated	Occurring at 5.50m from surface
3/006	Structure	Stone Structure of 3/004	1.80m Diameter across well to outside edge of stone structure.	Actual thickness of stone structure wall 0.50m	1.16m
3/007	Layer	Layer under 3/002 to southern extent of Trench 3	4.00m	Tr.	0.20m

A well was uncovered during landscaping associated with the excavation of foundation footing Trench 3. This was recorded in plan and variously photographed. The position of Trench 3 was adjusted to allow for the total preservation of the stone structure of the well, and the well was to be lined with geotextile across the base and sides, and across the top of the stone structure and outer edge before infilling with a weak concrete mix prior to building works on the site.

6.2 The well, uncovered during landscaping associated with the excavation of Trench 3 possibly dates to the construction of Brushings Farmhouse as suggested by its location close to the house. The well was recorded in plan and variously photographed prior to it's preservation in situ. The position of Trench 3 was adjusted to allow for the total preservation of the stone structure of the well and the well was to be lined with geotextile across the base and sides, across the top of the stone structure and

outer edge, before infilling with a weak concrete mix prior to building works on the site.
