**Archaeological Evaluation at  
Haslemere Primary School, Haslemere Avenue  
Mitcham, London Borough of Merton**

**ASE Project Number 3238  
ASE Report Number 2008010**

**January 2008**

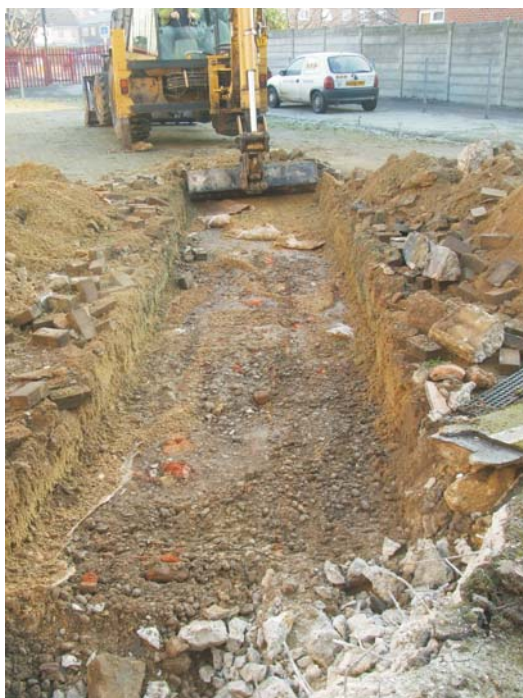
Plate 3: Trench 1 Excavation

- 3.3** The trial trenches were excavated under constant archaeological supervision using a JCB back hoe equipped with a grading bucket (see Fig. 3 and Plates 3 and 4).

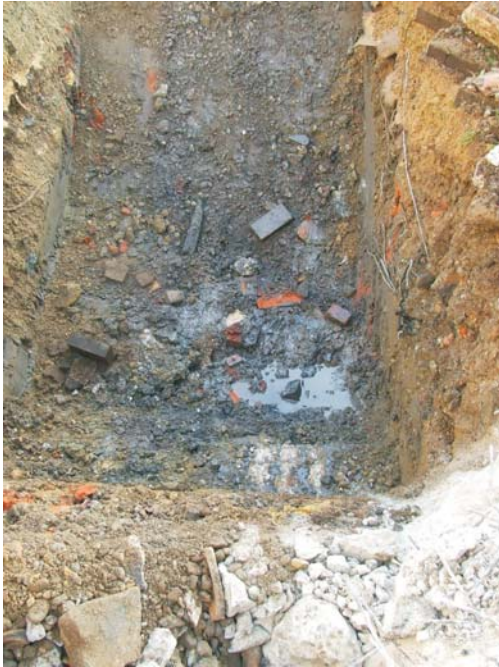
Plate 5: Trench 1 Contamination

Hydrocarbon contamination was believed to be present in both trenches. The extent of this contamination across the site is not known, however, given the makeup of these trenches any archaeological remains within the area of the proposed development could be heavily truncated and/or contaminated.

The earliest deposit was the natural, comprising alluvial clays and river terrace gravels [107], encountered at a maximum height of 15.47m OD at the centre of the trench falling away gradually north through the trench to 15.26m OD. The exact stratigraphic sequence in Trench 1 was unclear due to restriction of access for Health and Safety reasons. However, the next deposit above the natural was a brick surface, [106], above which was a layer of coal dust, [105]. Layer [103] sealed the deposits in this trench but were seen to be cut by a modern service, [104]. A layer of terramatt, [102], had been placed throughout the trench prior to a levelling/make up layer, [101], of coarse sand being laid as a base for the extant brick car park, [100].

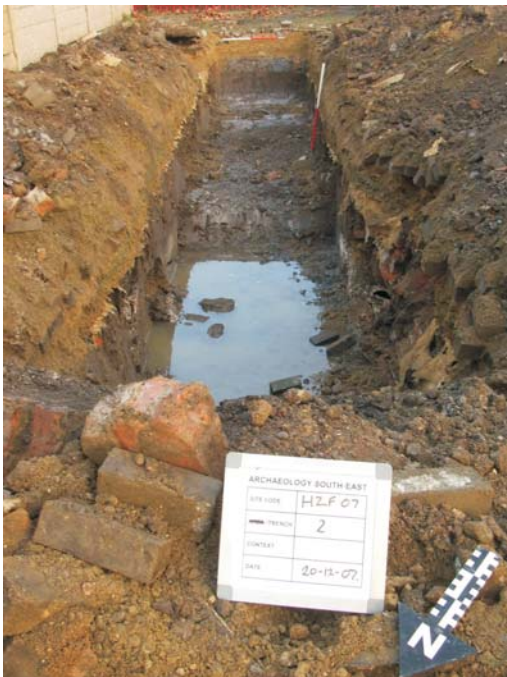
Plate 6: Trench 2 Contamination

The earliest deposit was the contaminated natural, comprising alluvial clays and river terrace gravels [204], encountered at a maximum height of 15.72m OD at the centre of the trench falling away gradually south through the trench to 15.70m OD. The next deposit above this was a layer of demolition rubble, [203] which included pockets of contamination. Above this was a layer of terramating, [202], sealing the contaminated deposit prior to a layer of coarse sand levelling/make-up, [201], and above this the extant brick car park, [200].
