An Archaeological Watching Brief at St Mary's Terrace, Hastings

**NGR: 582090 109683
Site Code: HAS07**

**Project No. 3162
ASE Report No. 2008026**

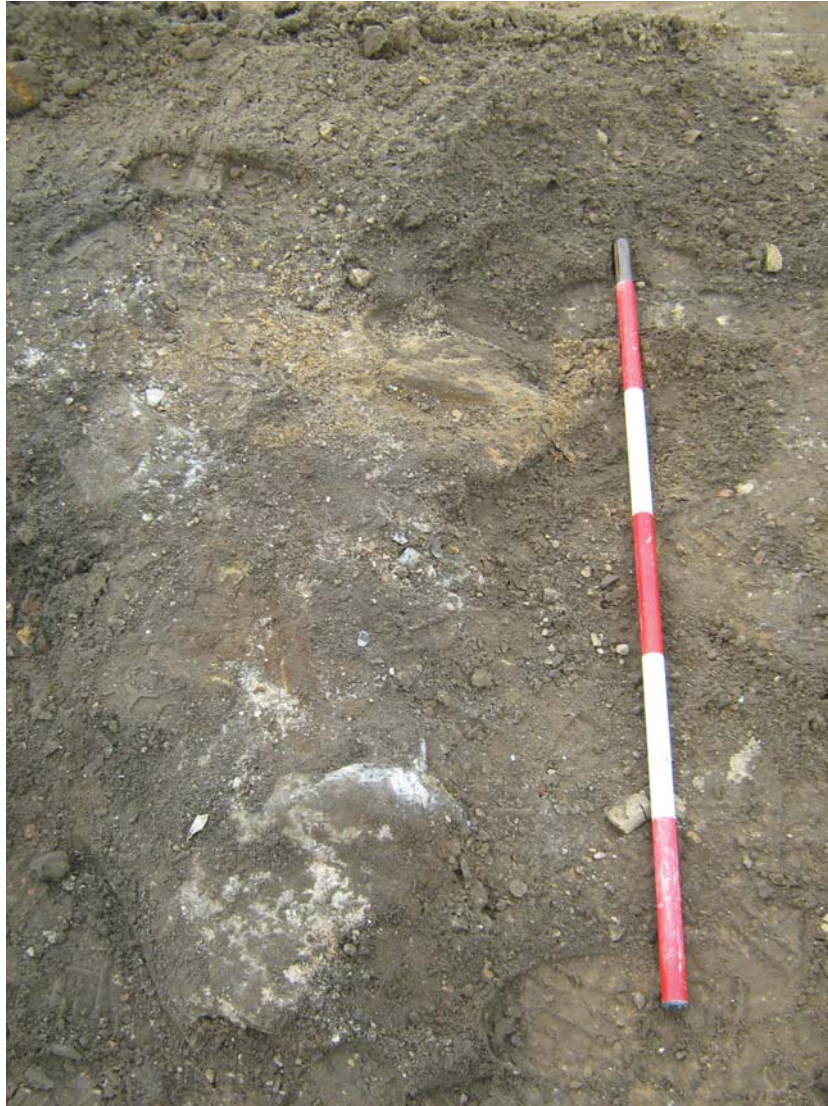
- 4.3** The grassed area was monitored during the topsoil stripping. A number of post Victorian brick and tile fragments and modern glazed ceramic fragments were identified in the topsoil. An area of degraded concrete (**005**), figure 3, was identified at the highest point of the area stripped, surrounding this were a few large sub-angular sandstone blocks. As the limit of excavation had been reached and the area was not to be affected by the compound structures, no further excavation of the degraded concrete was undertaken.

© Archaeology South-East		St Marys Terrace, Hastings -Flood Alleviation Scheme	Fig. 3
Project Ref: 3162	July 2008	Photograph showing Area of degraded Concrete (005) Identified in grassed area Facing west	
Report Ref: 2008026	Drawn by: SM

- 5.1 Degraded concrete (005) and sandstone blocks in the topsoil to the north of the playing field area may indicate the location of a demolished modern/post medieval structure. The location of this structure, on top of a hill with an uninterrupted view to the sea and harbour, makes an excellent viewpoint. No structure is shown as present on the site on the map of 1850 (Hastings Press, 2008) it is likely that any structure here post dated that time. The limit of the excavation in this area had been reached with no further impact expected on this deposit so further investigation of this deposit was not undertaken.

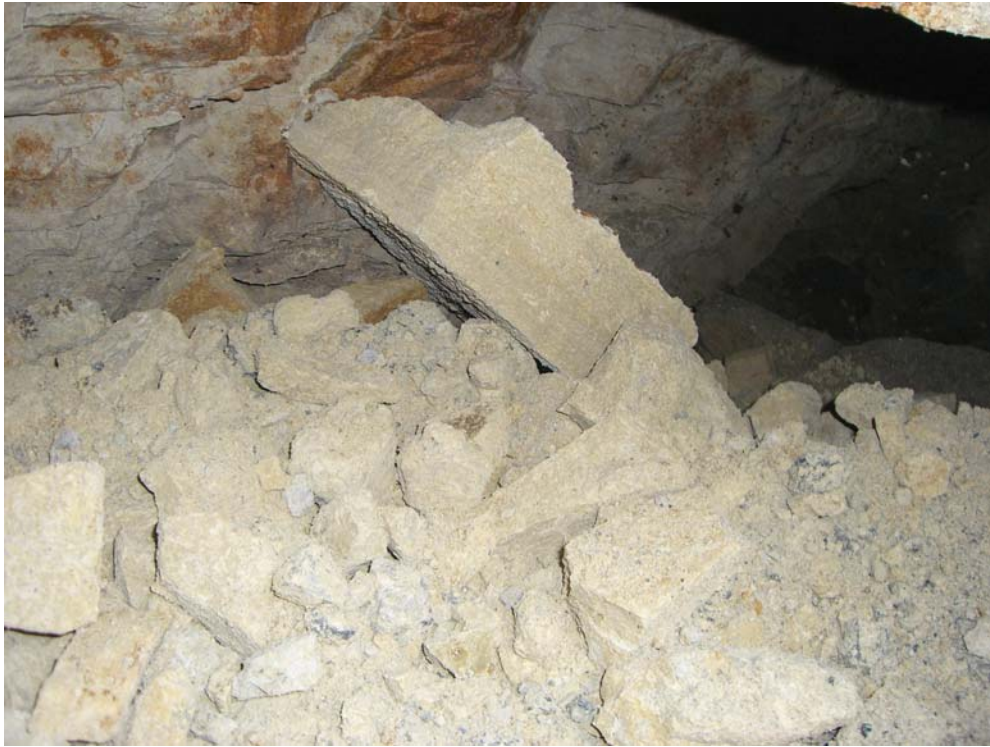
- 4.5** Towards the north of the site in the area directly in front of the Angel pub, a void was observed during excavation works (figure 4). The void extended approximately 2 metres beyond the edge of the trench with a width of 0.60 metres and an approximate height of 0.40 metres. A disused sewerage pipe below the level of the void suggested that it had resulted from the settling of backfill of the sewerage pipe trench and therefore a non-archaeological anomaly.

Fig. 4 View into void facing east

- 5.2 A void in the natural sandstone was uncovered in front of the Angel pub. Hearsay evidence reported in Wessex (2007) tells of underground tunnels being present leading from the pub away westwards. The void uncovered during the present works followed the line of a disused sewer. This is not believed to be the tunnel mentioned in the desk based assessment and a more likely explanation for the void is settling of backfilled material laid during the backfilling of the sewer pipe trench. Another possibility is that the line of a natural void/fissure proved the most convenient place to lay the sewerage pipe so the pipe follows the void rather than vice-versa. If the tunnel to the pub does exist it is possibly located further to the north along Plynlmmon Road as was indicated by a number of locals and the landlord of the Angel pub.

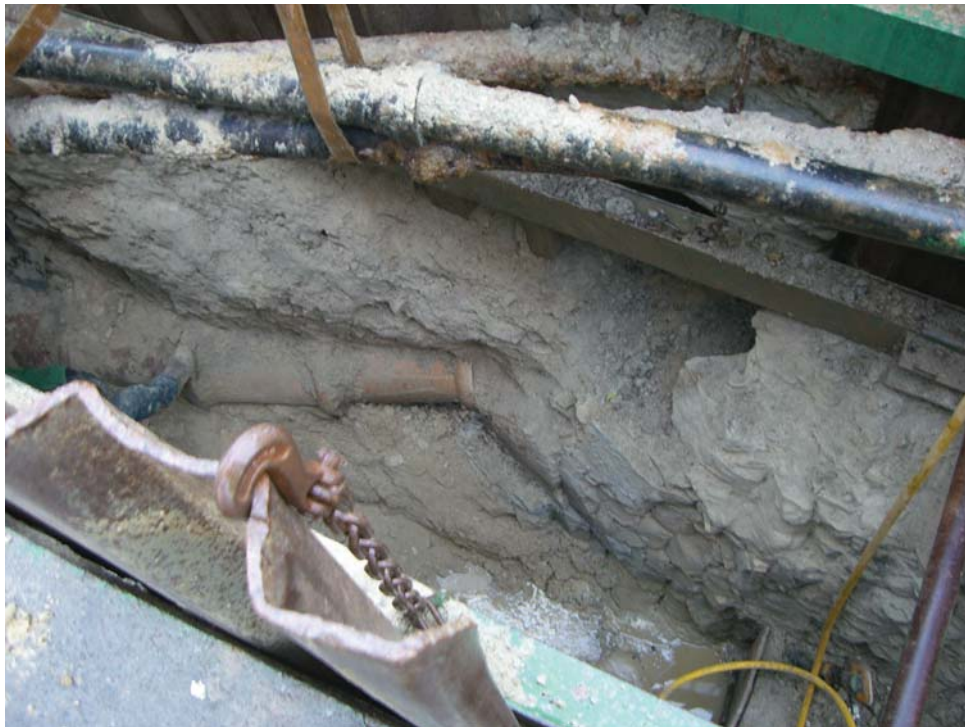
Fig. 5 Void space (right of photograph) with sewerage pipe below
