**An Archaeological Evaluation at
32 Hayling Rise and 24 Woodland Avenue,
Worthing, West Sussex, BN13 3AF**

Planning ref. 07/0170/OUT & 07/0567/ARM

ASE Project no. 3361

ASE Report no. 2008040

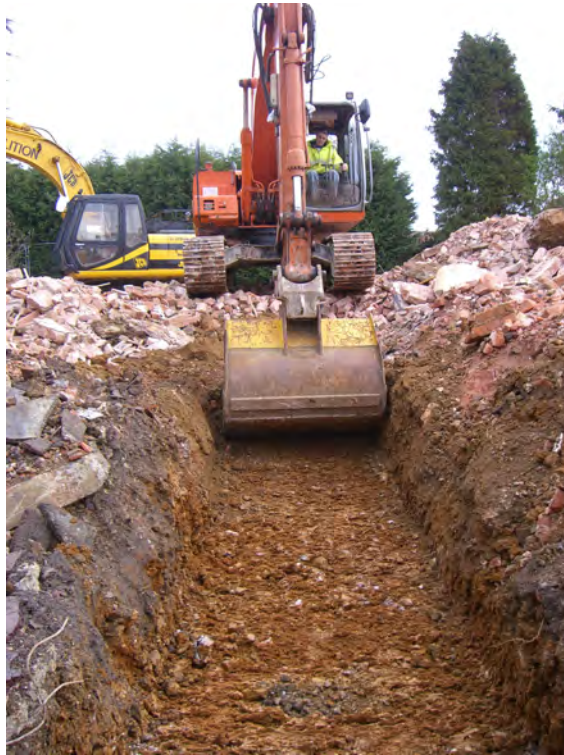
Fig. 3: Working shot of excavation of trench 2

- 3.1 Two trenches, both measuring 12 metres in length and 1.8m in width were excavated by machine under archaeological supervision (Fig. 3). The trench locations were accurately located using offsets from known positions and a Global Positioning System (DGPS) and DGPS Total Station (Leica 1205 R100 Total Station, Leica System 1200 GPS). The trenches were located in the area of a proposed underground car park in order to test the area most severely affected by the development and were agreed with Mark Taylor, Senior Archaeologist (WSCC), prior to the commencement of excavation.

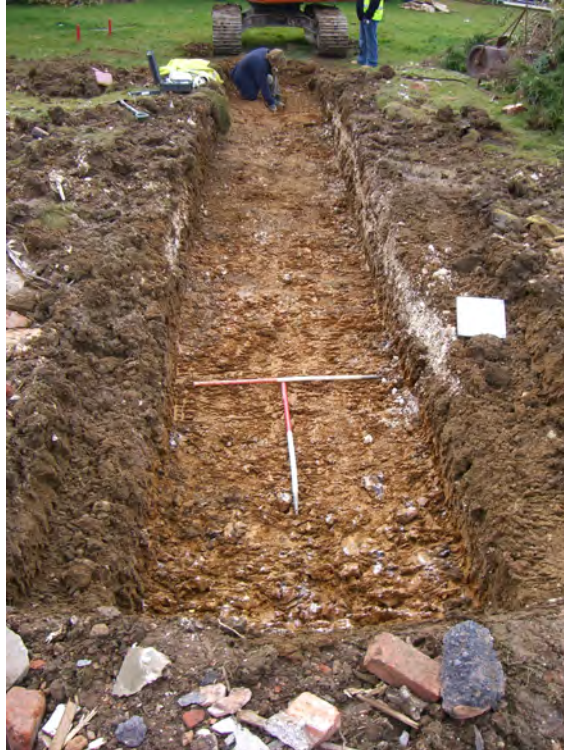
Fig. 4 Trench 1 facing south

4.1 Trench 1 (Fig 4)

Trench 1 was located to the south of the site, orientated in a north to south direction. It measured 12 metres in length and 1.8 metres in width.

The topsoil (**1001**) covering the trench was a mid orangish brown silty clay and reached a depth of 0.25 metres. Some modern material such as brick fragments were also noted within the topsoil, resulting from the recent demolition of the residential property.

A layer of subsoil (**1003**) lay underneath the redeposited natural. It was a mid brown silty clay with occasional small stone inclusions. No archaeological material was present within the layer. It covered the entire length and width of the trench and reached a depth of 0.2 metres in depth before reaching the natural (**1004**).

The Natural **(1004)** was a mid orange clay with chalk and flint nodule inclusions. It was encountered at a maximum height of 66.89m OD at the northern end of the trench, falling away to 66.71 m OD to the southern end of the trench. No features of archaeological significance were observed within this trench.

5.3.1 **Trench 1** revealed a dumped deposit of natural chalk **(1002)** which originated from the landscaping of the gardens around the previous residential building, most probably the excavation of the pond approximately 15 metres north of the trench.

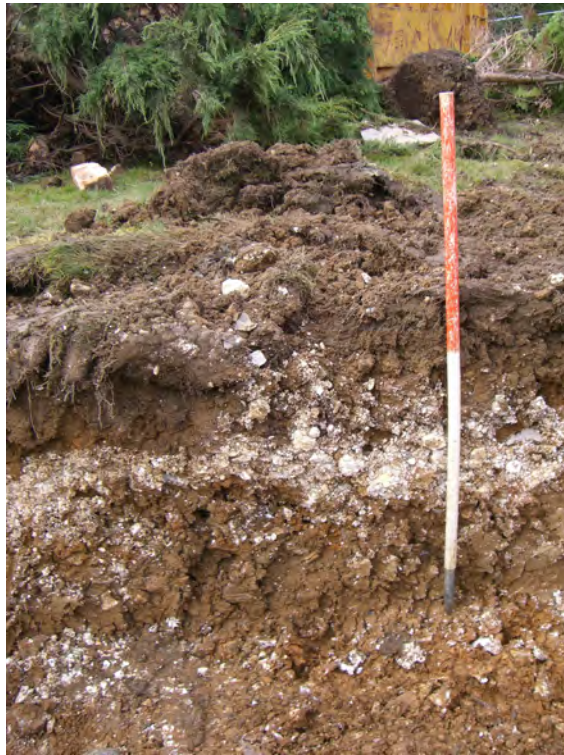
Fig. 5: West facing section of Trench 1

A layer of redeposited natural (**1002**) was present underneath the topsoil (see Fig 5). It was a layer of mixed white chalk with occasional patches of mid brown silty clay. It extended across the width of the trench but was only seen in 7.5 metres of the length of the trench. It measured 0.2 metres in depth.

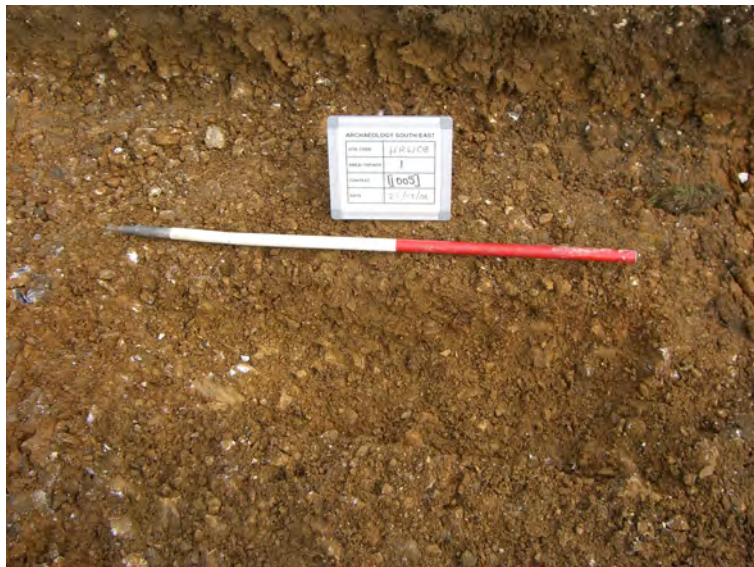
Fig. 6: West facing section of natural feature

A possible natural linear feature **[1005]** was found cut into the natural at the southern end of the trench (see Fig 6). It was 1.05 metres in width and 0.2 metres in depth and crossed the width of the trench in an east to west orientation. It was irregular in shape and profile with gentle to moderately sloping sides. It was filled by a single fill **(1006)**; mid orangish brown silty clay, which was completely sterile of finds.

5.2.2 The linear cut **[1005]** found at the southern end of **Trench 1** represents a naturally occurring feature. This can be seen through its irregular shape and profile, the shallow depth and the single sterile fill. It probably represents a depression in the natural that has been filled by overlying subsoil.

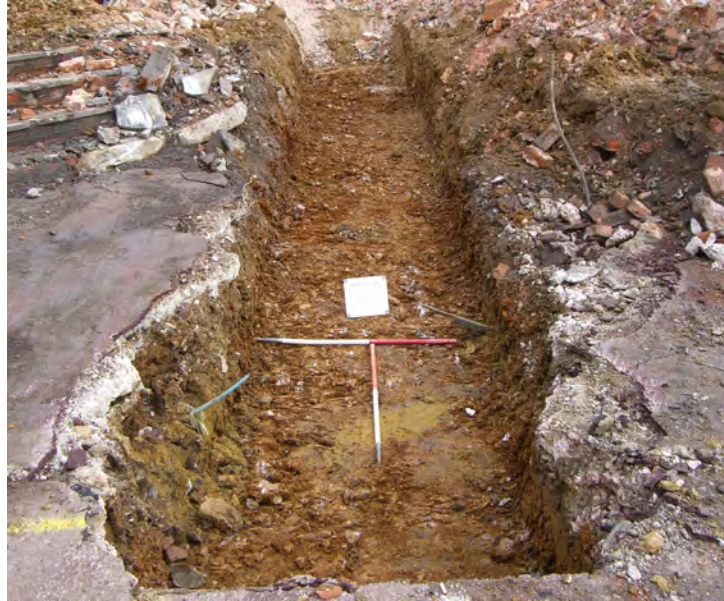
Fig. 7: Trench 2 facing east

4.2 Trench 2 (Fig 7)

Trench 2 was located along the northern extent of the site, orientated in an east to west direction. It also measured 12 metres in length and 1.8 metres in width.

Due to the location of the trench across the foundations of the demolished residential property, no topsoil was encountered during the excavation of the trench. The highest stratigraphic deposit was a layer of concrete **(2001)**, 0.15 metres in depth.

A layer of made ground **(2002)** was located underneath the concrete. It was a dark brownish orange gravely clay with occasional modern inclusions of brick and tile fragments and glass shards. This layer covered the entire length and width of the excavated trench and measured 0.65 metres in depth.

Natural deposit **(2003)** was similar in colour and composition to **(1004)**, the natural within trench 1. It was encountered at a maximum height of 67.91m OD at the eastern end of the trench, falling away to 67.42 m OD to the western end of the trench. No features of archaeological significance were observed within this trench.

5.3.2 The concrete layer **(2001)** and made ground **(2002)** uncovered in **Trench 2** originated from the construction of the residential property in the 20th century. Due to the fact that the natural is at a higher level in the north-east corner of the site, the area was probably stripped down to the natural before building began, destroying any archaeological deposits that may have once been here.
