**An Archaeological Watching Brief at New Barn,
Michelgrove, Patching, West Sussex**

**Planning Ref: PA/9/06
Arun: Patching**

**Project No: 2755
Site Code: NBP07**

**ASE Report No.:2008196
OASIS id:archaeol6-50246**

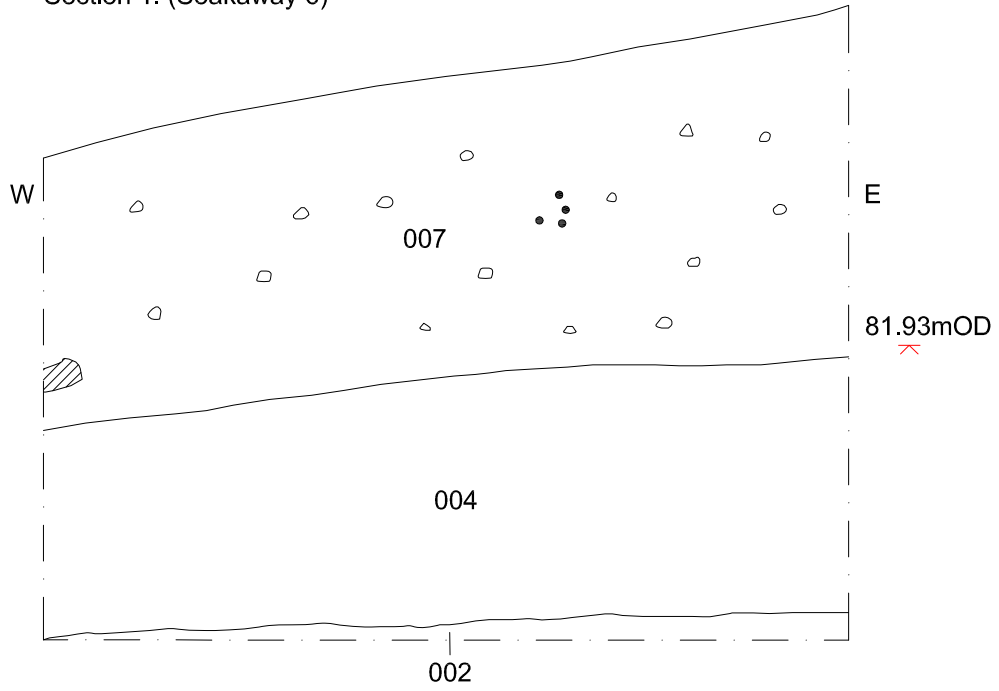
Section 1: (Soakaway 6)

4.11.1 Soakaway 6 measured 2.0m square and excavated to a depth of 1.60m. The profile comprised 0.70m of mixed topsoil deposit [007] (disturbed by BT cabling) overlying chalk rubble subsoil [004] of 0.60m thickness. 'Natural' chalk [002] was encountered at 1.40m. No archaeological features were observed. A piece of 1930's ceramic was found in the topsoil (not retained).

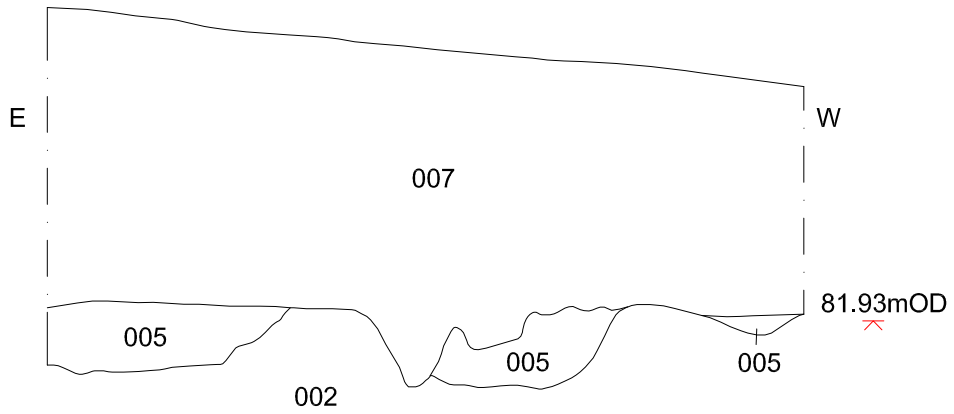
Section 2: (Soakaway 7)

4.12.1 Soakaway 7 measured 1.90m square and was excavated to a depth of 1.80m. The profile comprised 0.80m of mixed topsoil deposit [007], a mid-dark brown loamy soil containing 15% sub-angular natural flint pieces (50-70mm diameter), the disturbed nature of this deposit is emphasised by the inclusion within its matrix of 19th/20th century bricks and glass bottles (not retained). Deposit [007] immediately overlay the chalk bedrock [002].

4.12.2 The north facing section of Soak away 7 (fig. 3) shows some irregular hollows at the base of the subsoil deposit [005] close to the contact with the 'natural' chalk. On investigation there was some evidence of solifluction (Coombe rock) but also root activity suggesting a former north-south hedge line on the west side of the existing track way. No other archaeological features or finds were noted in Soak away 7.

- 6.3 Soak away 7 produced a possible archaeological anomaly. Irregularities at the interface between deposits [007] and [005] suggest root action and disturbance associated with a possible former hedge line running north-south on the west side of the barn some metres closer to the barn than the extant hedge line. It is therefore possible that the old hedge line was removed at the time the barn was originally constructed.
