**A Revised Archaeological Interpretive Survey
of
Gillhope Farm House, Mayfield,
East Sussex**

**Commissioned by
Francis Brand**

REPORT NO. 0232 (Revision 2)

MAYFIELD - GILLHOPE FARM HOUSE

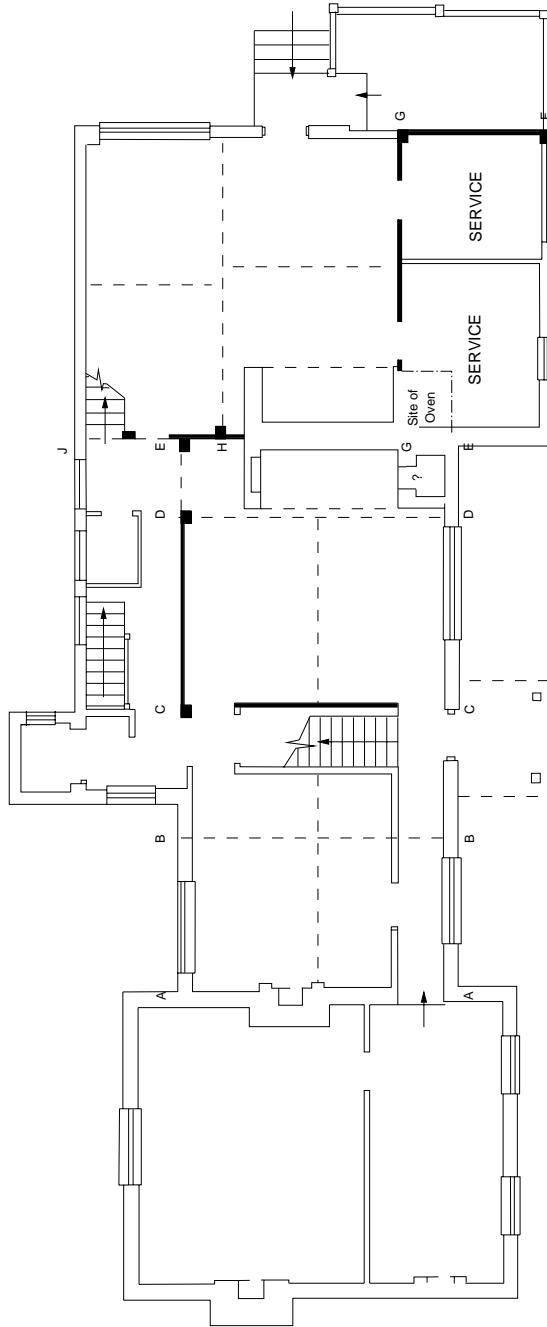
Drawn By	D Martin	Revision No	1	Date of original survey	1976	Date of this revision	2005
Site Ref	P29/03	Revised Drawing No.	232/1

GROUND-FLOOR PLAN AS EXISTING, 2005

OVERVIEW OF THE BUILDING [Revised Drawing Nos. 232/1-3]

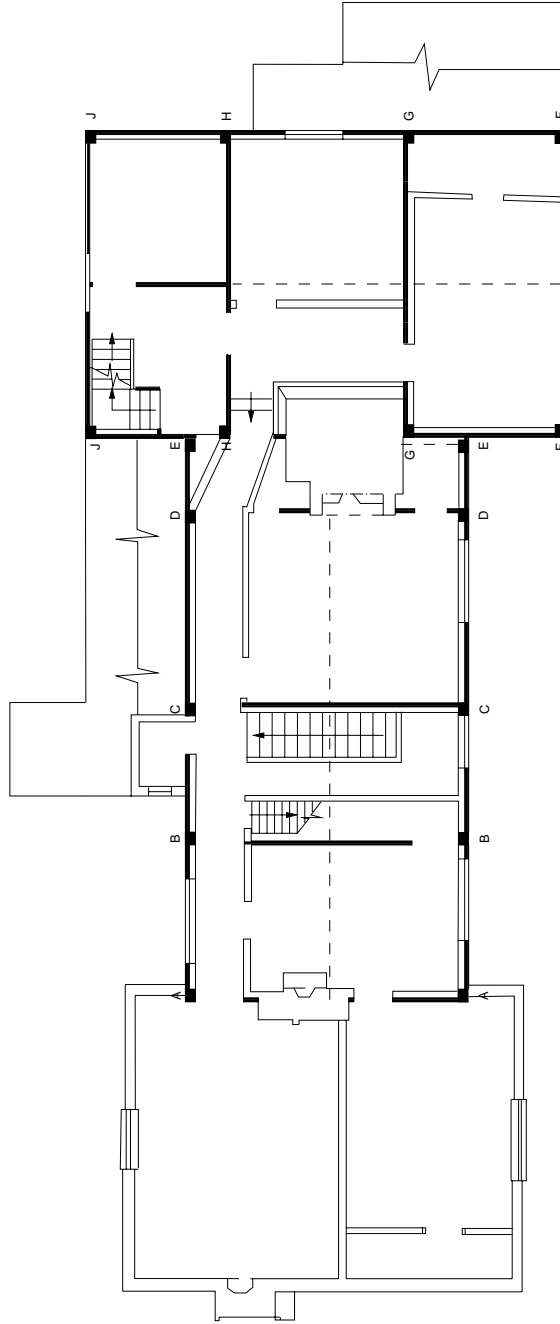
Drawn By	D Martin	Revision No	1	Date of original survey	1976	Date of this revision	2005
Site Ref	P29/03						
Revised Drawing No.	232/2

FIRST-FLOOR PLAN AS EXISTING, 2005

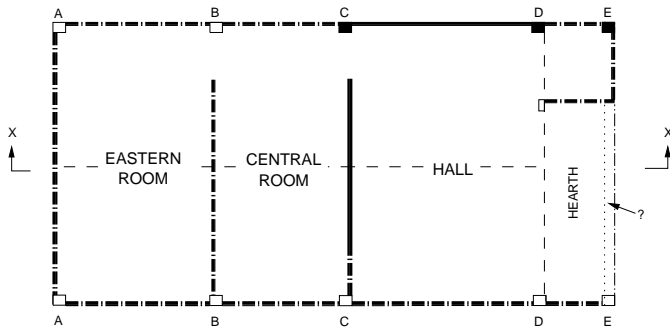
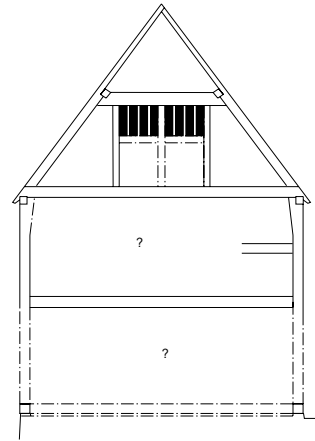
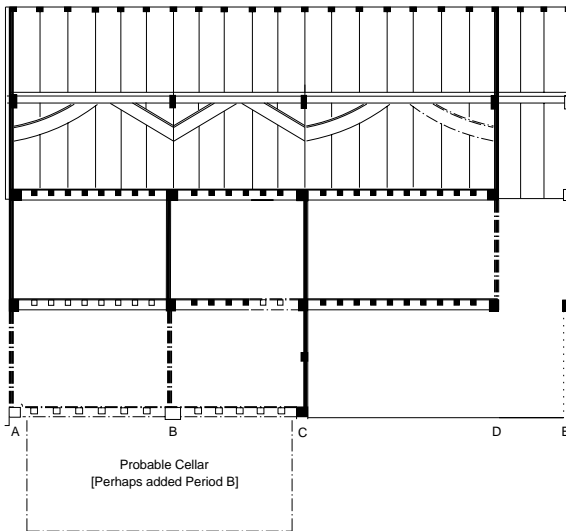
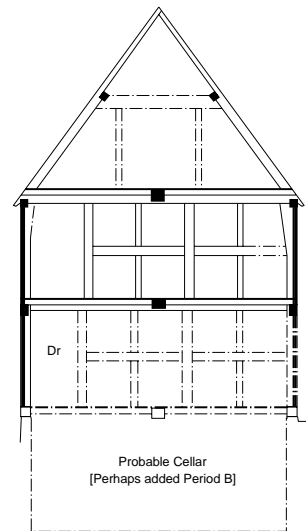
**GILLHOPE FARM HOUSE, MAYFIELD, EAST SUSSEX
 PERIOD-A RECONSTRUCTION DRAWINGS**

PERIOD A (1575 +/-25 years) [Revised Drawing Nos. 232/4-5]

In its initial form the house comprised a four-bay range which measured 11.15 metres x 5.60 metres (36'7" x 18'4") overall. Although now one room, mortices beneath the crossbeam of truss B-B indicate that on the ground floor the two unequal-length bays at the eastern end originally house two separate rooms interconnected by a doorway at the southern end of the dividing partition. Beneath both bays is a cellar and, although the cellar itself contains no closely datable original features (and thus could have been intruded during period B) a neat, haunched mortice in the eastern face of the soleplate to truss C-C indicates the position of a floor girder, suggesting that the ground floor within this part of the house was always of suspended type, implying a cellar from the outset. The western room comprised a large single-bay hall which was served by an enclosed hearth sited within a narrow western end smoke bay. This combination of a hall with two un-heated single-bay rooms beyond one end is not a standard layout locally.

In all, details of five period-A windows are currently recoverable: three in the rear elevation and a pair within the eastern roof gable (*see* Drawing Nos. 232/4 and 5). All are of four lights and were of unglazed type with diamond-section mullions. That within the rear wall of the hall chamber still retains its heavy-section mullions, but in all other instances they have been removed and are today evidenced by the mortices. None of the openings show obvious indications of having had shutters.

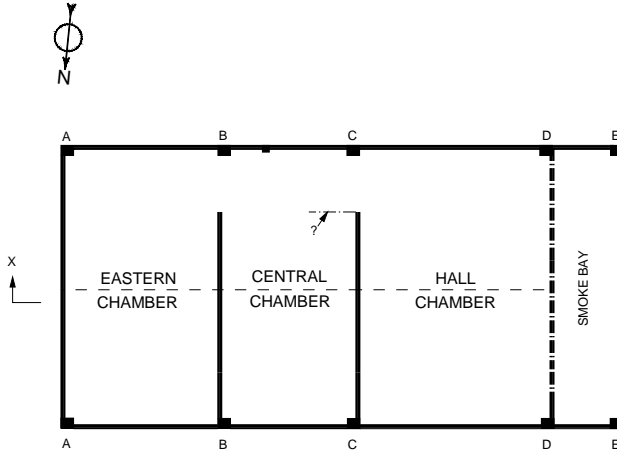
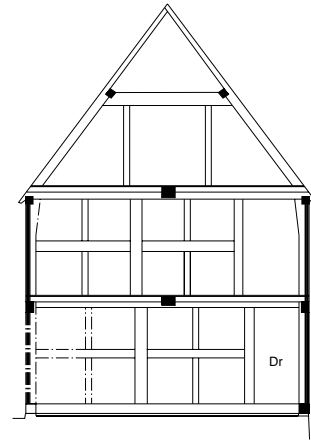
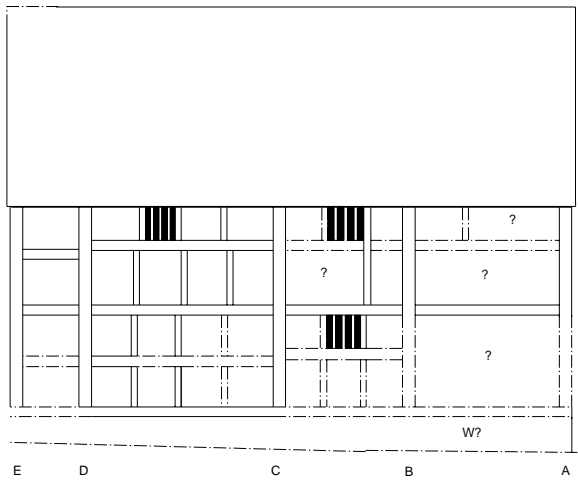
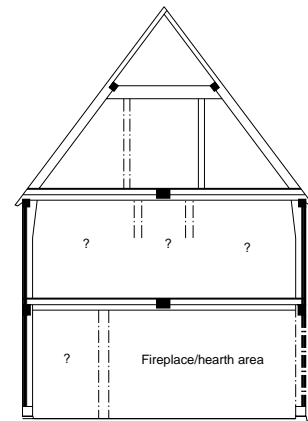
232/5

**GILLHOPE FARM HOUSE, MAYFIELD, EAST SUSSEX
 PERIOD-A RECONSTRUCTION DRAWINGS**

On the first floor there were three chambers set in-line: one over the eastern bay, a central chamber, and a large chamber over the hall, thereby repeating the arrangement on the floor beneath. The location of the door openings leading between the chambers likewise repeats that on the ground floor, being sited at the southern end of the cross partitions. However, at this level the openings are exceptionally wide and the possibility of their having been a passage divided off along the southern edge of the central chamber cannot be ruled out. It is unclear how, during period A, the chambers were reached from the floor below: there is no obvious location for an original staircase (*see* below). The narrow westernmost bay was fully partitioned off from the rest of the house at its upper levels and was open to the hearth area/fireplace below: it formed a smoke bay. All three first-floor chambers had adequate storey heights of *c.*2.10 metres (6'10") measured from first floor to underside of attic floorboards, with side walls which measure *c.*1.90 metres (6'3") from floor to top of wallplate.

At truss D-D, within the roof, most of the daub infill dividing the smoke bay from the hall bay survives *in situ* and retains thick soot encrustation on its western side. The daub is supported on laths nailed to the face of the staves.

One internal doorway survives (and remains in use) at ground-floor level, sited at the southern end of the hall's eastern end partition (truss C-C) and a lack of stave holes to the south of the southernmost stud mortice in the underside of the crossbeam of truss B-B indicate that this arrangement was repeated within this truss also. Similarly at first-floor level, there were doorways at the southern end of these trusses, but in these instances both doorways were noticeably wider than those on the ground floor (*see* B-B in Drawing 232/4 and C-C in Drawing 232/5). The excessive width of these two openings could indicate that they led into a passage divided off down the southern side of the central chamber. The existence of a pegged mortice (as if for a midrail) in the eastern face of the door jamb in truss C-C would be consistent with such an interpretation, though no other evidence was found for a partition on this alignment.

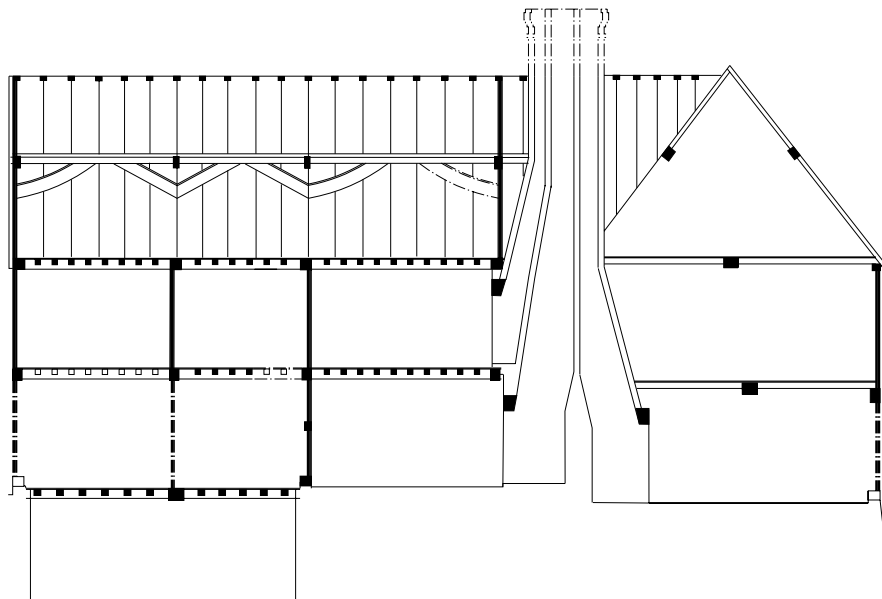
232/6

GILLHOPE FARM HOUSE, MAYFIELD, EAST SUSSEX
PERIOD-B RECONSTRUCTION DRAWINGS

PERIOD B (Mid 17th C) [Revised Drawing Nos. 232/6-9]

The house was doubled in size at this date by the construction of a new three-bay crosswing set at right angles to the original range, at its western end. This new range measures 9.50 metres x 6.10 metres (31'2" x 20'0") and housed on the ground floor a large two-bay heated kitchen with a pair of service rooms to its north. On the first floor the range was divided by partitions at each of its trusses, with the rear (southern) bay subdivided along its axis. This allowed a small chamber within the south-western corner of the range, with a landing and staircase area to its east. The central chamber was accessed from the landing area, with the front (northern) chamber beyond being reached through it. None were heated. As with the period-A part, the roof area was utilized as attic/garret rooms from the outset, with the staircase rising in the south-eastern corner of the southern bay.

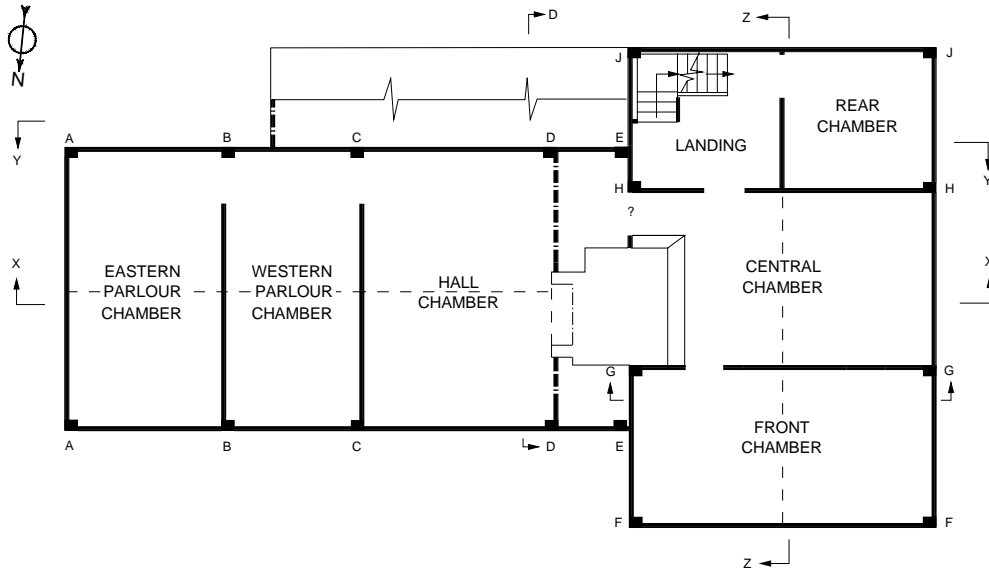
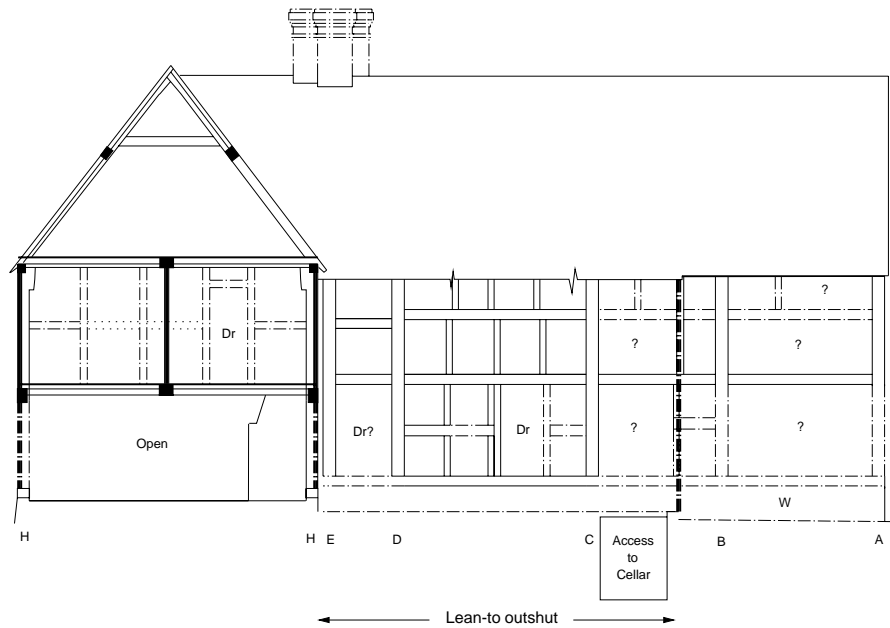
232/7

**GILLHOPE FARM HOUSE, MAYFIELD, EAST SUSSEX
 PERIOD-B RECONSTRUCTION DRAWINGS**

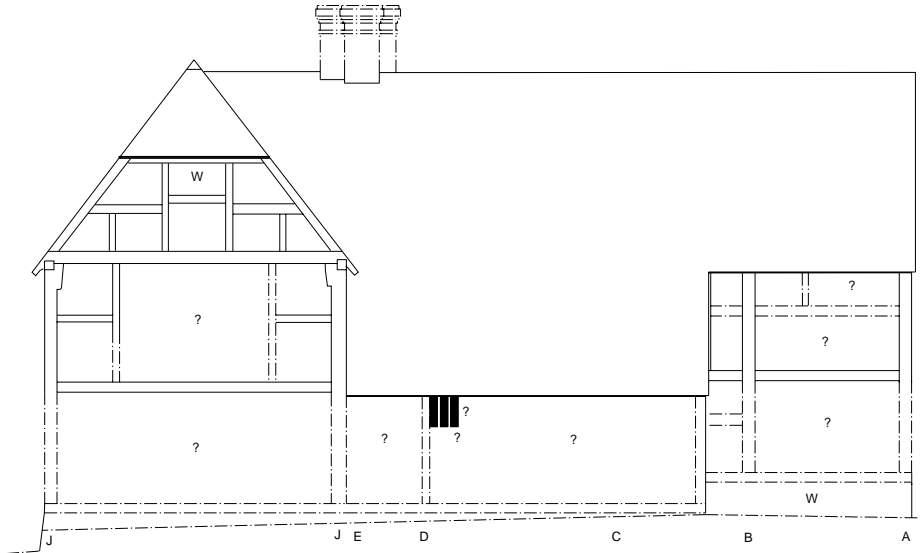
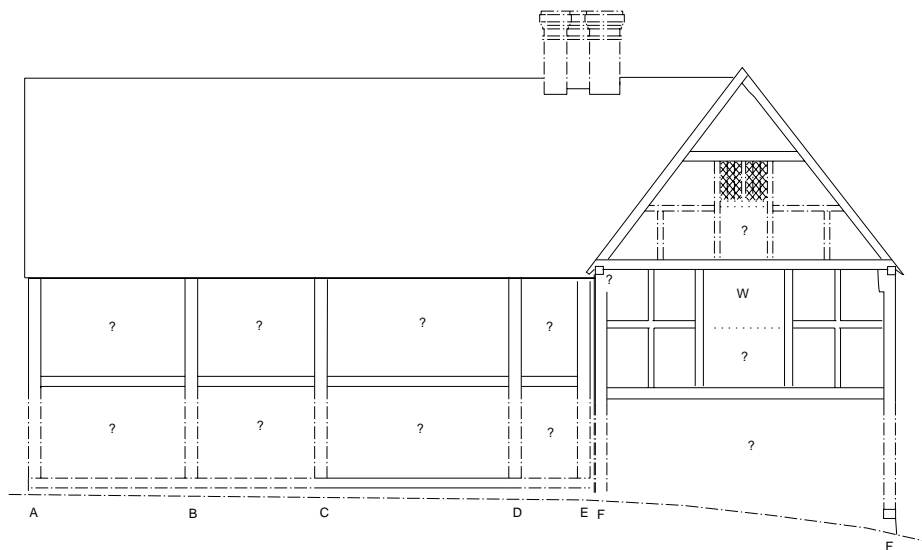
232/8

**GILLHOPE FARM HOUSE, MAYFIELD, EAST SUSSEX
PERIOD-B RECONSTRUCTION DRAWINGS**

The locations of the windows within the northern gable and southern stub gable are evidenced by the position of the queen studs and, in the case of the front gable, by mortices in the underside of the collar. The mortices indicate that this window was of two panes with two vertical glazing tie bars to each of the panes. The glass was set into a rebate in the front face of the collar, and was thus virtually flush with the external face of the wall. This was a design of window introduced locally during the middle years of the 17th century: it only became popular late in that century though, from other evidence within the crosswing, this appears to be an early example. A new window frame now masks the underside of the collar within the rear stub gable, though notes taken in 1976 suggest that this window was of three panes and had only one tie bar to each pane. If this were so, it is not clear why the variation.

Based upon the design of the wall framing, windows appear to have been set centrally within the front and rear walls of this range at first-floor level, but of these no details are currently known. Another period-B window is evidenced (and, indeed, still survives intact, though now blocked) within the western wall of the western service room. This small two-pane glazed window has a central mullion which is chamfered internally.

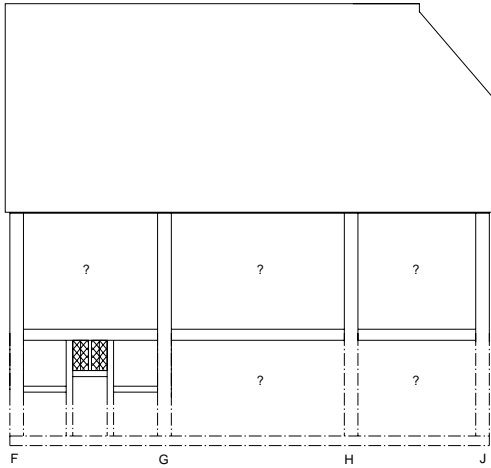
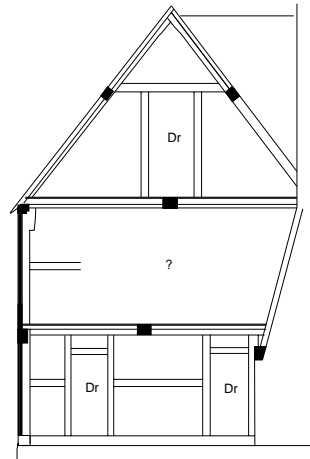
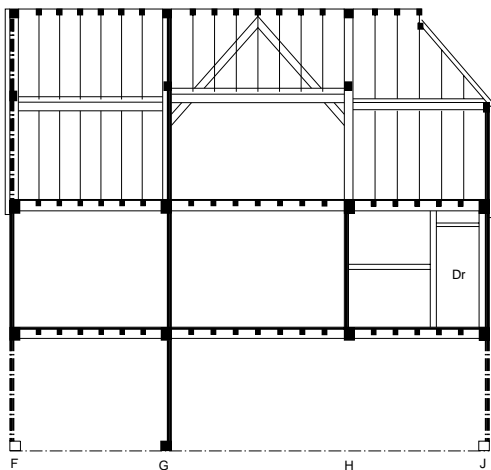
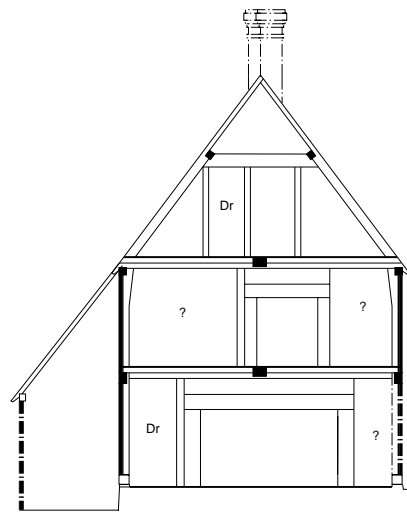
232/9

**GILLHOPE FARM HOUSE, MAYFIELD, EAST SUSSEX
PERIOD-B RECONSTRUCTION DRAWINGS**

The roof is built using two bays of staggered-butt-purlin construction (the northern and central bays) but with side-purlin construction in the southern (rear) bay. The reason for this variation appears to be associated with the use of a half-hipped rear terminal, for the side purlins are jointed into the principal rafters of truss H-H, but clasped into position at the collar of truss J-J. All trusses incorporate collars: that to truss G-G helps support the garret's internal partition. The intersection between the roofs of the period-A and -B ranges is formed by lay boards fixed over the western slope of the crosswing roof. In order to give an open space, common rafters were never fitted within this western roof slope beneath the purlin of bay G-H.

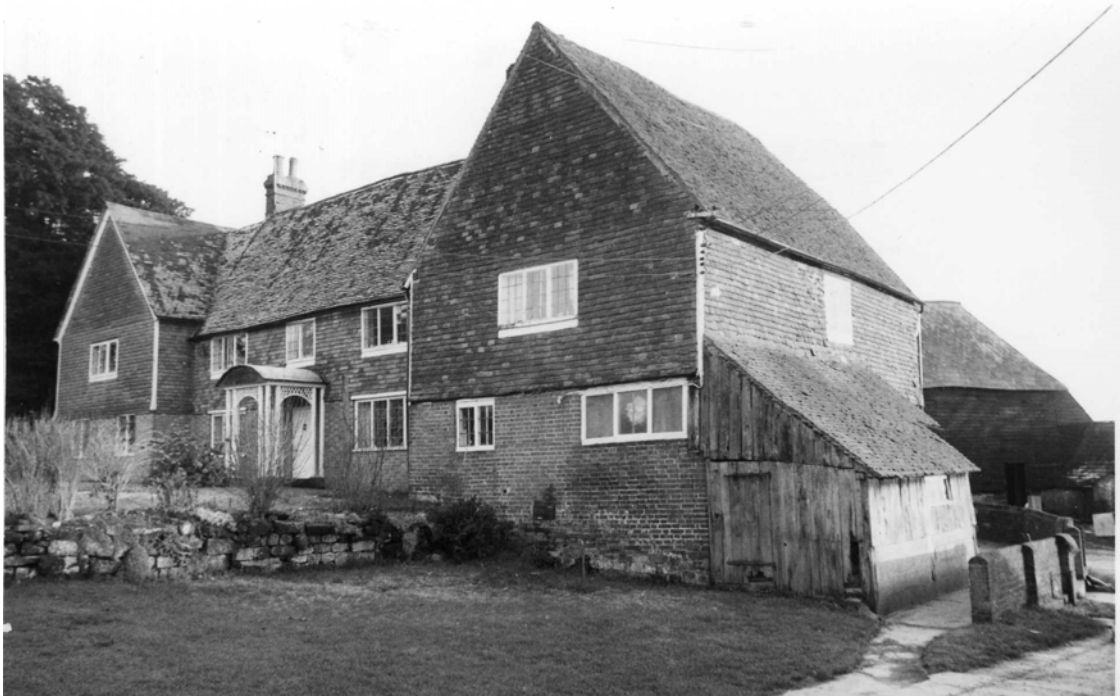
Plate 1.

Exterior from north in 1976 showing base/cruck hall (converted into barn) at rear.

Given the non-standard plan of the initial phase of the present house, and the fact that the barn/former house was set very close to the rear (*see* Plate 1), there is the strong possibility that this initial phase of the present house was constructed as additional accommodation/workspace serving the old house. If this were so, it is unclear whether the old house was downgraded to purely service use — with the principal accommodation housed within the new build — or whether the reverse was the case with the new house

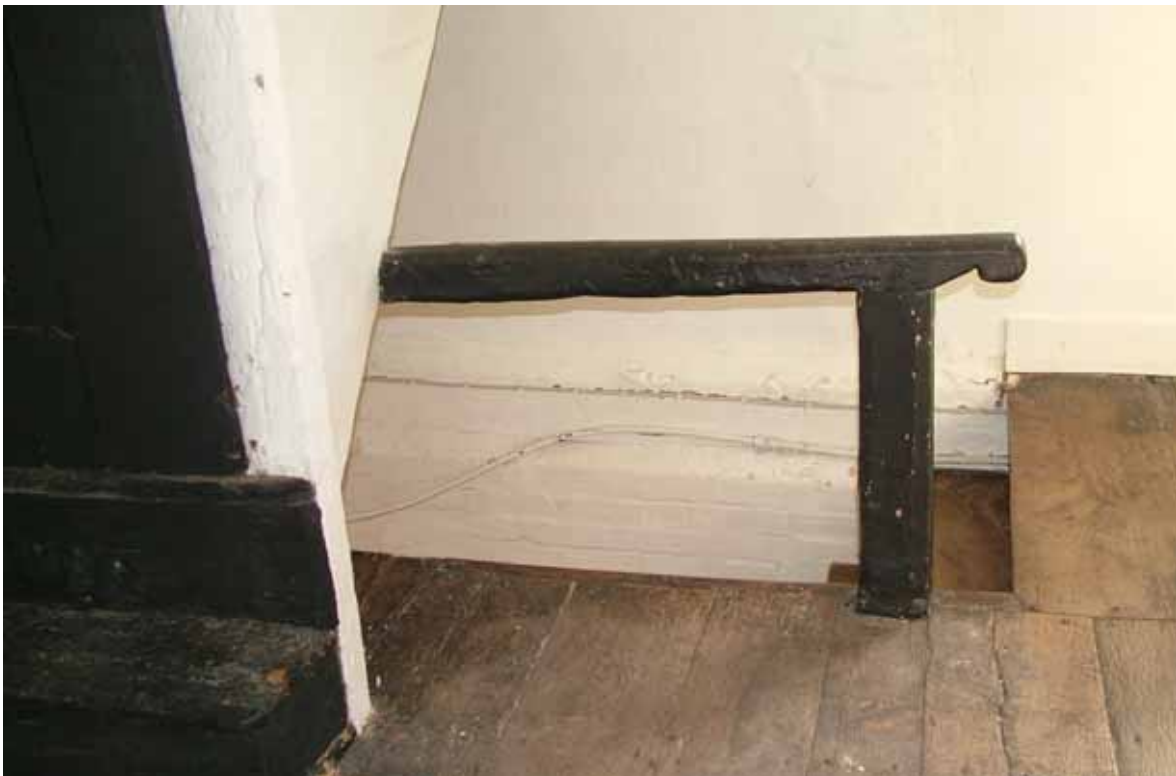
Plate 2.

Period-B handrail to stair within crosswing.

Although relocated in its present position at a late date (it was placed here after an intruded post-period-B partition had been removed) the balustrade protecting the side of the cellar steps is of antiquity. It is set upon a baseplate and has a chamfered handrail. Between the handrail and baseplate are moulded splat balusters of symmetrical, early profile (*ie* late 16th- or early 17th-century) - *see* plates 3 and 4. It is not known whether these balusters originated from within the house or were imported from elsewhere. Whatever their provenance, they are a rare survival locally and are thus of historical significance. It is likely that prior to the addition of the balustrade the cellar steps would have been closed by a hinged trap door in the floor.

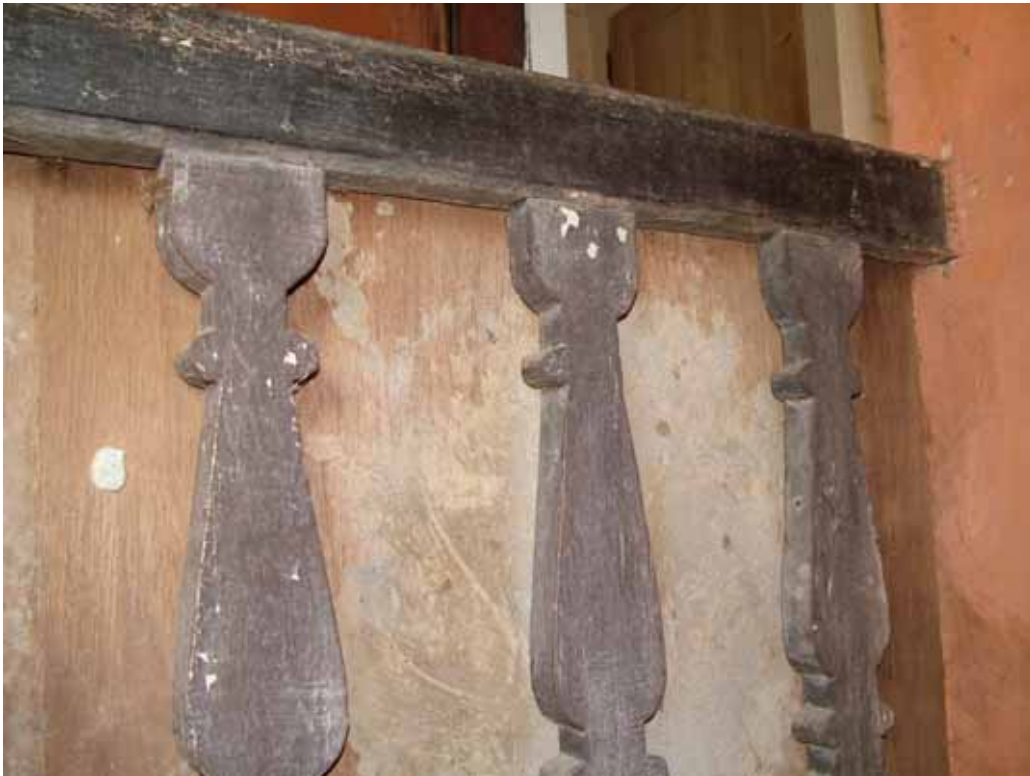
Plate 3.

Reused splat balusters protecting steps to cellar.

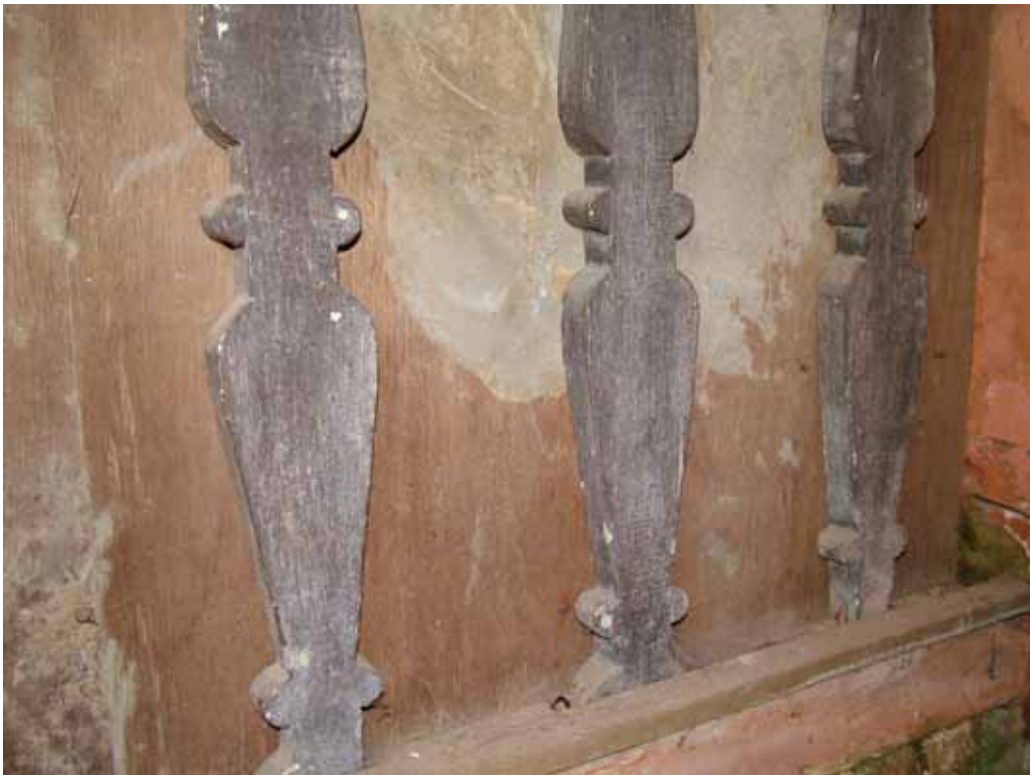
Plate 4.

Reused splat balusters protecting steps to cellar.

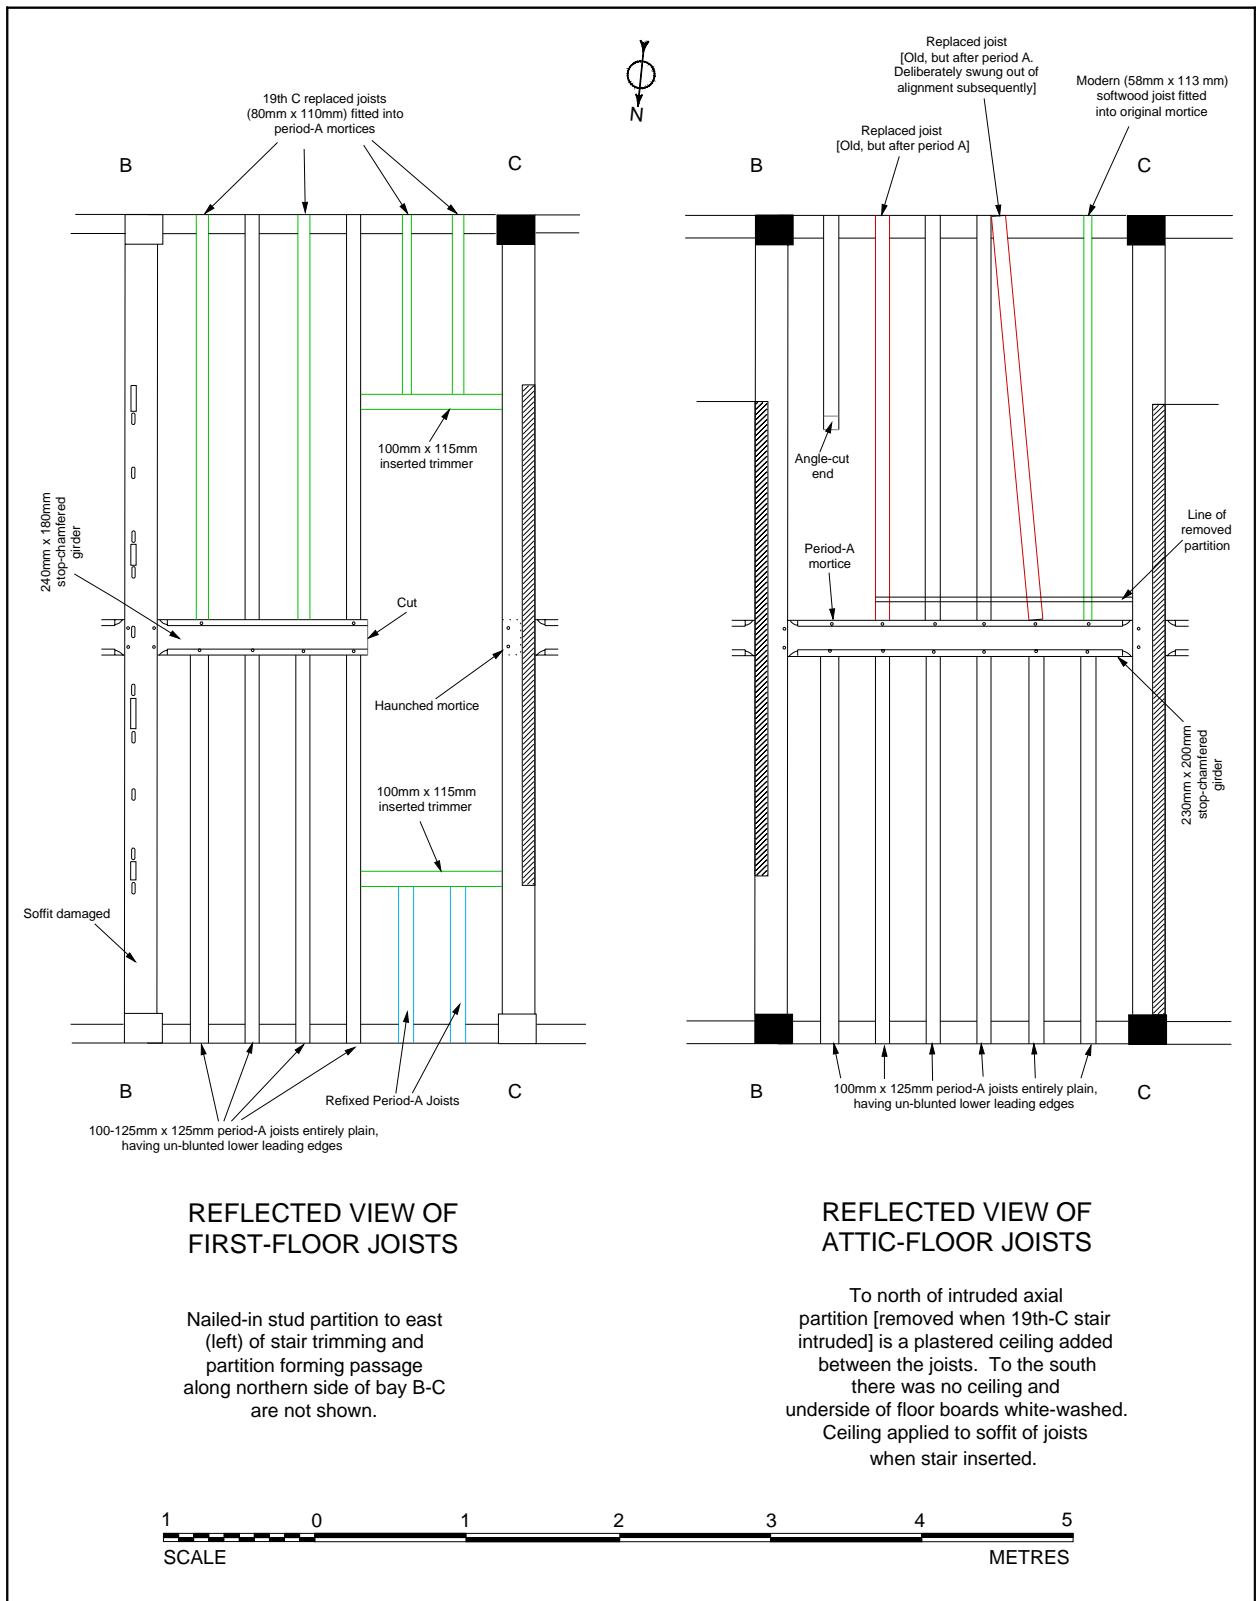
232/A1

RECORD OF FLOOR JOISTS, BAY B-C, AS AT 24/10/07

Nailed-in stud partition to east (left) of stair trimming and partition forming passage along northern side of bay B-C are not shown.

To north of intruded axial partition [removed when 19th-C stair intruded] is a plastered ceiling added between the joists. To the south there was no ceiling and underside of floor boards white-washed. Ceiling applied to soffit of joists when stair inserted.
