**An Archaeological Interpretative Survey
of
84 High Street, Westham,
East Sussex**

Project Ref. 3172

REPORT NO. 1673

WESTHAM - 84 HIGH STREET

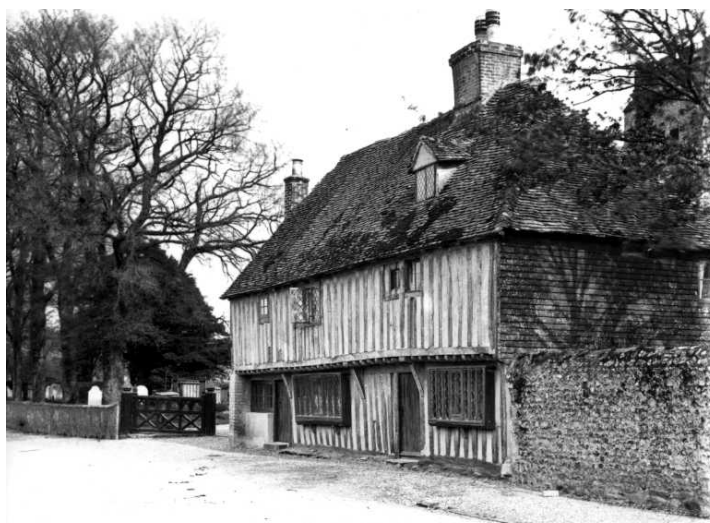
Plate 1
Exterior in the early 20th century
[Hastings Museum and Art Gallery]

Primary access into the house was originally via a doorway sited to the north of the chimney, hard against the western principal post of the chimney bay. The doorway — which remained open and in use early in the 20th century (see Plate 1) is still evidenced by a neat stop chamfer on the jetty plate and by pegged-in door jambs. Located against the principal post of truss B-B, within the eastern bay, are the remains of a narrow (620 mm, or 2'0") doorway which formerly led into the shop. This too is evidenced by a stop chamfer on the jetty plate and by a pegged mortice for the missing door jamb (Plate 4).

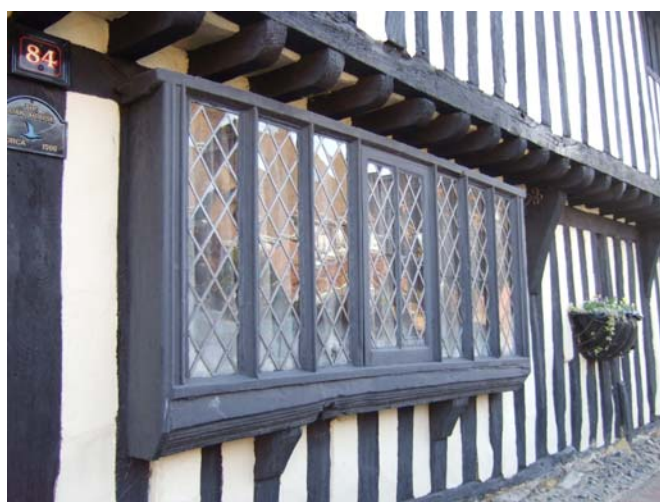
Plate 2
Oriel window serving hall

Within the front elevation a variety of window designs have been utilized in order to reflect the use/importance of the rooms or chambers they served. Both the parlour and hall are lit by projecting oriel windows, weathered at their heads by the overhang of the jetty (see Plates 1-3). Both have moulded, roll-and-hollow-chamfered mullions and frame and a separate head which makes use of two loose tenons fixing it back to the face of the wall frame — the positions of the loose tenons are indicated by pairs of peg holes in the underside

of the jetty plate and head. Beneath the solid moulded cill of the long eight-light hall window are two brackets, whilst the slightly shorter parlour window has only one central bracket. The shop at the eastern end of the house was served by a pair of blank openings set side by side, separated from one another by a shared jamb evidenced by its pegged mortice. A horizontally-set hinge ride still remains in the external face of the jetty plate for a former top-hung shutter, whilst a pegged mortice to its right may be associated with some form of support mechanism for holding the shutter open. To the right of the shop front survives the stopped-chamfered surround of the narrow 'squeeze door' which led into the shop (Plate 4).

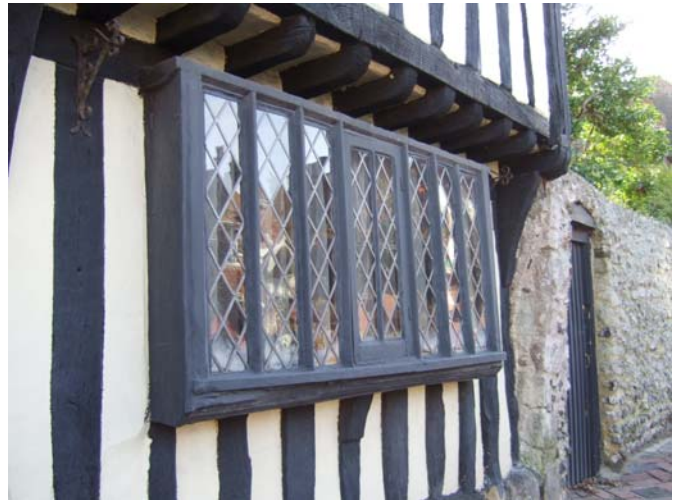
Plate 3
Oriel window serving parlour

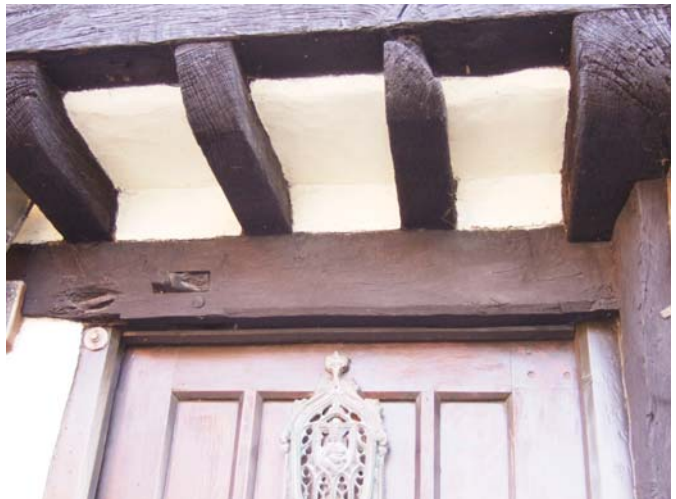
Plate 4
Mortice in jetty plate with hinge pintle to left
and chamfered surround to doorway to right.

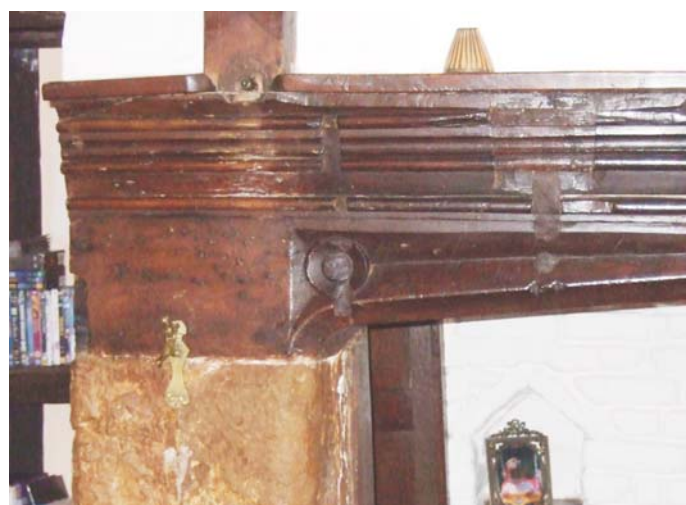
Plate 5
Ornamentation on lintel of hall fireplace.

The house was served from the outset by a good-quality three-flue chimney, with inglenook fireplaces heating both the hall and parlour. Both have stone jambs and moulded timber lintels, that to the hall having 'sun flower/poppy-type' decoration and simplistic stylised foliage to its sunk spandrels (see Drawing No 1673/7 for the moulding profiles and Plate 5). A near identical design can be seen on the fireplace lintel within neighbouring Heron Cottage *etc.* Within the back wall of each fireplace are triangular-headed niches, whilst the side jambs incorporate built-in seats.

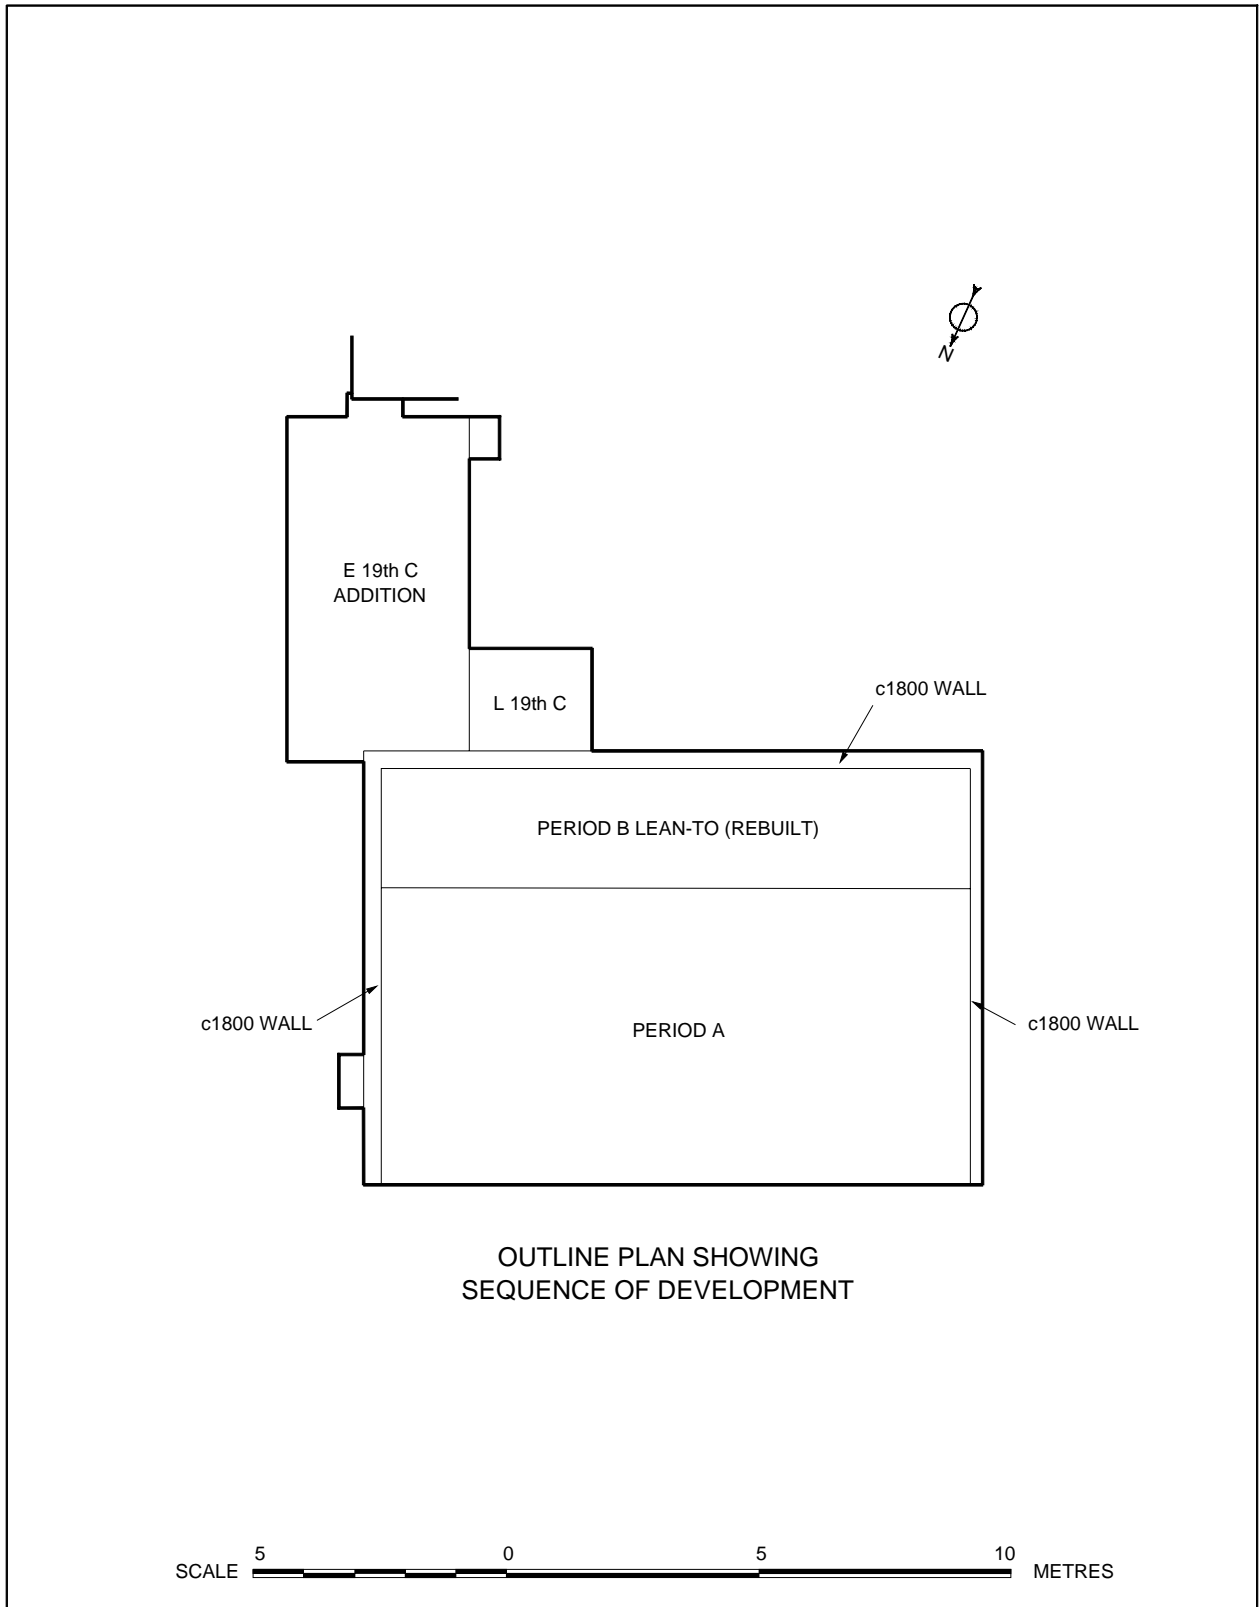
84 HIGH STREET, WESTHAM, EAST SUSSEX OUTLINE PLAN SHOWING SEQUENCE OF DEVELOPMENT				Site Ref P106/04
Drawn By J Clubb Revision No - Date of original survey 2007 Date of this revision 2007				Drawing No. 1673/2

OVERVIEW OF THE BUILDING [Drawing No. 1673/2-4]

Dating from the middle years of the 16th century [**Period A**] this four-bay house is close studded within its continuously-jettied street facade and has projecting ground-floor display windows to its hall and parlour. At the eastern end of this elevation was a shop front incorporating a narrow squeeze doorway. Access to the main part of the house was via a doorway between the hall and parlour (both heated). This led into a baffle entry immediately in front of the chimney. Except for a possible display window (perhaps capped by a gable above) lighting the heated hall chamber, the remainder of the windows within the house were small and of unglazed type. When first built it was not possible to gain direct access from the eastern chamber to the other two first-floor chambers, and thus there must have been two sets of stairs. A garret area existed over the hall chamber, probably lit by a window in the front roof slope. At this period the roof was hipped at both ends.

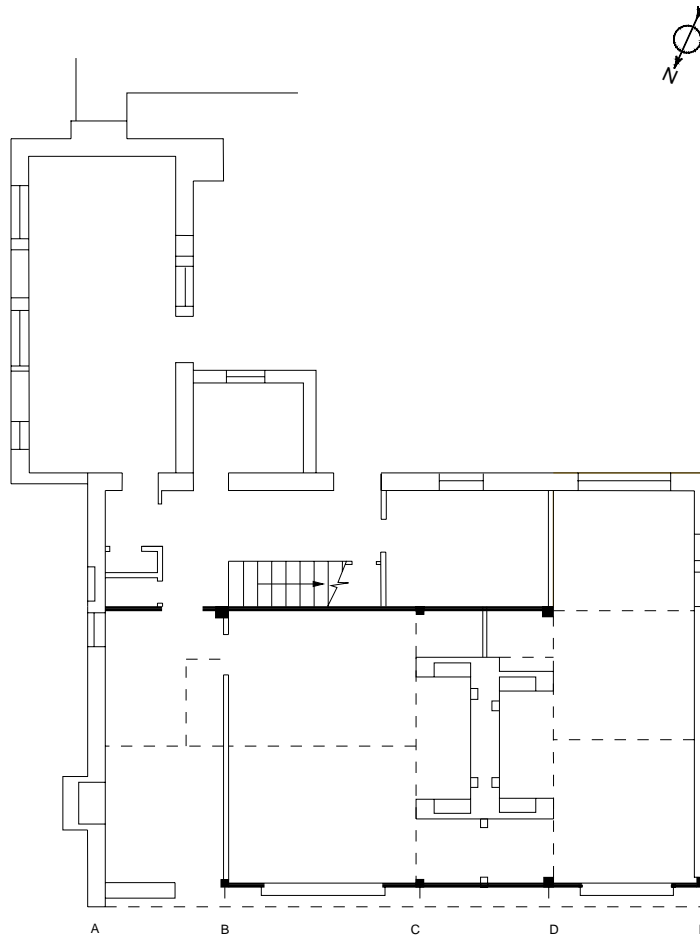
Drawing No. **1673/3**

84 HIGH STREET, WESTHAM, EAST SUSSEX
OUTLINE PLAN AS EXISTING, 2007

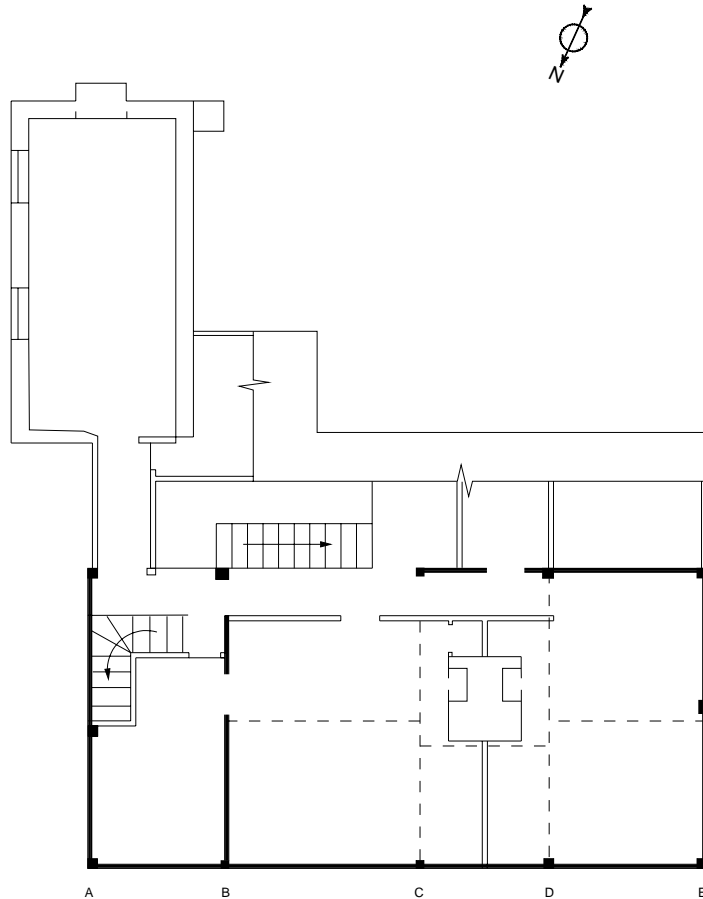
84 HIGH STREET, WESTHAM, EAST SUSSEX OUTLINE PLAN AS EXISTING, 2007				Site Ref	P106/04		
				Drawing No.	1673/4		
Drawn By	J Clubb	Revision No	-	Date of original survey	2007	Date of this revision	2007

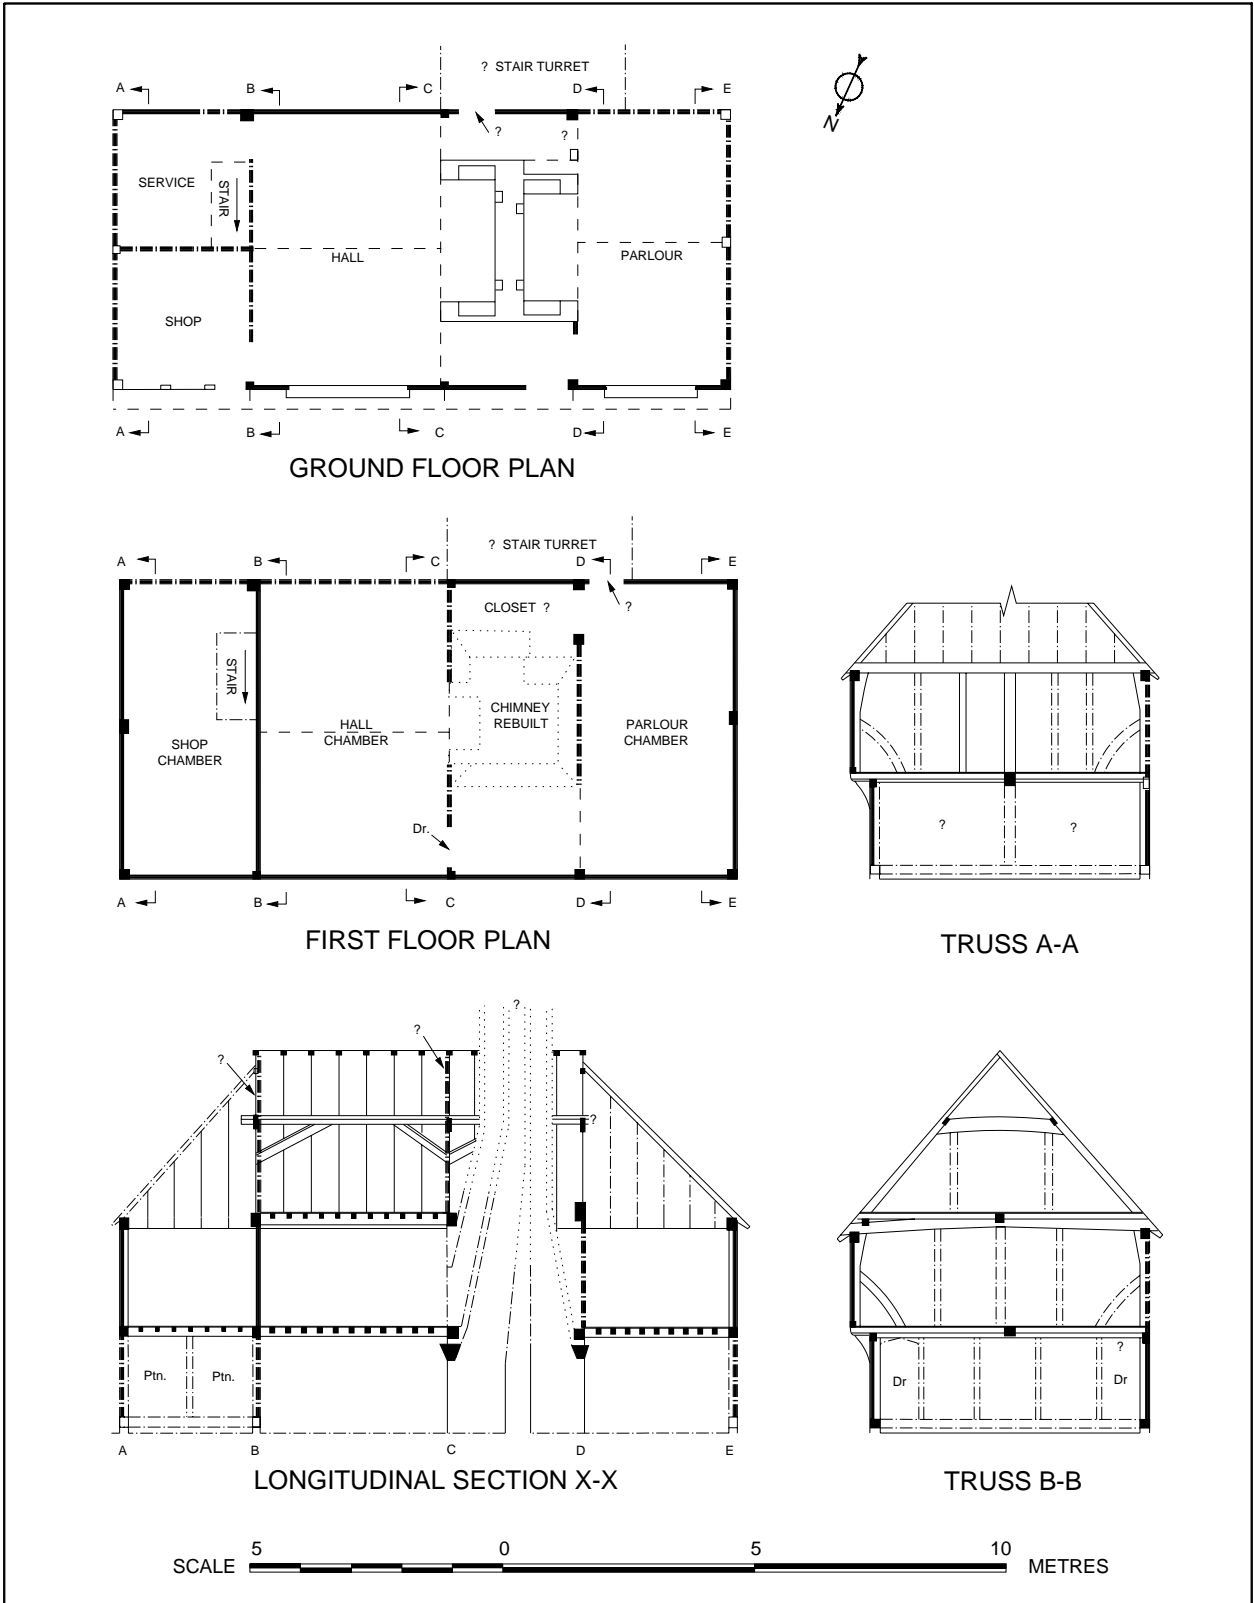
84 HIGH STREET, WESTHAM, EAST SUSSEX PERIOD-A RECONSTRUCTION DRAWINGS				Site Ref	P106/04
				Drawing No.	1673/5
Drawn By	J Clubb	Revision No	-	Date of original survey	2007
				Date of this revision	2007

PERIOD A (Mid 16th C) [Drawing Nos. 1673/5-7]

Above the shop/service room was a single chamber (marked Shop Chamber in Drawing No. 1673/5). This had no interconnection with the remainder of the chambers on the first floor and was accessed from the service room via a stair located against the eastern face of truss B-B. The hall chamber and parlour chamber housed the private accommodation of the house and were linked to each other by a doorway adjacent to the front wall, within truss C-C. Access to these chambers was via their own staircase, no doubt located within the separately-framed outshut which stood against the rear wall. The door from this appears to have led into the parlour chamber, through which the hall chamber was reached. A second door in the parlour chamber apparently gave access to a closet-like space beside the chimney.

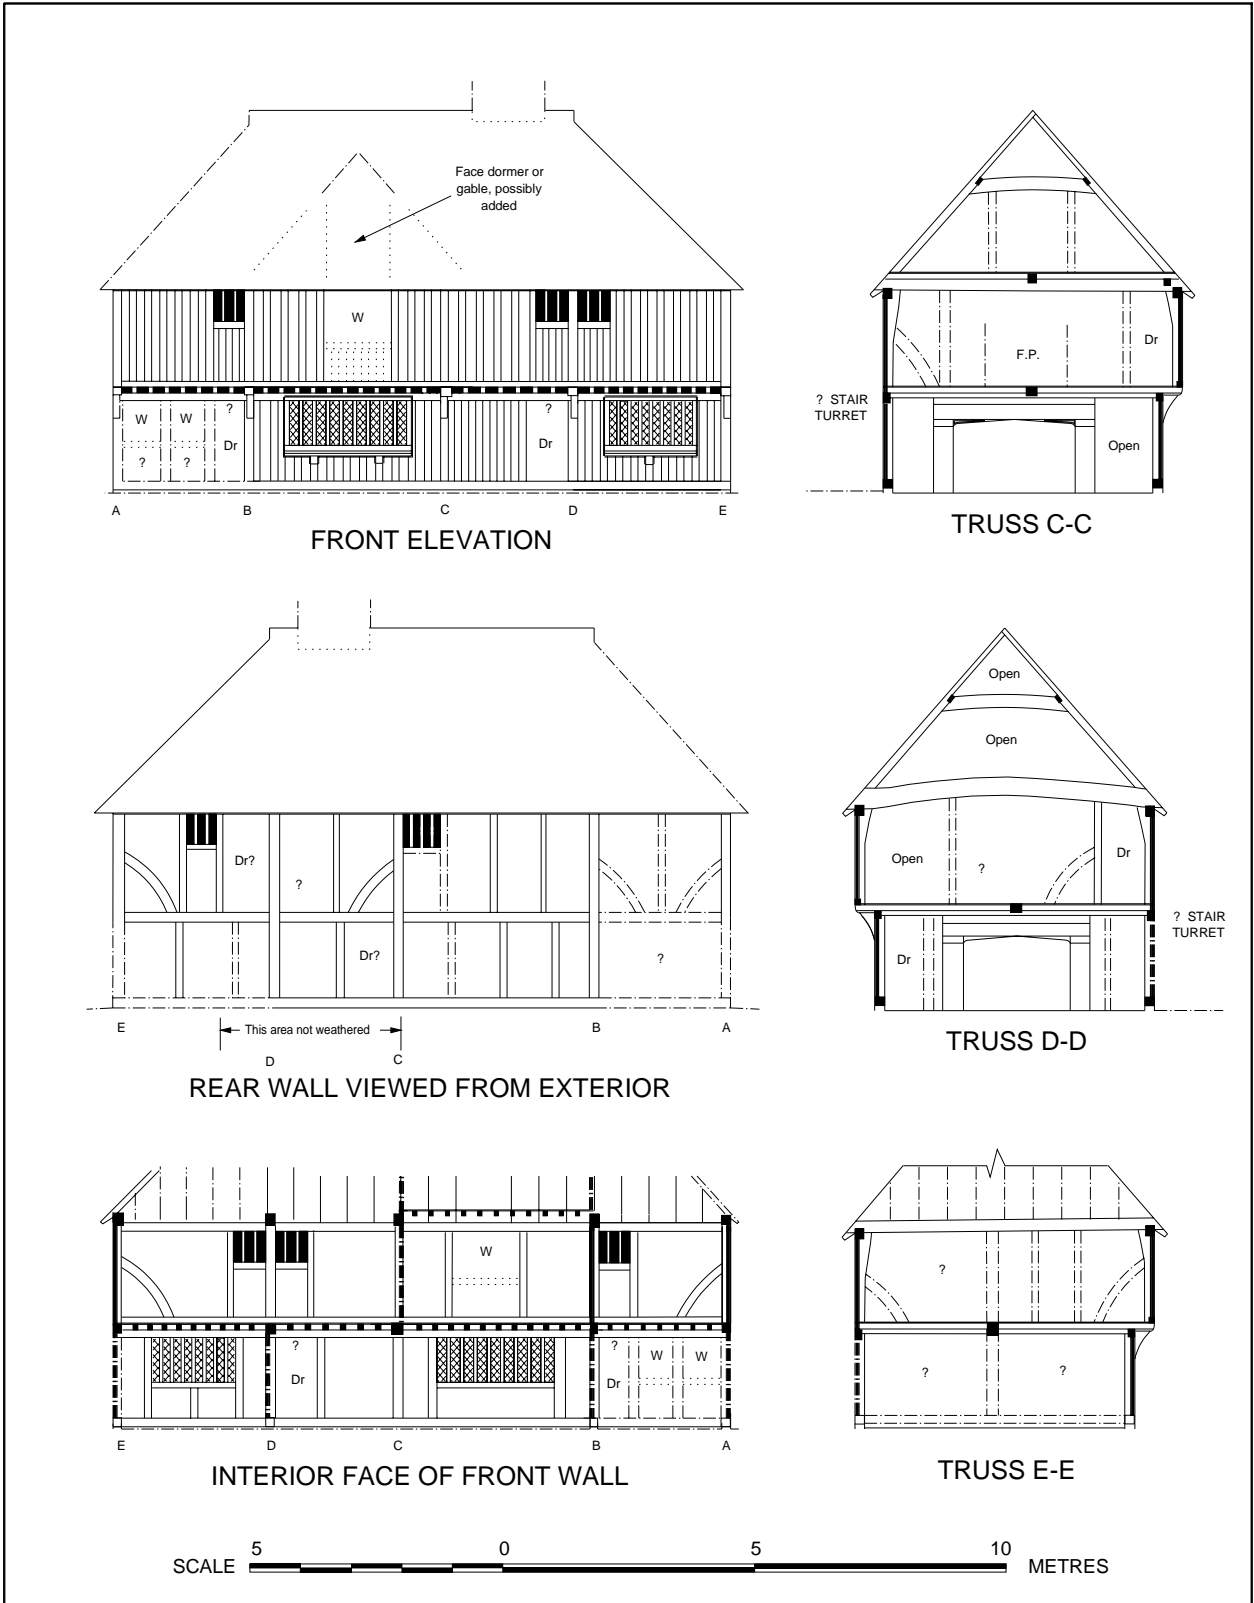
84 HIGH STREET, WESTHAM, EAST SUSSEX PERIOD-A RECONSTRUCTION DRAWINGS				Site Ref	P106/04
				Drawing No.	1673/6
Drawn By	J Clubb	Revision No	-	Date of original survey	2007
				Date of this revision	2007

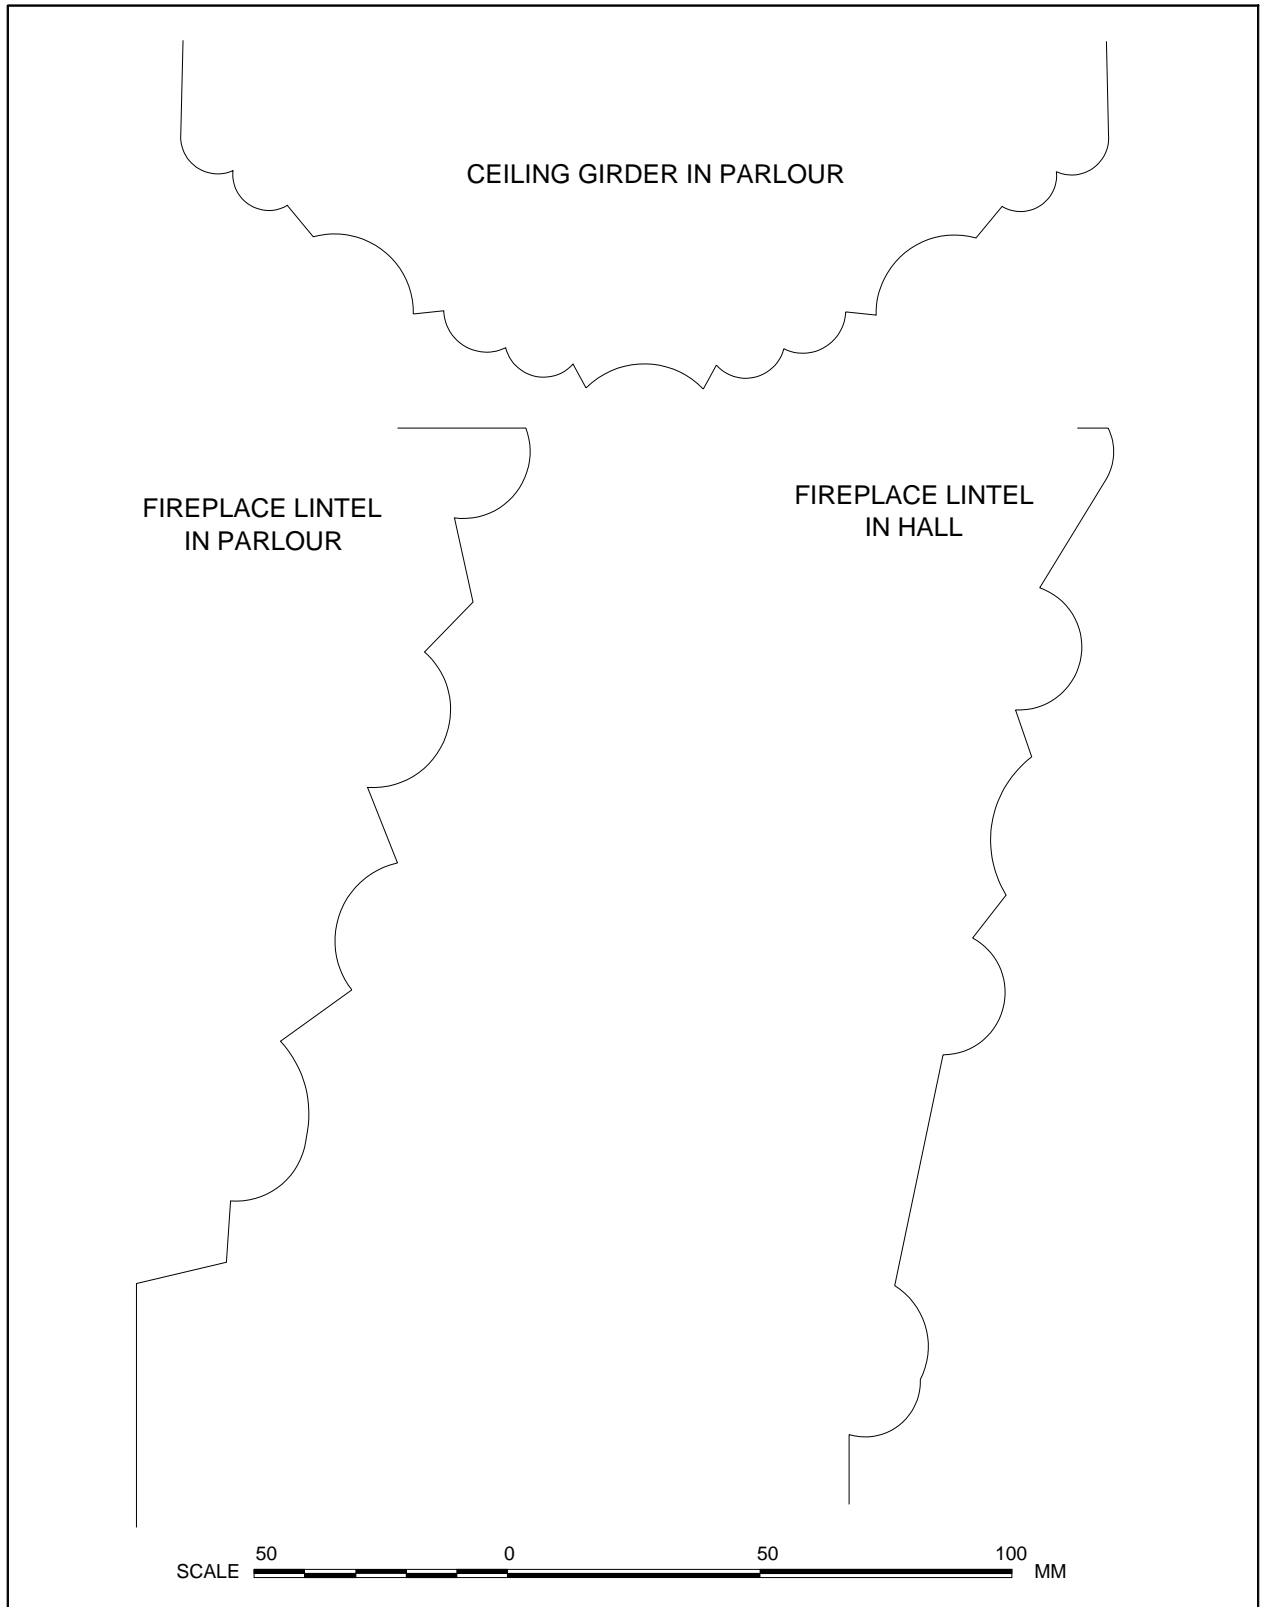
84 HIGH STREET, WESTHAM, EAST SUSSEX DETAILS OF PERIOD-A MOULDINGS				Site Ref	P106/04		
				Drawing No.	1673/7		
Drawn By	J Clubb	Revision No	-	Date of original survey	2007	Date of this revision	2007

All the ceilings over the main ground-floor rooms are of central-girder type with the girders carrying closely-spaced joists which, on average, measure 95-100 mm wide x 115 mm deep. All project forward over the front wall to carry the first-floor jetty: the joists ends remain exposed and are rounded. Rising from the ground-floor principal posts and integral with them are plain jetty brackets. Within the hall and parlour the joists are stop chamfered, but within the eastern bay they are plain. Furthermore, because of the stair trimming to the south, the joists do not align on either side of the girder. The soffit of this girder has been trimmed back so any chamfer that may have existed has been removed, but the girder within the hall is chamfered and has stepped-and-hollowed stops. A large-diameter hole drilled in the soffit of the girder probably indicates the former location of a pivot pole for a harness to keep a young child away from the open fire. Being the most important room of the house, the ceiling girder within the parlour is moulded — for its profile see Drawing No. 1673/7.

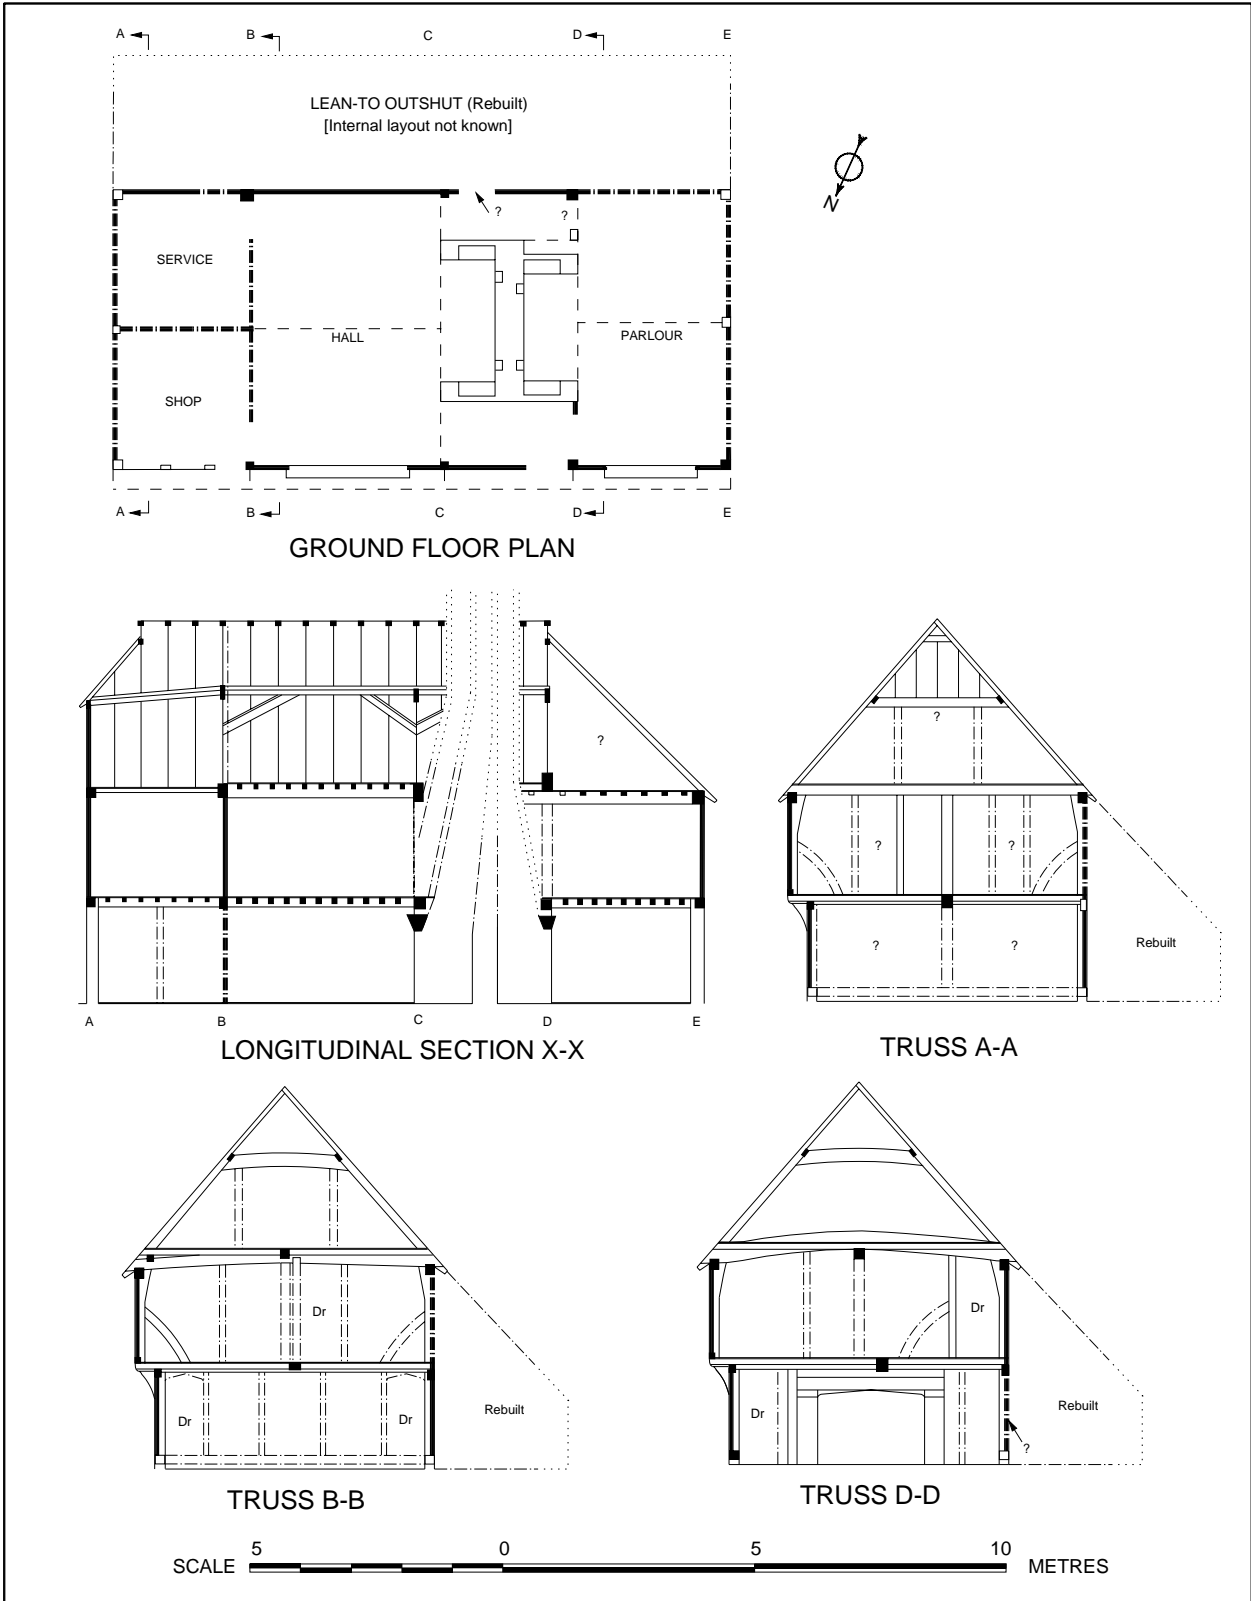
84 HIGH STREET, WESTHAM, EAST SUSSEX PERIOD-B RECONSTRUCTION DRAWINGS				Site Ref	P106/04
				Drawing No.	1673/8
Drawn By	J Clubb	Revision No	-	Date of original survey	2007
				Date of this revision	2007

PERIOD B (17th C) [Drawing No. 1673/8]
