**An Archaeological Interpretative Survey of  
Former Oast House at  
Pound Farm, Fletching, East Sussex**

**Project Ref. 3189**

### **FLETCHING - FORMER OAST HOUSE AT POUND FARM**

### **PERIOD A (c.1800, probably Early 19th C) [Drawing Nos. 1672/1-2]**

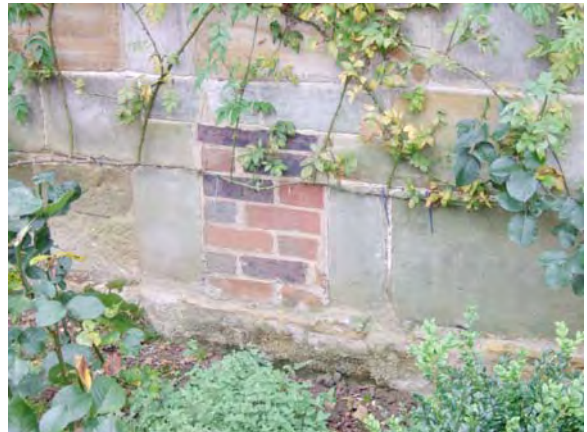
*Plate 1*  
*Blocked vent in north wall (others in south wall similar).*

There is a small rectangular ventilation opening immediately above plinth level in each of the northern and southern externally walls, against the western face of the internal

partition at A-A, with another, narrower vent further east in the south wall (see Plate 1). There are two further vents at a similar level in partition A-A, capped by segmental brick-on-edge arches. All are now blocked.

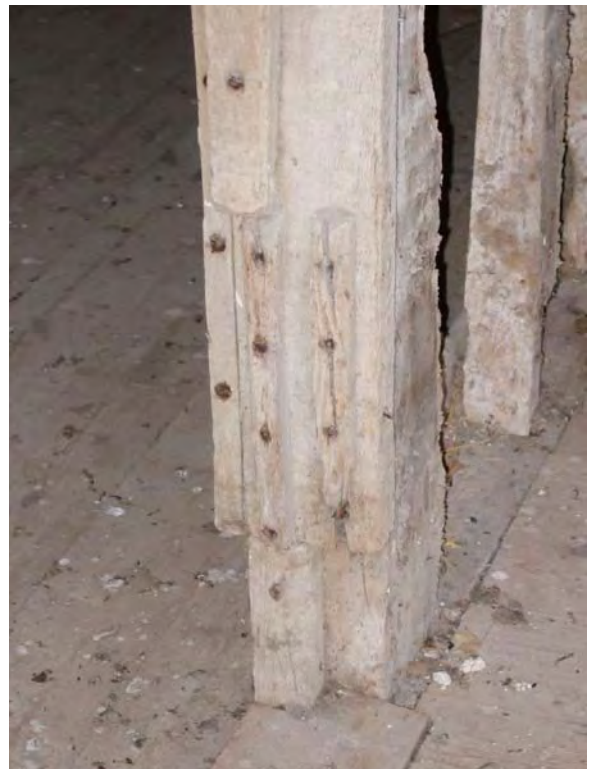
*Plate 2*  
*Base of door jamb leading into drying chamber (right). Note slides for lift boards, impression of steps and lath marks on righthand face of studs, terminating at former floor level.*

On the first floor the door jambs and head of the opening giving access from the stowage area to the drying floor of the kiln survives and, as already noted, the jambs of this trim the tiebeam. The drying floor was originally at a higher level than that of the stowage area, accounting for the impression of steps visible on the inside faces of the jambs. The bases of the jambs retain timber slides for lift boards which prevented the drying hops from cascading out of the drying floor onto the cooling floor (see Plate 2).

The floor with the eastern kiln area has been reconstructed at a lower level, but its original level is indicated by a number of features. For instance there is an offset part way up the first-floor storey height caused by the difference in thickness of the brickwork: this offset supported the north-south aligned joists. The floor level is also indicated by the point at which the nail holes for the former plaster covering on A-A terminated, by the cut-out for the steps visible in the door jambs, and by fixing holes on the studs indicating how the westernmost joist was supported against the wall, this joist having been trimmed by the steps rising through the doorway (Plate 2). The remainder of the building's first floor is

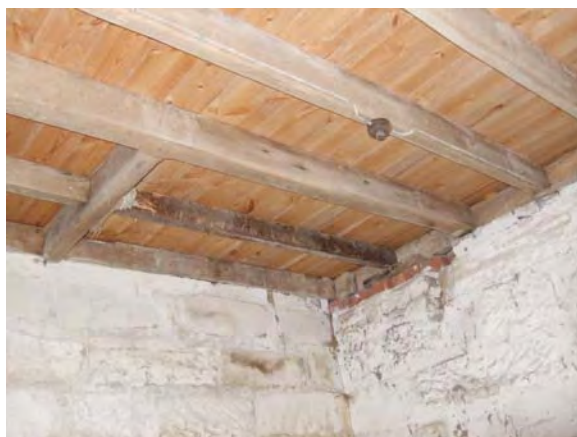
*Plate 3*

*Blocked stair trimming in ceiling of store.  
(The darker joist is inserted).*

Access to the first floor was via a stair ladder which rose against the northern wall of the central room: its position is evidenced by a neatly-formed trimmed opening through the floor joists (Plate 3). Two notches in the eastern face of the crossbeam of B-B indicates the position of the stair carriage. The stair has been removed and the trimming blocked. When not in use, the stair trap was protected by a hinged door-like boarded hatch, the three ledges of which are still evidenced by neat rebates cut into the trimmer joists in order to allow the hatch to lay flat when in its closed position.

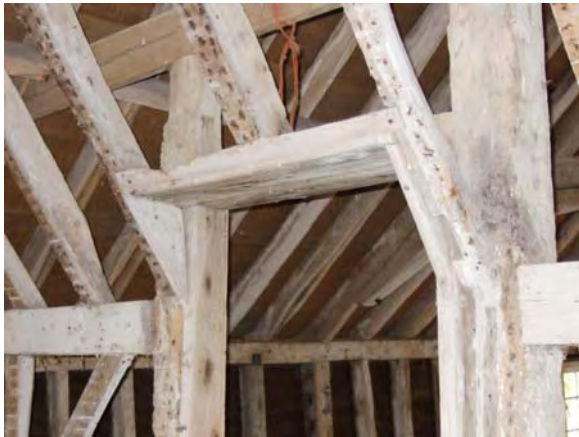
*Plate 4*

Rising from the eastern face of the tiebeam within truss A-A are sloping 'rafters' which extend up to lay boards fixed beneath the roof slope in order to form a plastered skeeling, funnelling the hot air from the kiln up through the roof and out through a

*Remains of skeeling rising from truss A-A.  
Note the way the door trims the skeeling.*

conical flue (now removed - Plate 4). The underside of these sloping rafters were originally masked by plaster, and usually the same is true for all the roof slopes within the kiln area, but not in this instance. Just beneath the head of the hip is a high-set collar, and there is another collar two rafters to the west. These are still linked by a timber which formerly carried the spindle for a rotating cowl (Plate 5). The pair of rafters positioned between the high collars has been replaced, indicating that these were originally part height, so as not to impede air flow up through the roof 'flue' and cowl. Halvings cut into the side faces of the rafters beneath the high collars are further evidence of the 'flue'.

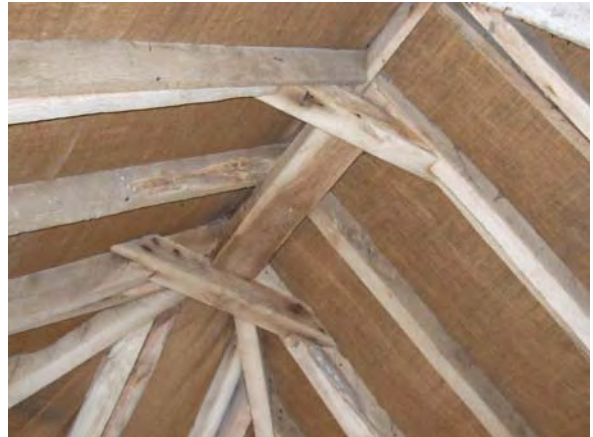
*Plate 5*

*Support for former cowl.*
