**An Archaeological Interpretative Survey of
Tapsells, Tapsells Lane, Wadhurst, East Sussex**

**Project Ref. 3390
Report No. 2008238**

WADHURST - TAPSELLS, TAPSELLS LANE

NGR TQ 6238 3222

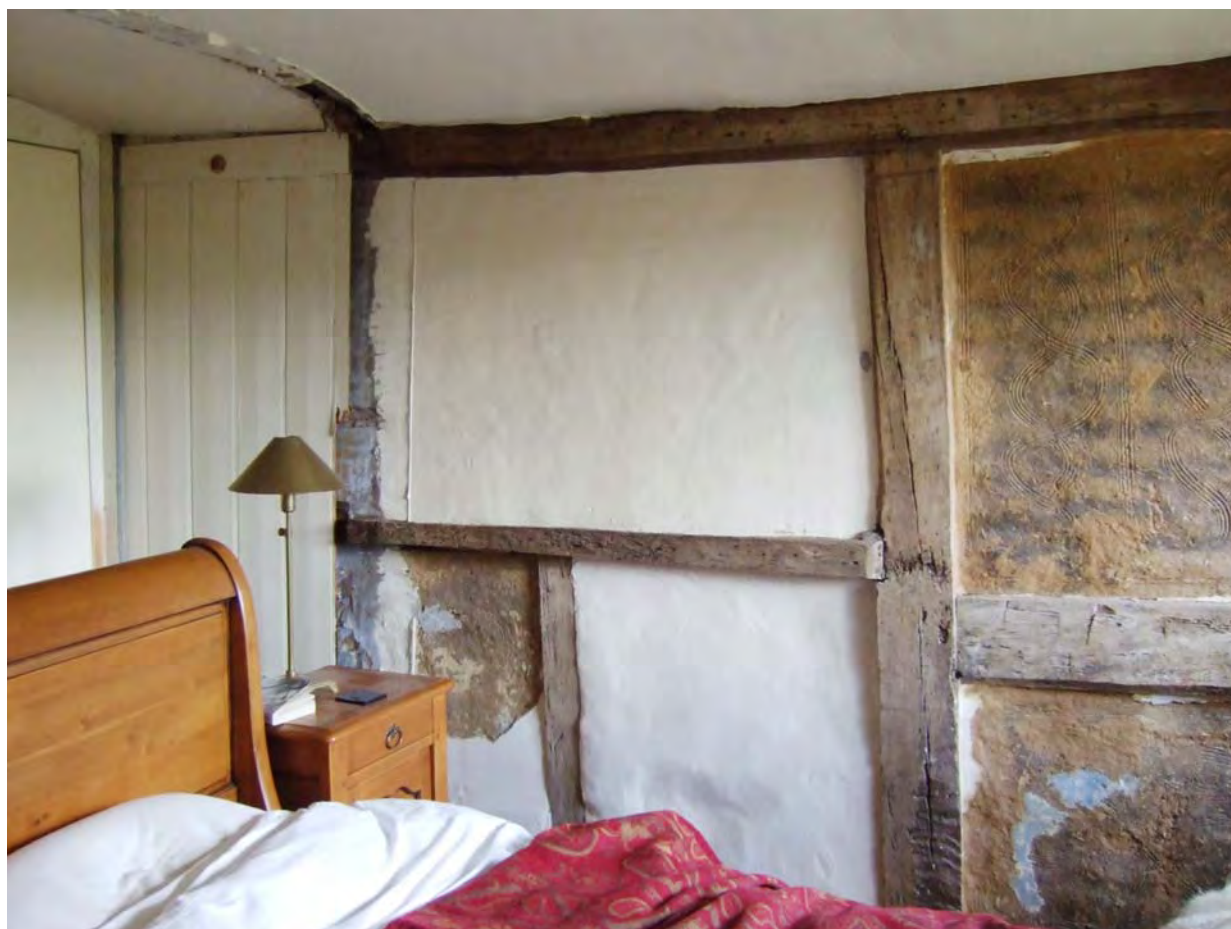
Plate 1
Blocked window in front wall of hall chamber, with remains of adjacent comb-decorated daub

Not all the windows in the house were unglazed. Positioned centrally within the front wall of the hall chamber is a blocked window opening c.1.50 metres (5'0") wide, but only 800 mm (2'8") deep (see Plate 1). Its proportions are totally different to those of the unglazed windows in the parlour bay and in the rear wall of the hall bay. This window was designed to be glazed from the outset. Furthermore, the cill of the opening has haunched joints at the jambs. Above the cill, the internal face of the un-damaged eastern jamb is neatly chamfered with stopped ends. Although not proof, the evidence suggests that the window was not only of glazed type, but that it projected slightly from the external face of the wall, either as an planted-on frame or as an oriel, perhaps capped by a small front gable. As with the other windows, it too was formerly closed by a sliding shutter — not uncommon in early glazed windows of this type. Plaster covers the lower edge of the side girt on the level below, masking the pattern of peg holes from

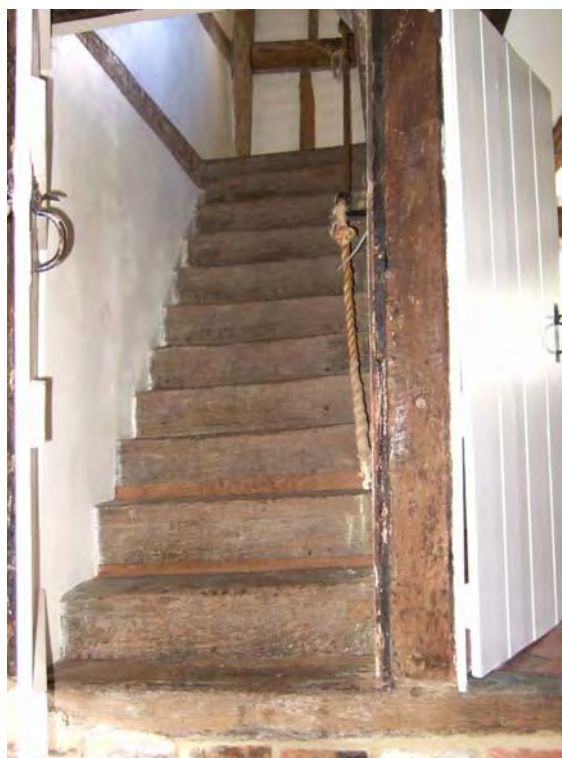
Plate 2
Triangular-tread staircase
leading to first floor.

One of the significant features of Tapsells is that it retains both of its original period-B stairs, albeit the flight leading to the attic was subjected to some modification when the roof was rebuilt to a less steep pitch. The stair rising to the first floor is built hard against the rear wall — a traditional location — and rises direct from the hall as a straight flight. Although repaired, many of its solid triangular-section steps survive *in*

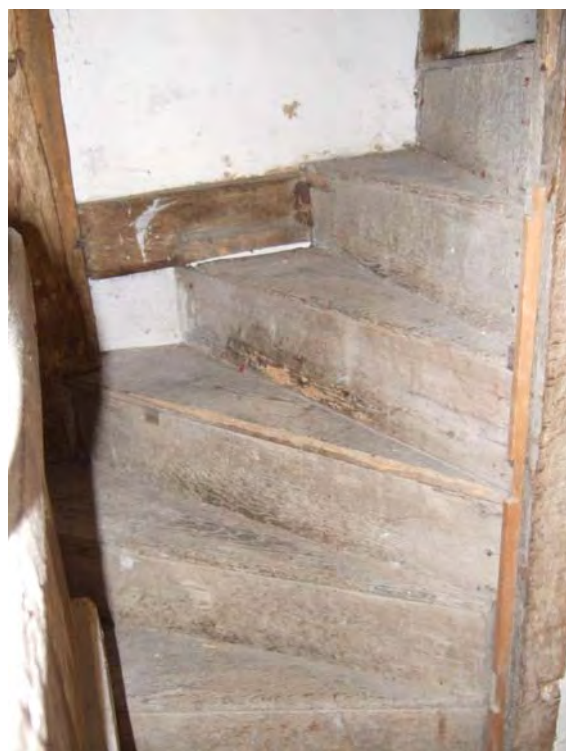
Plate 3
Staircase leading to attic.

situ (Plate 2). Rising above this flight, in the southwestern corner of the southern parlour chamber, is a part winder, part straight-flight stair of composite construction rising to the attic area (Plate 3). Although the trimming in the ceiling shows it to be original to the build, only the lower winders remain from period B, the upper part having been rebuilt with one less winder during period D/E in order to give sufficient headroom when the roof pitch was lowered. The positions of the removed winders are visible as notches cut into the newel post (Plate 4). The supporting construction includes a moulded beam.

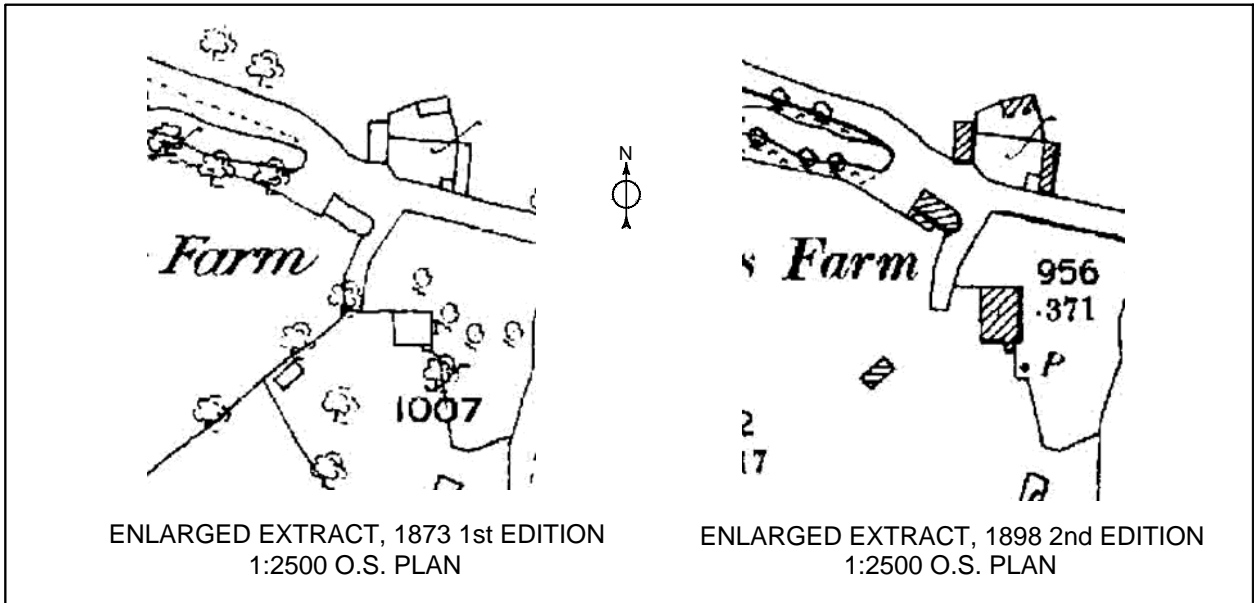
TAPSELLS, WADHURST, EAST SUSSEX HISTORICAL MAPS AND DEVELOPMENT PLAN				Site Ref	P104/14
				Drawing No.	1684/1
Drawn By	J Clubb	Revision No	-	Date of original survey	2008
				Date of this revision	2008

LOCATION [Drawing No. 1684/1]

Set back slightly from the southern side of Tapsells Lane, Tapsells is built on a northeast facing slope at about 135 metres above mean sea level, and is sited approximately 1.1 miles WNW of Wadhurst Church. The structure consists of two parallel ranges — a late 16th-century range positioned behind a narrower and taller late 19th-century front addition. It is built upon an east-west axis with its principal elevation facing north, towards the lane.

A new symmetrically-fronted range with end chimneys and a central entrance was built in front of the earlier house in the late 19th century — the 1:2500 ordnance survey plans confirm that this had not been constructed in 1873 when the survey work for the 1st edition of the plan was undertaken, but had been added by 1898 (see Drawing 1684/1). The range houses two rooms on each storey, separated on the ground floor by a central entrance passage: the equivalent space on the first floor houses closets. The ground-floor external walls are of neat stretcher-bonded cavity brickwork incorporating a slate damp proof course, whilst the timber-stud first-floor walls are covered in machine-made tile hanging typical of the period. Some associated alterations were made to the earlier house, the principal of these being the intrusion of a new staircase and landing (both since removed).
