**An Archaeological Interpretative Survey of
The Crown, Horsted Keynes, West Sussex**

**Commissioned by
David Head MCIAT ACIOB on behalf of Steven McArthur**

Project Ref. 3522

HORSTED KEYNES - THE CROWN

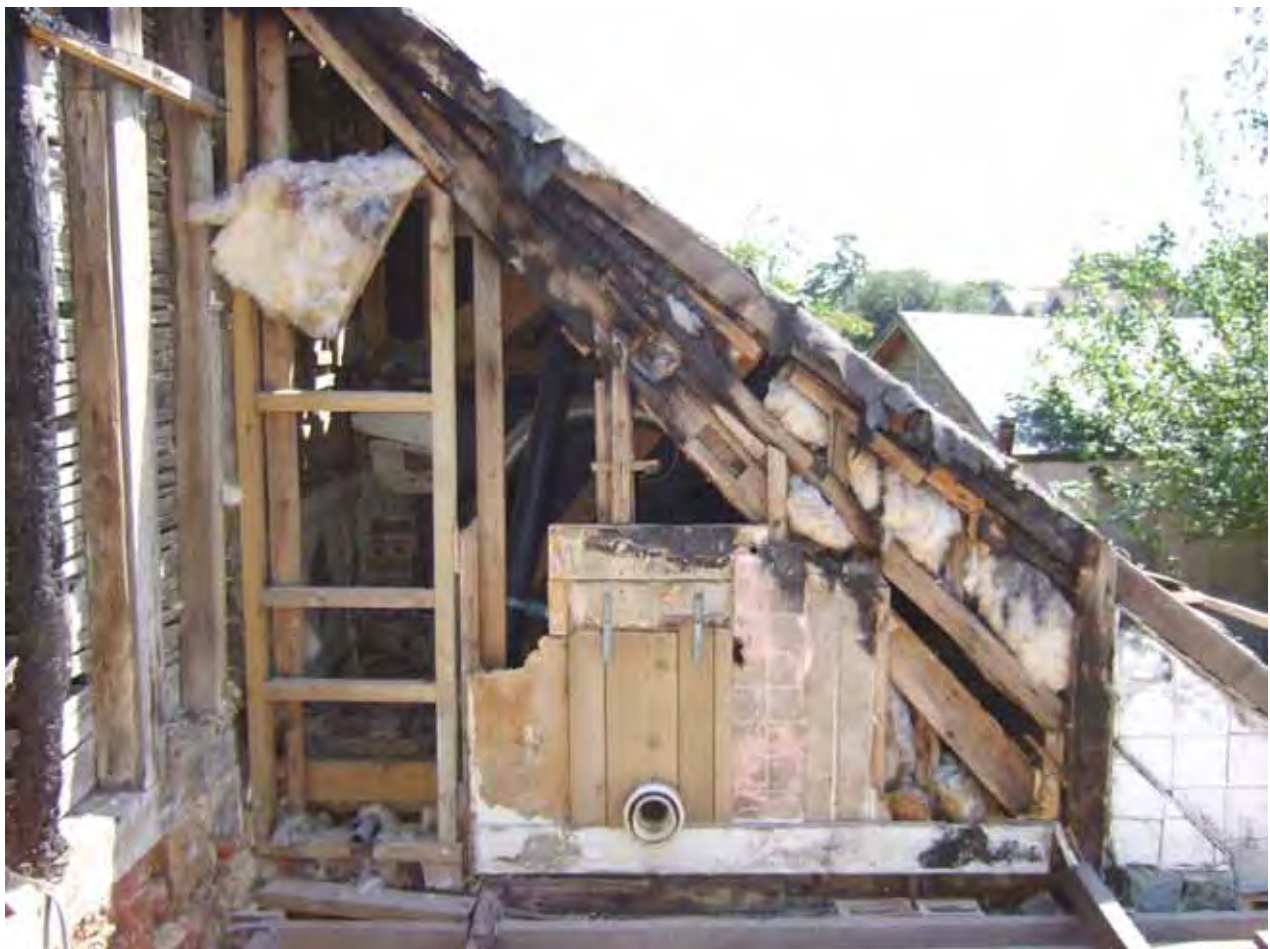
Plate 2

Southern gable of Period-E1 lean-to, showing two subsequent phases of adjustment, firstly shallowing the pitch and secondly widening the outshut.

Yet another phase of upgrading was carried out in the early 19th century. The principal alteration undertaken at this date was the reconstruction of the main roof to a less steep pitch, incorporating a new brick gable and chimney cap at the western end, replacing the earlier (assumed tile hung) gable of timber-stud construction. At the same time the period-E1 rear lean-to outshut was widened, capped by a less steeply pitched roof cradled over the period-E1 southern end gable (see Plate 2). Furthermore, the principal

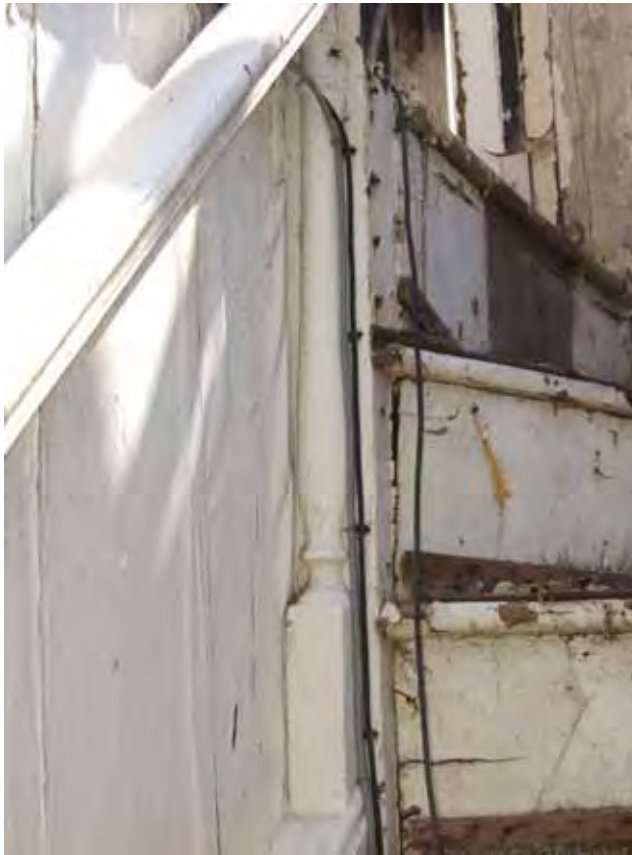
Plate 3
Remains of early 19th-century balustrade.

windows in the north elevation were replaced by tripartite double-hung sashes, apparently fitted within the original period-E2 openings without the need for modification. Internal alterations of this period were minor, but included the insertion of a new stairs, in a slightly different location than previously. This 19th-century staircase has itself been partly rebuilt subsequently, but is evidenced by a handrail, newel post and an attached turned half baluster trapped at a point near the head of the flight (Plate 3), together with the carriage and upper treads and risers visible above the cellar steps.

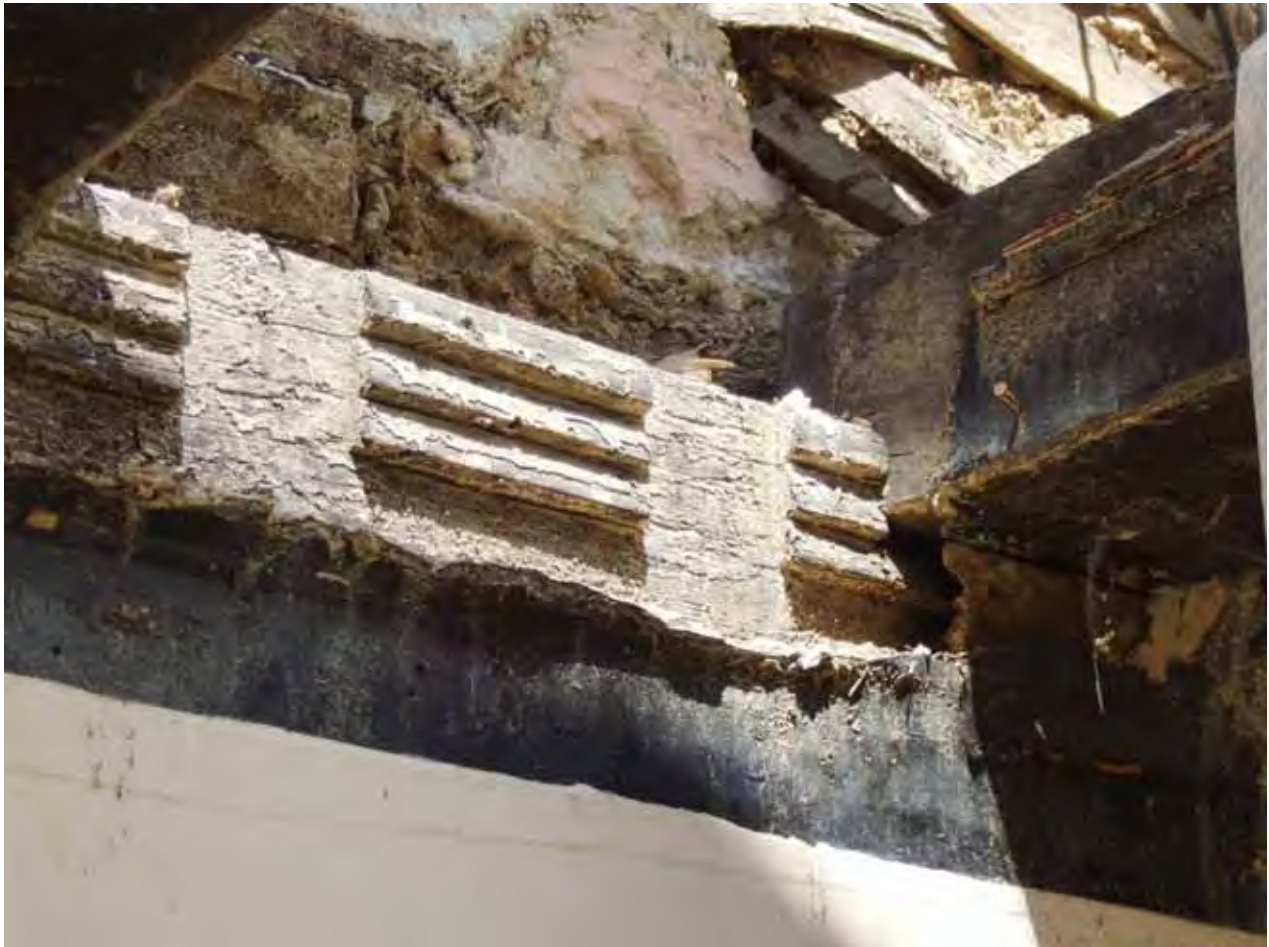
Plate 4

Detail of crenellation on Dais Beam. The moulding on the lower part of the beam is hidden from view at this point.

end of the truss originally incorporated a footbrace matching that at the opposite end. The dais beam itself has had its bottom section trimmed off, removing all evidence regarding the design of the ground-floor wall framing. Even so, the moulded and crenellated hall face of the beam survives in good condition, allowing the profile of much of the moulding to be ascertained (see Drawing No. 1687/5). The style of the moulding is pure 'Decorated', indicating a 14th-century date. Furthermore, the design of the crenellation is of early type (Plate 4).

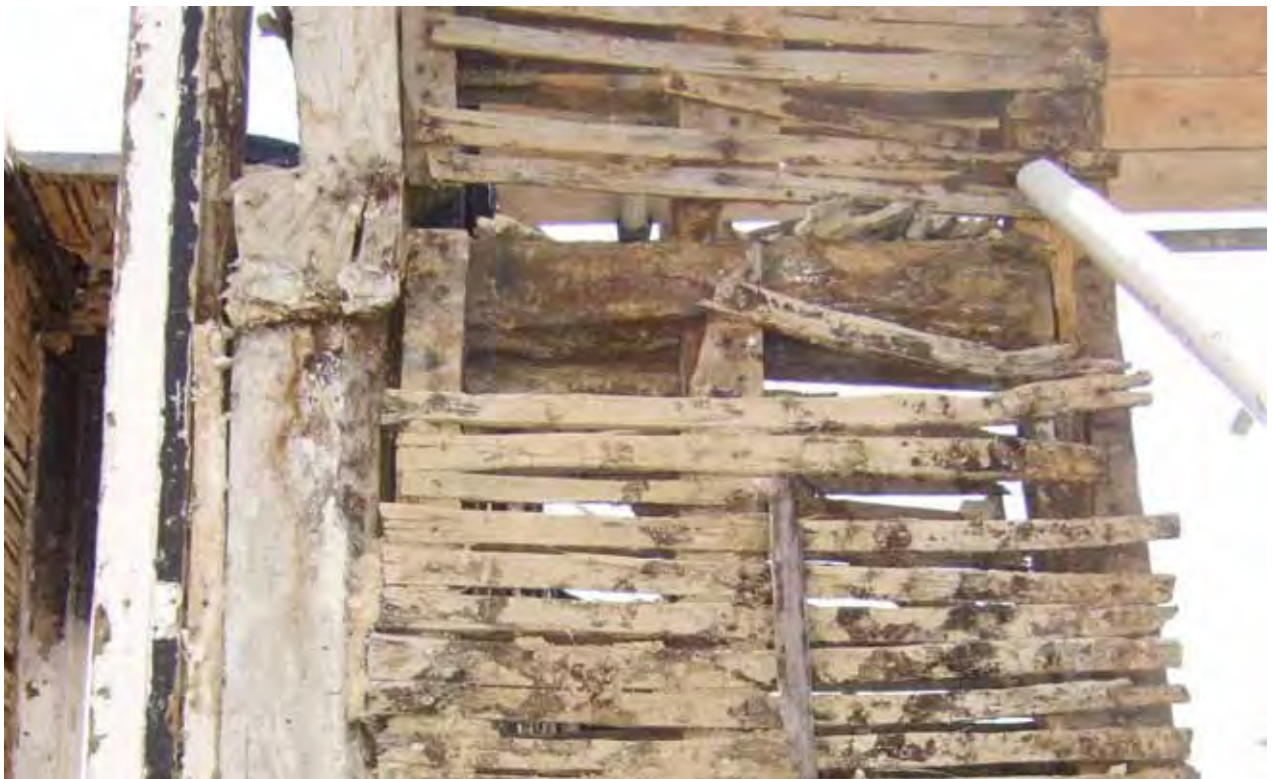
Plate 5

*Detail showing trapped, sawn-off fragment of medieval western wallplate with stub-section of wallplate to south wall of period-C range projecting to right.
To the extreme right, the period-E2 stone wall has been demolished for safety.*

sawn-off fragment of the medieval wallplate trapped between the two sections of rebuild. It is this fragment, about 200 mm long, which is shown in Plate 5. As further proof of the difference in construction date of the two sections of the mid 18th-century building, the period-E2 construction methods are totally different from those used during period E1 (see below).

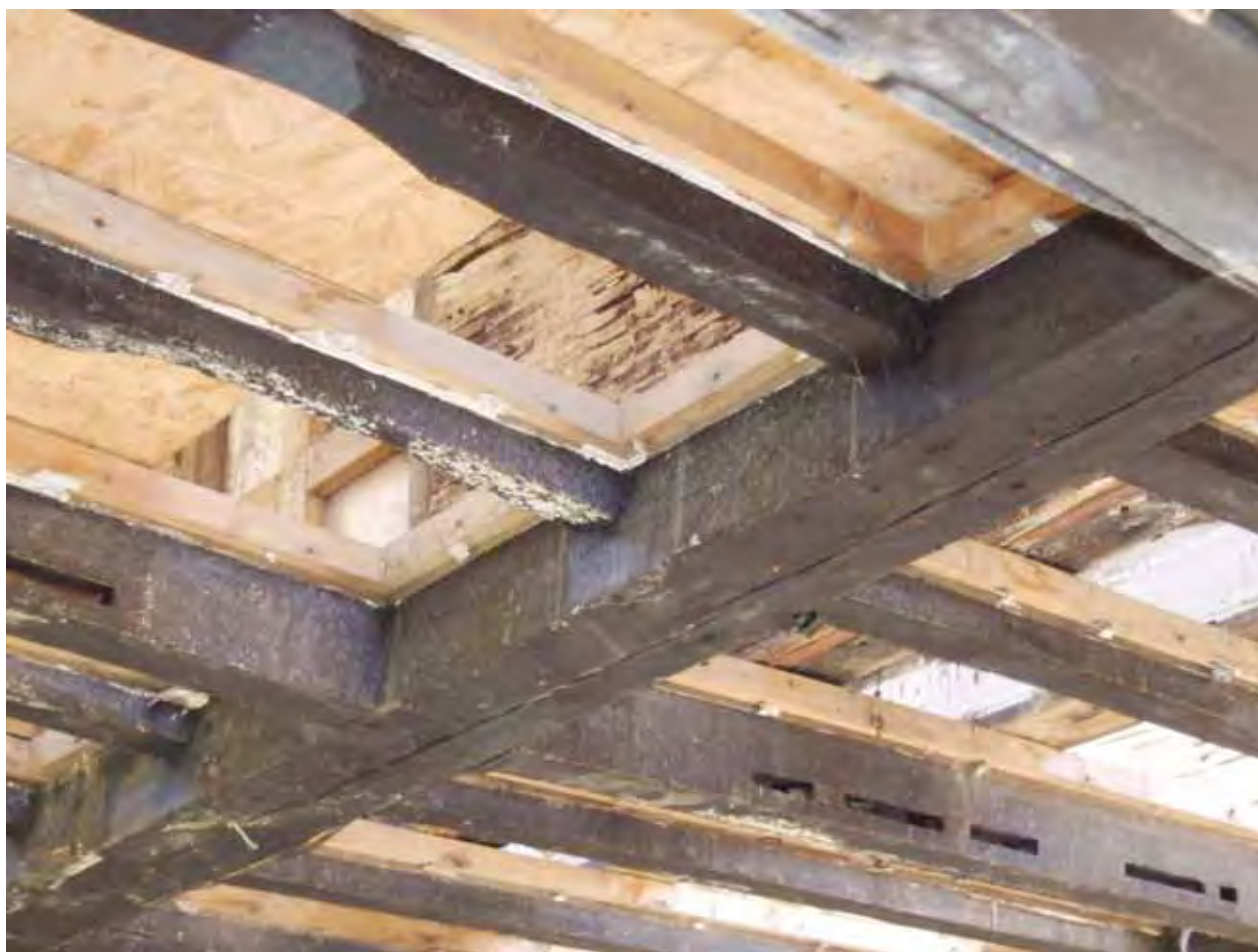
Plate 6

Ceiling to Back Parlour showing deeper joists set at intervals in order to support counter-joisting (removed) which carried the flush plastered ceiling.

to this room. This was achieved despite the need to incorporate deep structural timbers in order to carry the load. It has twin girders which originally supported a twin layer of joists. The upper set carry the floorboards of the chambers above. They span east-west and most measure 75 x 90 mm in section, but at two points across the ceiling they are deeper (80 mm x 185 mm) being the same depth as the girders (Plate 6). These deeper joists have a mix of mortices (one face) and long slots (opposite face) and are intended to carry a lower set of counter joists which supported the ceiling. The slots enable the ceiling joists to be fitted after completion of the floor construction: it is a method commonly used in good-quality work of this period. Rather misguidedly, during the 20th century all the ceiling joists were removed in order to expose the floor joists to view. On the storey above the joists (90 mm x 110 mm) were likewise always intended to be under-plastered, but here the tiebeams project down below the ceiling and are chamfered.

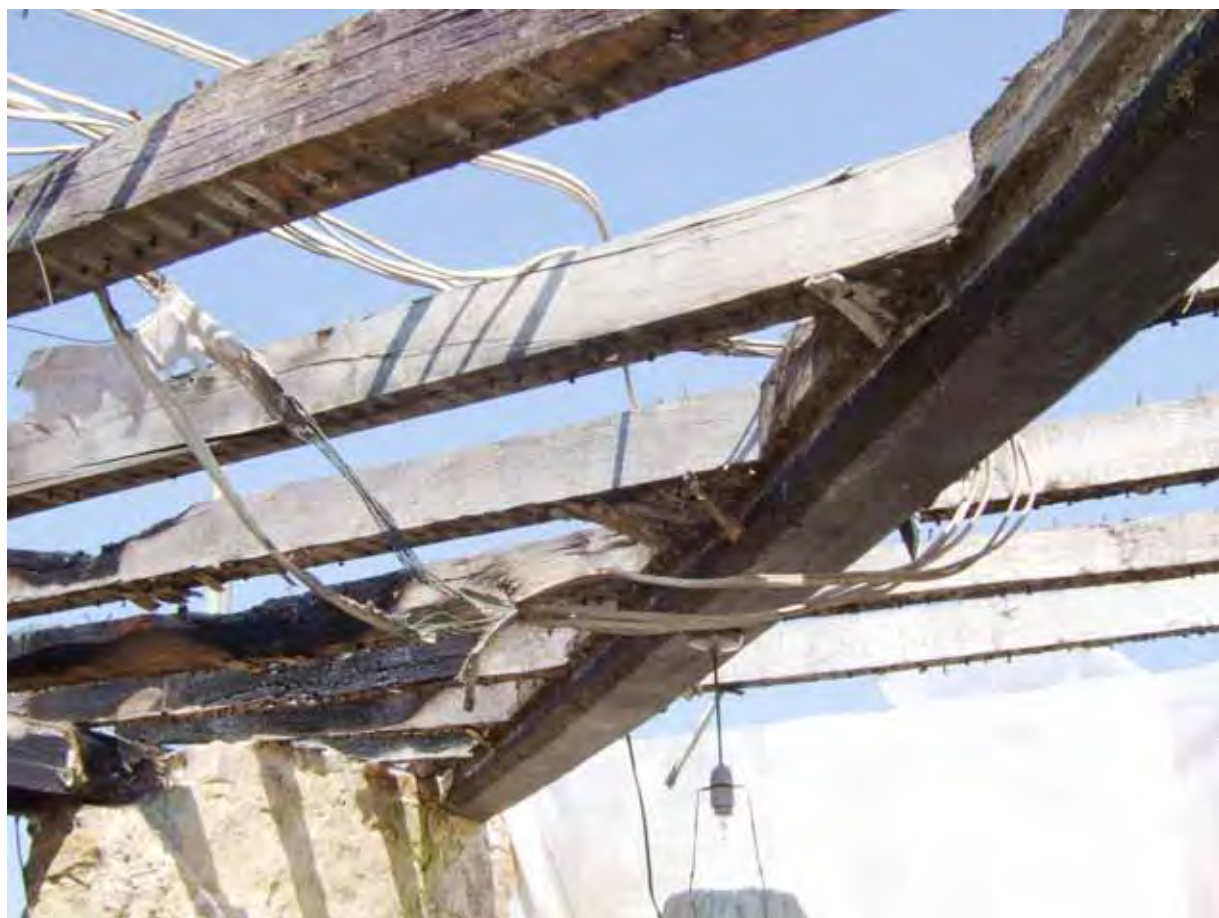
Plate 7

Dragon girder in ceiling of Old Parlour Chamber, looking towards NE corner.

Of particular interest are the ceilings over the kitchen chamber and old parlour chamber. Here a dragon girder (Plate 7) spans diagonally across the range to the north-eastern corner, supporting the ceiling joists, some of which are merely nailed into position. This diagonally-set timber serves as a tiebeam, supported the roof construction (see below). A second diagonally-set girder spans the kitchen chamber so as to prevent the east wall from spreading, following removal of the period-B tiebeam.

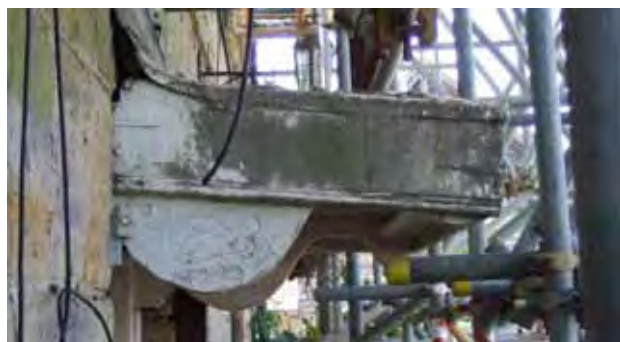
Plate 8

The northern wall (principal elevation) rises off a square-topped plinth, whilst at the level of the first floor is a projecting string course. The centrally-placed front doorway is capped by a flat timber hood, carried on brackets — it looks to be a 19th-century reconstruction (Plate 8). The flat arches over the ground-floor window heads have voussoirs which are angle-cut (Plate 9).

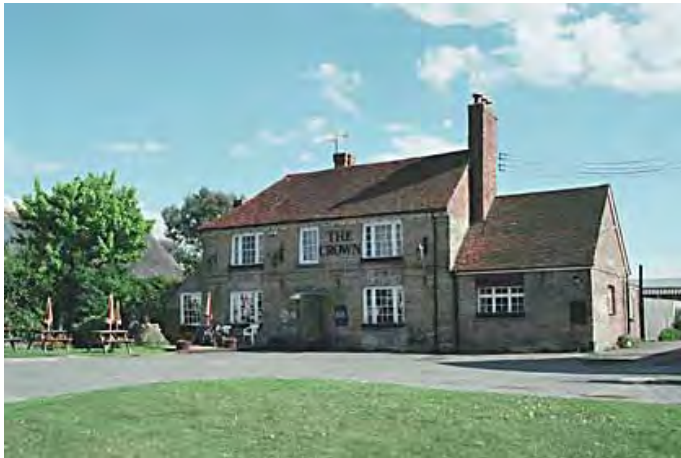
Plate 10

North elevation pre fire

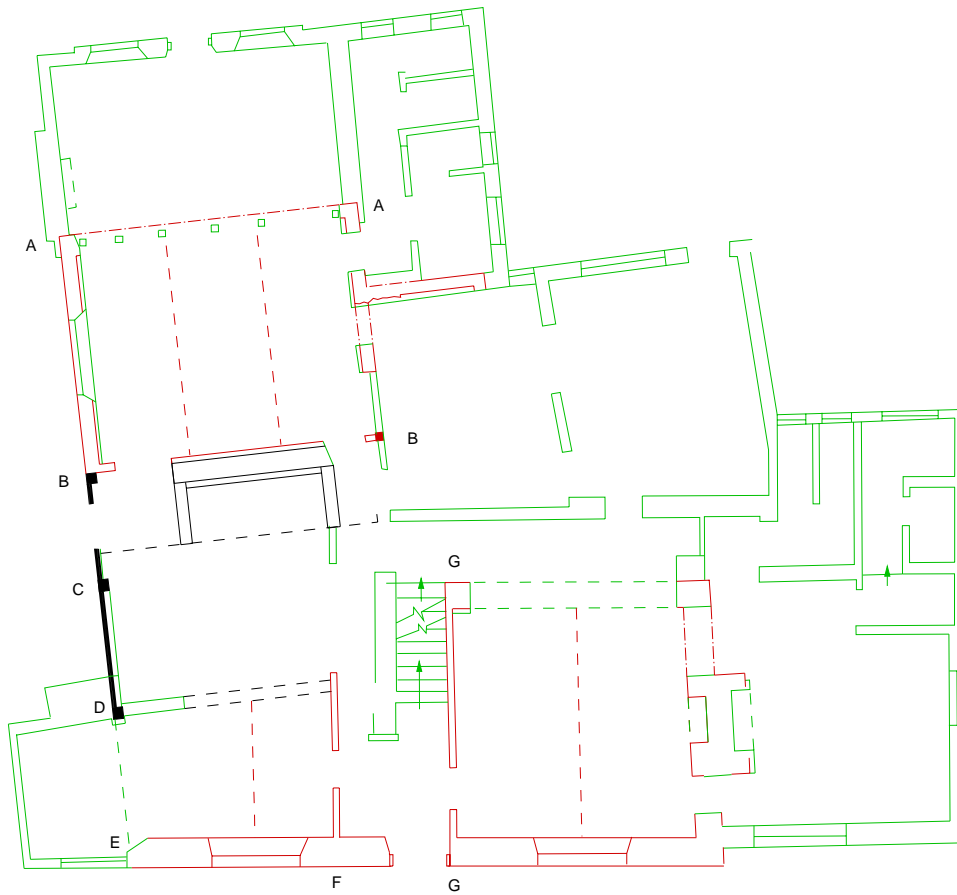
GROUND FLOOR PLAN

THE CROWN, HORSTED KEYNES, WEST SUSSEX GROUND-FLOOR PLANS AS EXISTING, 2004				Site Ref	P82/01		
				Drawing No.	1687/2		
Drawn By	J Clubb	Revision No	-	Date of original survey	2008	Date of this revision	2008
