**HAZELDEN FARMHOUSE,  
CRANBROOK, KENT**

**AN ARCHAEOLOGICAL  
INTERPRETATIVE SURVEY  
OF  
HAZELDEN FARMHOUSE,  
CRANBROOK, KENT**

**Commissioned by  
CHANTECLAIRE LTD.**

**PROJECT REF. 3806**

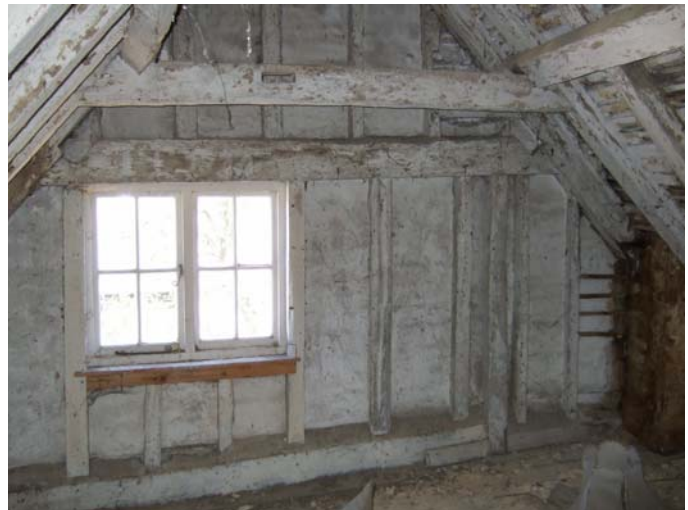
*Plate 1*  
*Period-A truss F-F showing later intermediate truss in foreground.*

As can be seen on Drawing No. 6, at roof level truss F-F (East Elevation) is framed differently to the other roof trusses. The levels of the collar and the (now removed) side purlins are lower than those in the remainder of the trusses, and the principal rafters are diminished accurately above the purlin notches. One of the original two queen studs in this truss survives underneath the collar. The truss was once windbraced. The principal rafters of the other trusses within the roof are all diminished and both these and the reset collars are morticed to match the configuration in truss F-F. However, the queen studs in the other trusses have been removed and the collars raised to suit the period-B roof. In addition, an intermediate truss has been incorporated into the roof adjacent to truss F-F in order to carry the end of the extant, later purlin (Plate 1; *also see Period B: Roofs below*). Therefore, though almost all of the roof was rebuilt during period B, truss F-F was left *in situ*. The reason for the truss's retention is not known, but it proves

the existence of a structure before period B, some of which survived the period-B rebuild.

internal truss has been incorporated adjacent to truss F-F in order to carry the ends of the higher period-B purlins. The collar in the retained period-A truss (F-F) is too low to fulfil this function.
