**An Archaeological Watching Brief at St Mary the Virgin Ticehurst, East Sussex.**

**Planning Ref: RR/2006/2055/P**

**Project No:2820  
Site Code: SMT06**

**ASE Report No. 2009121  
OASIS id:62882**

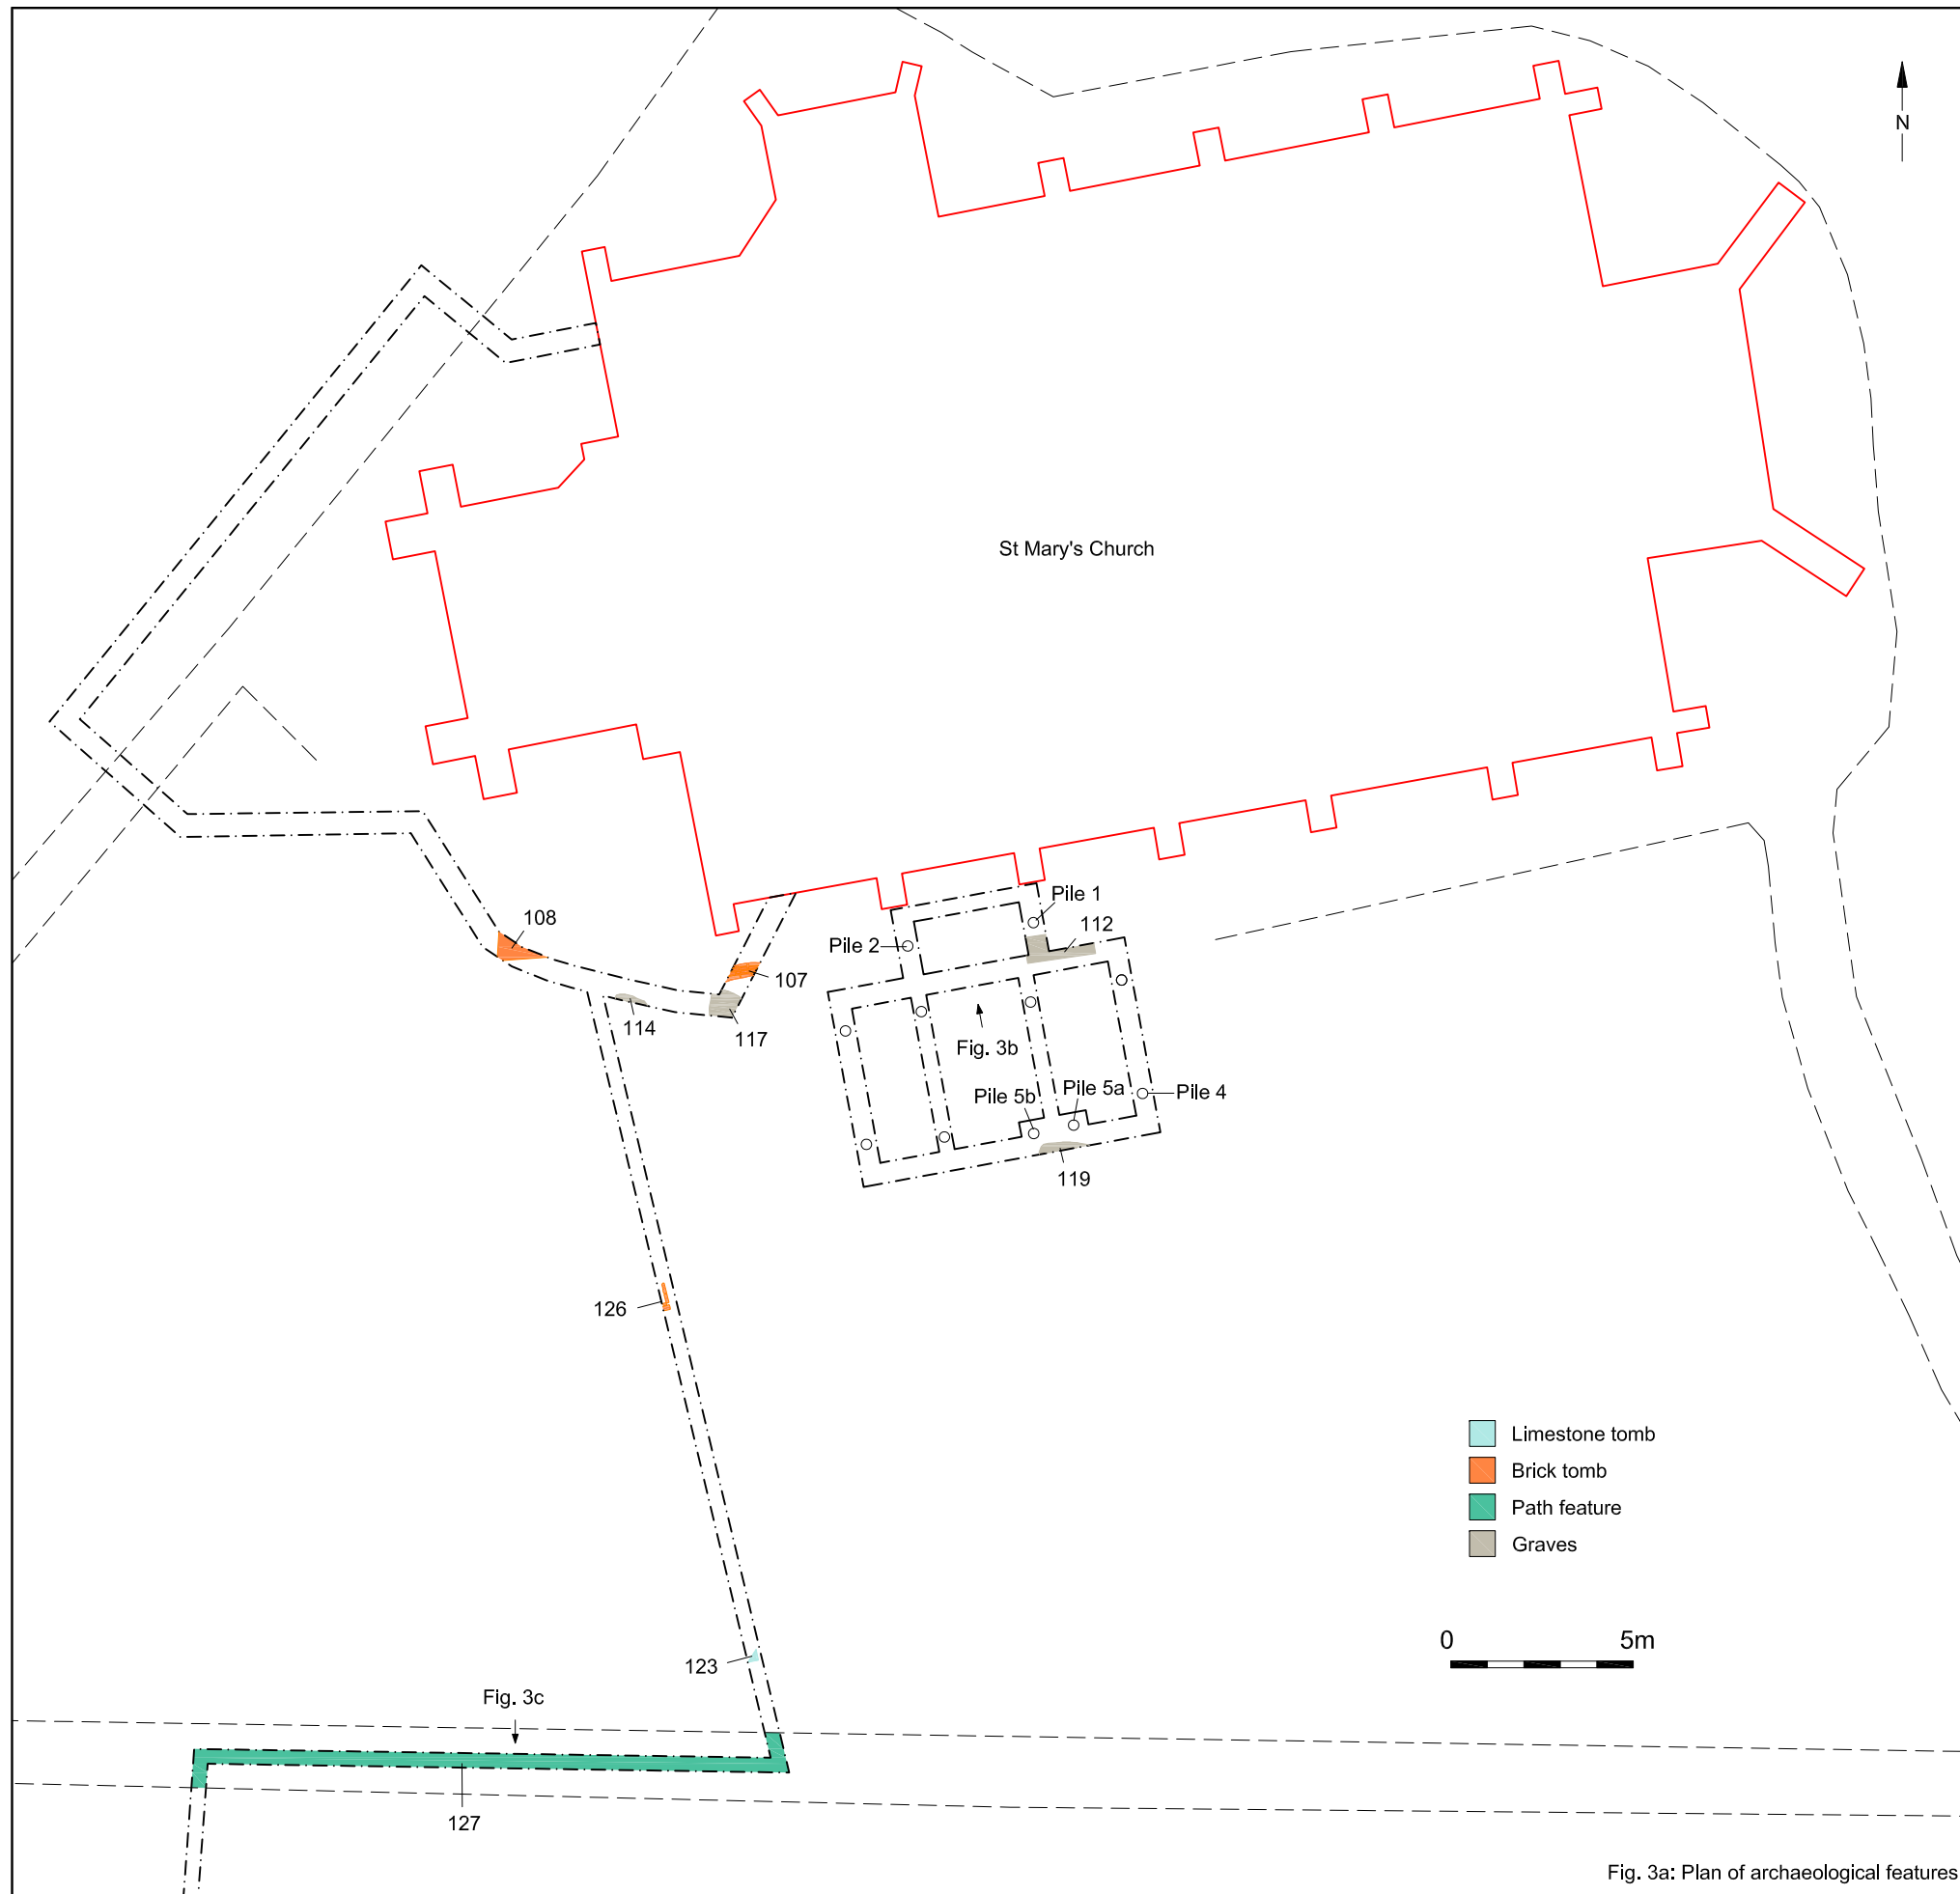
- 4.3** The general stratigraphy of the site was natural yellow clay [102] overlain by a cemetery soil of mottled yellowish brown clay [101] into which a number of burials and tombs were cut. Over the majority of the churchyard cemetery soil [101] was overlain by grey brown clayish silt topsoil [100].

- 4.5.1** Very few burials were encountered during the archaeological works (fig. 3). A brief summary of findings has been outlined below, but full context details for the burials and tombs recorded can be found in the appendix.
- 4.5.2** The outlines of four graves and four subterranean vaults were uncovered but with the exception of burial [119], no human remains were encountered. Interment in vaults and tombs was popular in the 19<sup>th</sup> century amongst those wealthy enough to afford such a burial, it is likely the people interred within were of wealthy status within the community.
