**9 HIGH STREET LYDD, KENT**  
**HISTORIC BUILDING SURVEY**  
**(NGR TR 042 209)**

9 HIGH STREET LYDD, KENT  
HISTORIC BUILDING SURVEY  
(NGR TR 042 209)

Project No. 4111  
Report No. 2009173

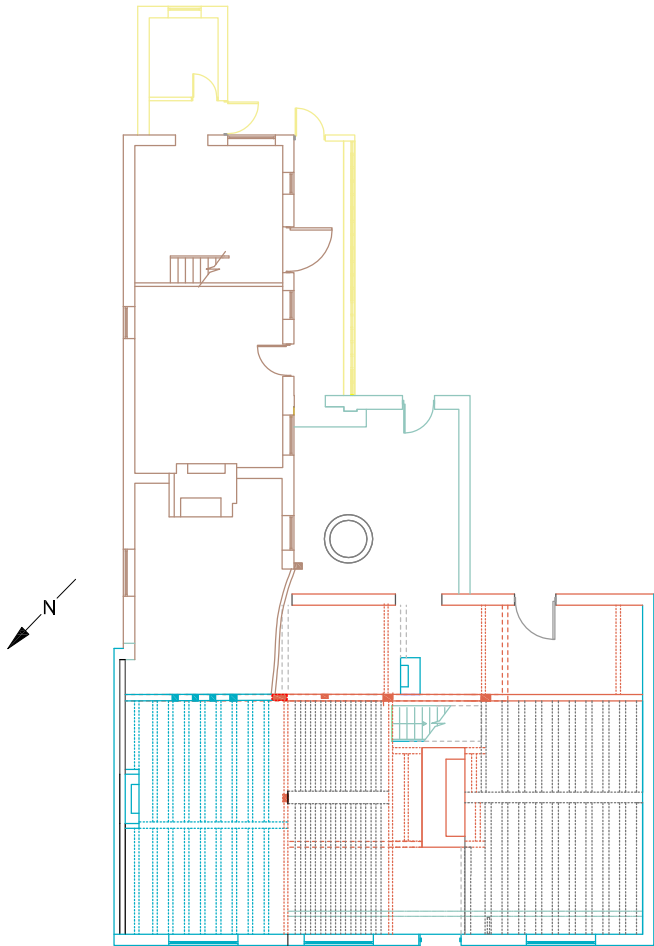
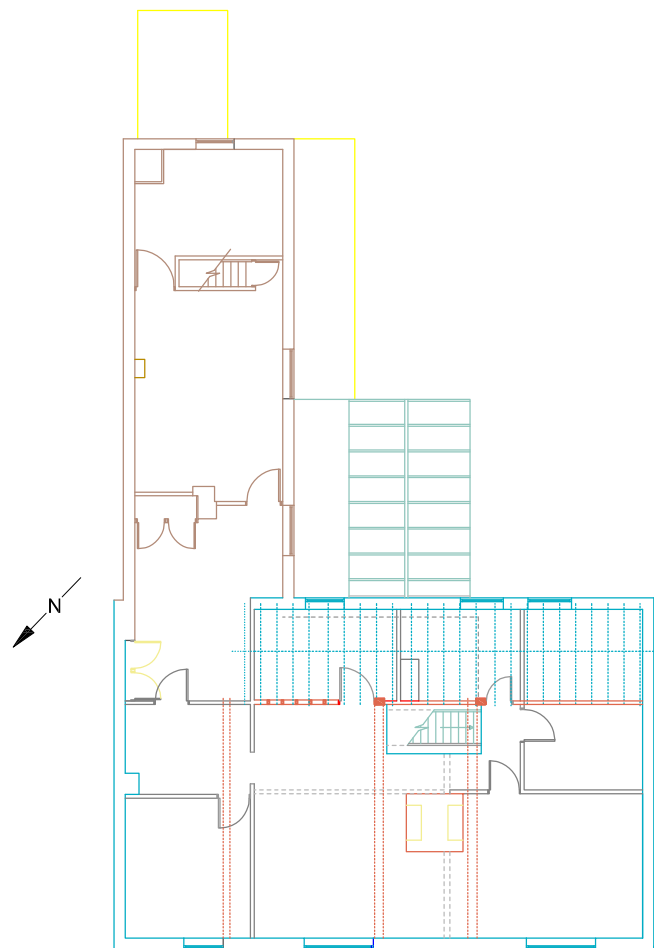
© Archaeology South-East		9 High Street, Lydd, Kent	Fig. 2
Project Ref: 4111	November 2009	Floor plans as existing showing historic detail (plans are based on those supplied by MHSB Associates)	
Report Ref: 2009173	Drawn by: mh

Ground Floor Plan

First Floor Plan

- 5.4 No further wall details relating the first phase of construction were observed, with the exception of the fact that the upper floor was jettied and as such extended beyond the ground floor line (indicated on Fig. 2 where modern timber has been added in the original location) which from the surviving brace mortise, halvings and pressure marks, was situated some 470 mm to the southeast of the current principal elevation facing onto the High Street.

- 5.26 The first floor over the narrow rear range was added at this stage, constructed in timber frame of the same type as that *in situ* at the northeastern end of the ground floor main range. The stud walling is visible in the northeastern rooms on the rear elevation and within the northwestern wall of the first floor room that abuts the perpendicular [Phase 4] rear range (Figs. 2 and 4).

- 5.31 The northeastern room (to the rear of B2, Fig. 2) has floorboards at 230 mm (9") wide that may be original to Phase 2.

- 5.41 A brick chimney stack is situated between the two principal ground floor rooms (Fig. 2), originally with fireplaces on both sides of the stack. The fireplaces have been removed and altered in recent years creating large recesses; the southeastern side is now shelved.

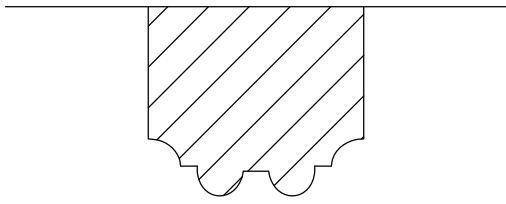
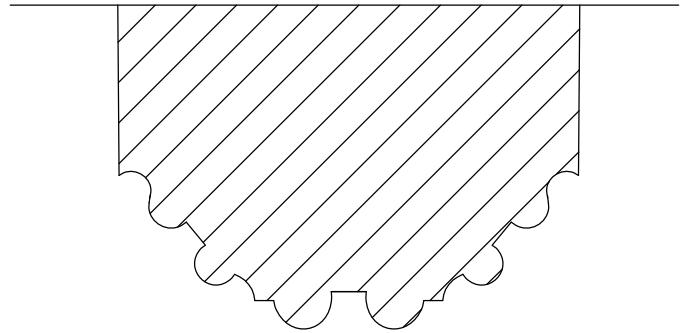
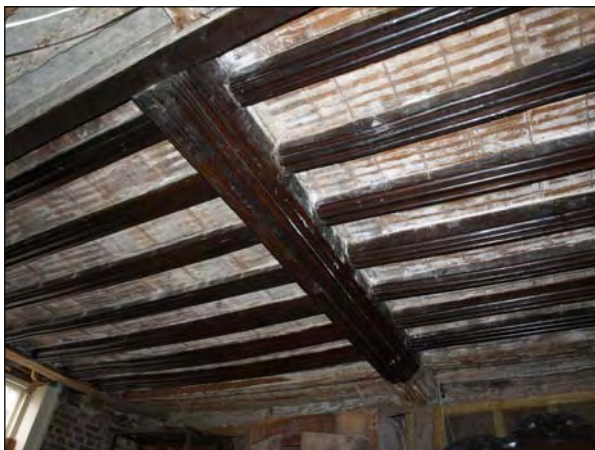
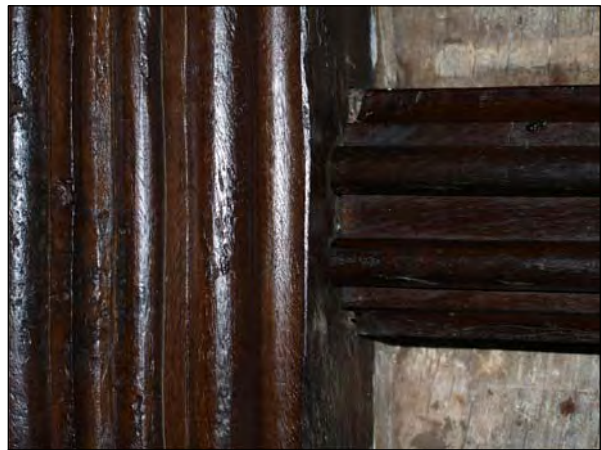
© Archaeology South-East		9 High Street, Lydd, Kent	Fig. 3
Project Ref: 4111	November 2009	Detail of Phase 1 (early 16th C) mouldings in ceiling of central ground floor room	
Report Ref: 2009173	Drawn by: mh

Joist moulding

Girder Beam moulding

General ceiling view

Detail of girder and joist

- 5.7 The ceiling details survive in the central and southwestern rooms of the main range. The ceiling over the central room comprises an ornately moulded girding beam (330 mm wide by 214 mm thick) bearing a series of mouldings including chamfers, both flat and hollow, cyma and roll mouldings culminating in a pair of parallel roll mouldings separated by a 23 mm wide recess (Fig. 3) in the centre of the soffit. The lower orders of the moulding are replicated on the joists (Plate 2) which bear the central recess flanked by the pair of roll mouldings with a hollow chamfer to each side. The joists are 140 mm wide by 125 mm thick and terminate in straight cut stops at the northwestern side of the ceiling to respect the location of the former jetty plate (Plate 2). The girding beam retains its straight cut stop detail at the northeastern side of the ceiling indicating that the present narrow crossbeam has been placed in the location of the original, at the northwestern extent of the central room. The southwestern end of the girder is truncated 780 mm short of the brick chimney stack and as such has been altered by the insertion of the stack in Phase 2 of the buildings development.

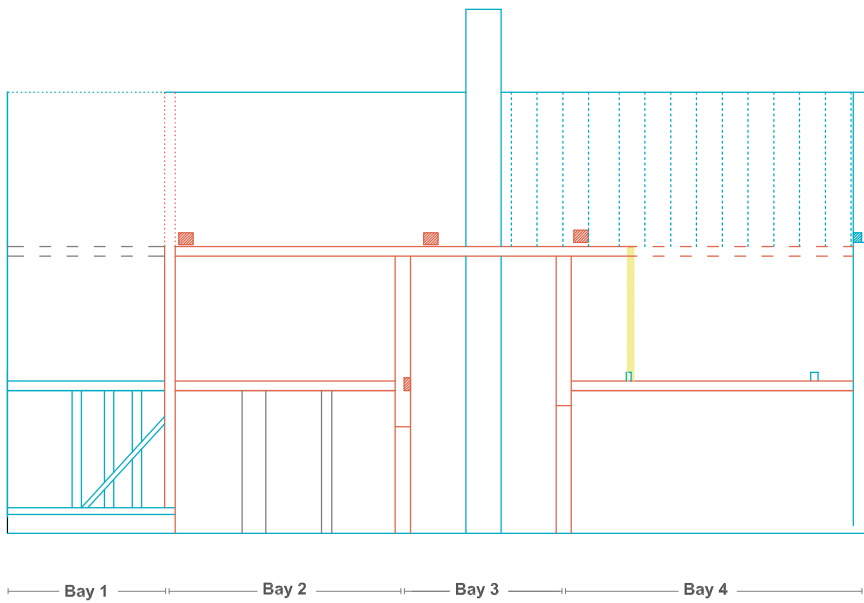
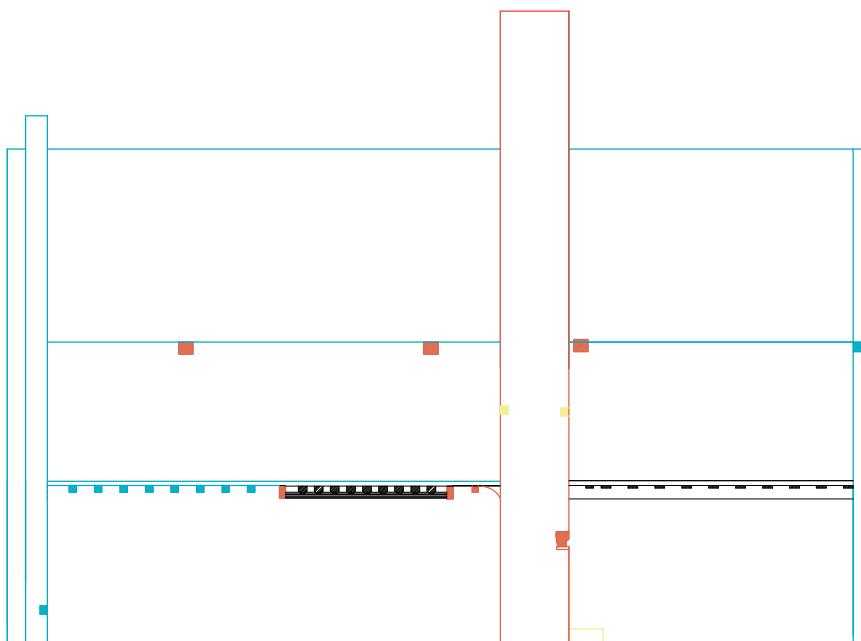
© Archaeology South-East		9 High Street, Lydd, Kent		Fig. 4
Project Ref: 4111	November 2009	Phased long section and timber framed wall between main range and outshot		
Report Ref: 2009173	Drawn by: mh

The 17th century (Phase 2) timber framed wall between main range and outshot

Long Section

- 5.16 The timber framed partition wall between the two parts of the building was added during this phase of development, separating the principal rooms from the smaller ones to the rear within the single storey outshot. The frame at this date is of three bays (Bays 2–4, Fig 4), with two full-height posts extending from the ground floor to the wall plate. The side-girt to the southwest (B4) is re-used with soffit details corresponding to a close-studded wall construction unrelated to the Phase 2 building.

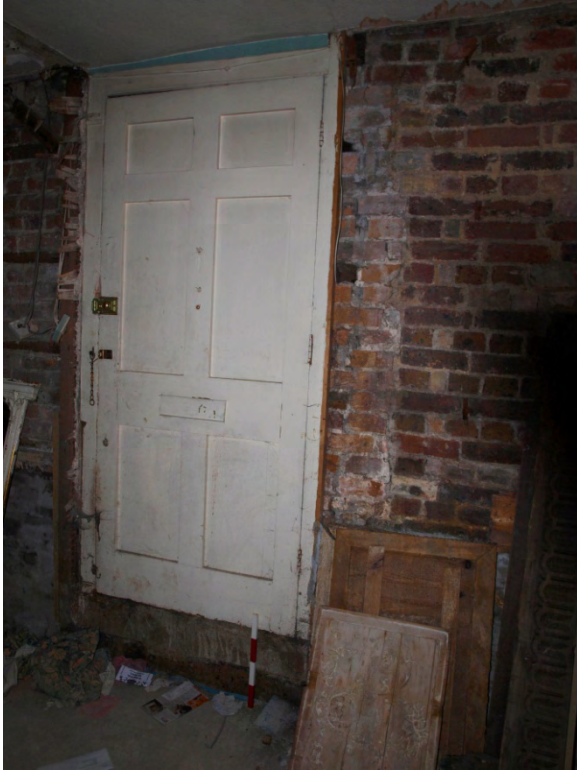
Plate 1: Main range - interior detail of the front door in the principal (northwestern) elevation (400 mm scale)

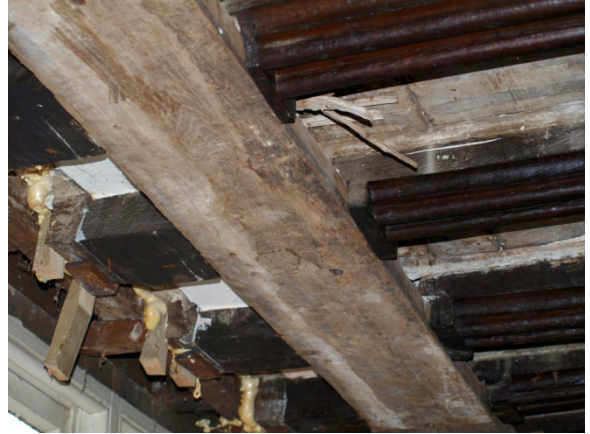
Plate 2: Main range - detail of the moulded joists in the central room ceiling shows straight cut stops at former jetty plate location

- 5.8 The southeastern end of the girder and the first two joists to each side of the beam are unpainted and the second joist bears a series of notches indicating the location of a former partition. The notches interrupt the roll moulding detail and are not original to the ceiling construction. The date at which the partition was added is not known.

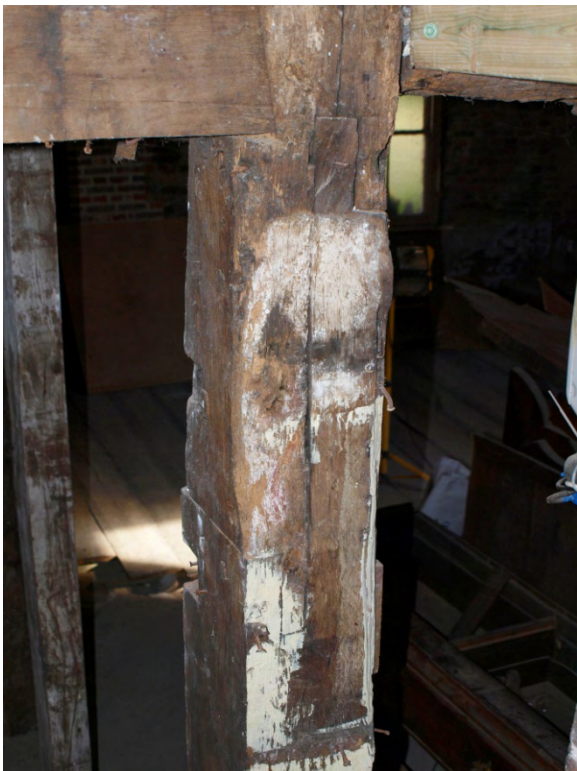
Plate 3: Main range – detail of scarfed post in Phase 2 partition wall

- 5.17 The posts to each side of B3 are also re-used (with much redundant jointing) and each post is of two separate parts jointed together using a

standard bladed scarf (Plate 3). The two outer bays (B2 and B4) have a side-girt mortise and tenoned into the corresponding posts while B3 has the shortest bay length (2.40 m) and has no girt and no evidence of jointing to support one. The result of which is a 'gap' in the three bays of the timber frame partition wall. The wall plate has a short spliced-in section over B3. The discrepancies in the frame may indicate that a specific feature was located here between main and rear range, perhaps a staircase to the upper floors housed within the outshot. It should however be noted that as so much of the building has been altered or obscured by later construction, the lack of framing detail or infill may be due to later developments rather than design.

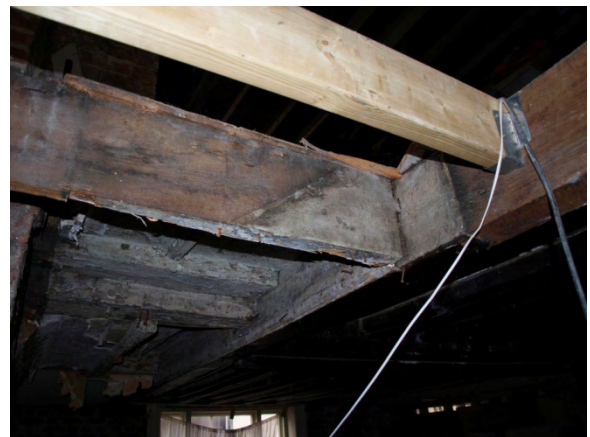
Plate 4: Main range – detail of the pressure mark on the trimmer joist indicating former staircase location and direction

- 5.21 As suggested above, there may have been an earlier staircase relating to this phase of construction housed within the outshot to the rear of the inserted chimney stack. This is suggested by the lack of side-girt and the rebuilt section of wall plate within the wall at B3. However, there is also evidence of an earlier stair string in the form of a pressure mark against the trimmer adjacent to the southeastern side of the chimney stack (Plate 4). This shows that a staircase had existed in the present location but leading up from the southwest room – the specific phase of construction of this staircase is not known. This staircase had been turned at some stage to create the access replicated in the interim staircase clamped in place by the current owner [Phase 6]. It is unlikely that the pressure marks of the earlier staircase related to the first phase of construction in that the trimmer is related the Phase 2 programme of works at the earliest.

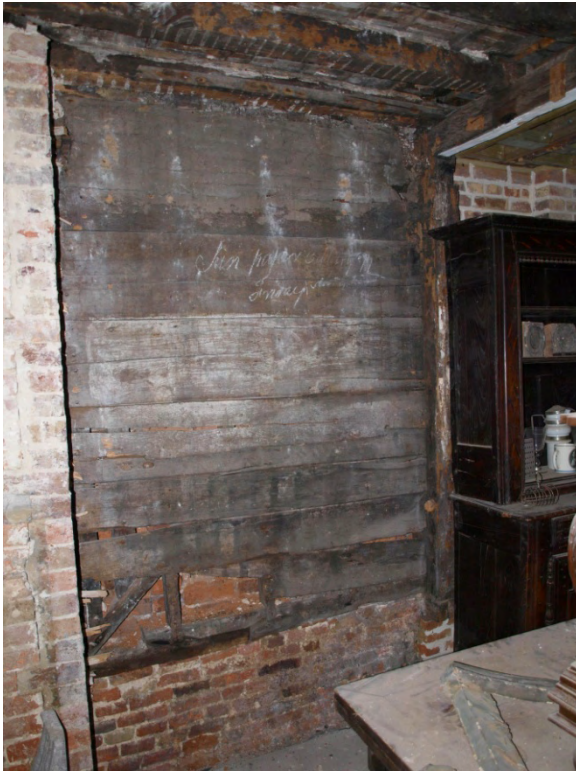
Plate 5: Main range – detail of the boarded northeast end wall, shows studs and straight raking shore jointed to sill beam over earlier brick sleeper wall

- 5.25 A wall with regular studs and straight raking shores jointed into a sill beam was added to the sleeper wall at the northeast end of the building and to the timber partition between main and rear ranges. The studs carried the infill material (lath and plaster – no longer *in situ*) and the studs incorporating re-used material were jointed to plate and sill. Those interrupted by the raking shore were nailed in place. The sill beam of the southeastern wall is supported over a low, rendered sleeper wall. To the southeast of the chimney in the same room are a series of surviving horizontal boards with long edges butted together, nailed to the same type of studwork (Plate 5).
