HARTRIDGE MANOR COTTAGE, CRANBROOK, KENT

HERITAGE STATEMENT

ASE Report No. 2010075

ASE Project No. 4364
Site Code: HMC10
Report No. 2010075

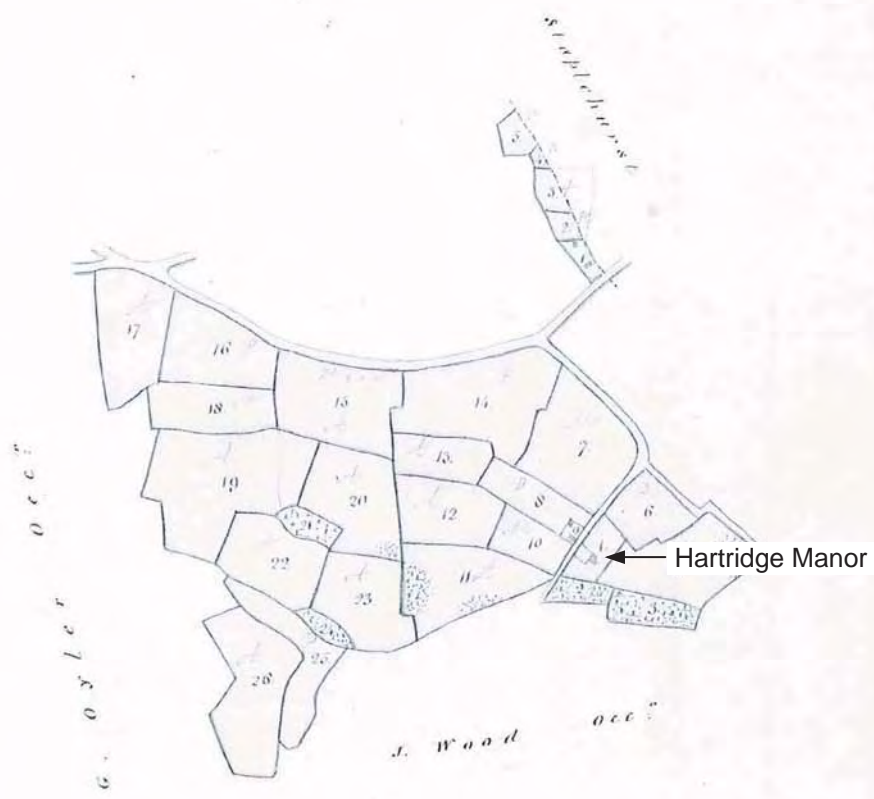
© Archaeology South-East		Hartridge Manor Cottage, Cranbrook, Kent	Fig. 5
Project Ref: 4364	May 2010	Cranbrook Estate Map, c.1810: Hartridge Farm	
Report Ref: 2010075	Drawn by: JC

- 6.1 The earliest referenced source for Hartridge Manor and Hartridge Mill is the Cranbrook Estate Map book of c.1810, which has a list of the acreage of all the lands belonging to an individual farm, and a plan of each property (Figs. 5 and 6). Hartridge Farm and Hartridge Mill Farm are entered separately, numbered 29 and 34 respectively (CKS U78 P31 nos. 29 & 34). Both farms were owned by Sir Horatio Mann, baronet, but the farms were tenanted separately: Hartridge Farm by Mr. Joseph Miller and Hartridge Mill Farm by Joseph Wood. Hartridge Farm had a total acreage of 167 acres 3 rods 19 perches, and Hartridge Mill Farm had an acreage of 92 acres 0 rods 38 perches (for the full schedule see Appendix 2). Both farms included Buildings and Yards: presumably the farmhouses. However, whereas it is clear that the present Hartridge Manor is the 'Building' referred to in Schedule 29, there are a number of buildings on the plot for Hartridge Mill Farm, and it is not clear which served as the farmhouse and which were subsidiary structures. However, it is interesting to note that the structure which from its position pertains to the present Hartridge Manor Cottage is of 'L'-plan on this illustration. This house lies close to the northern boundary of the property.

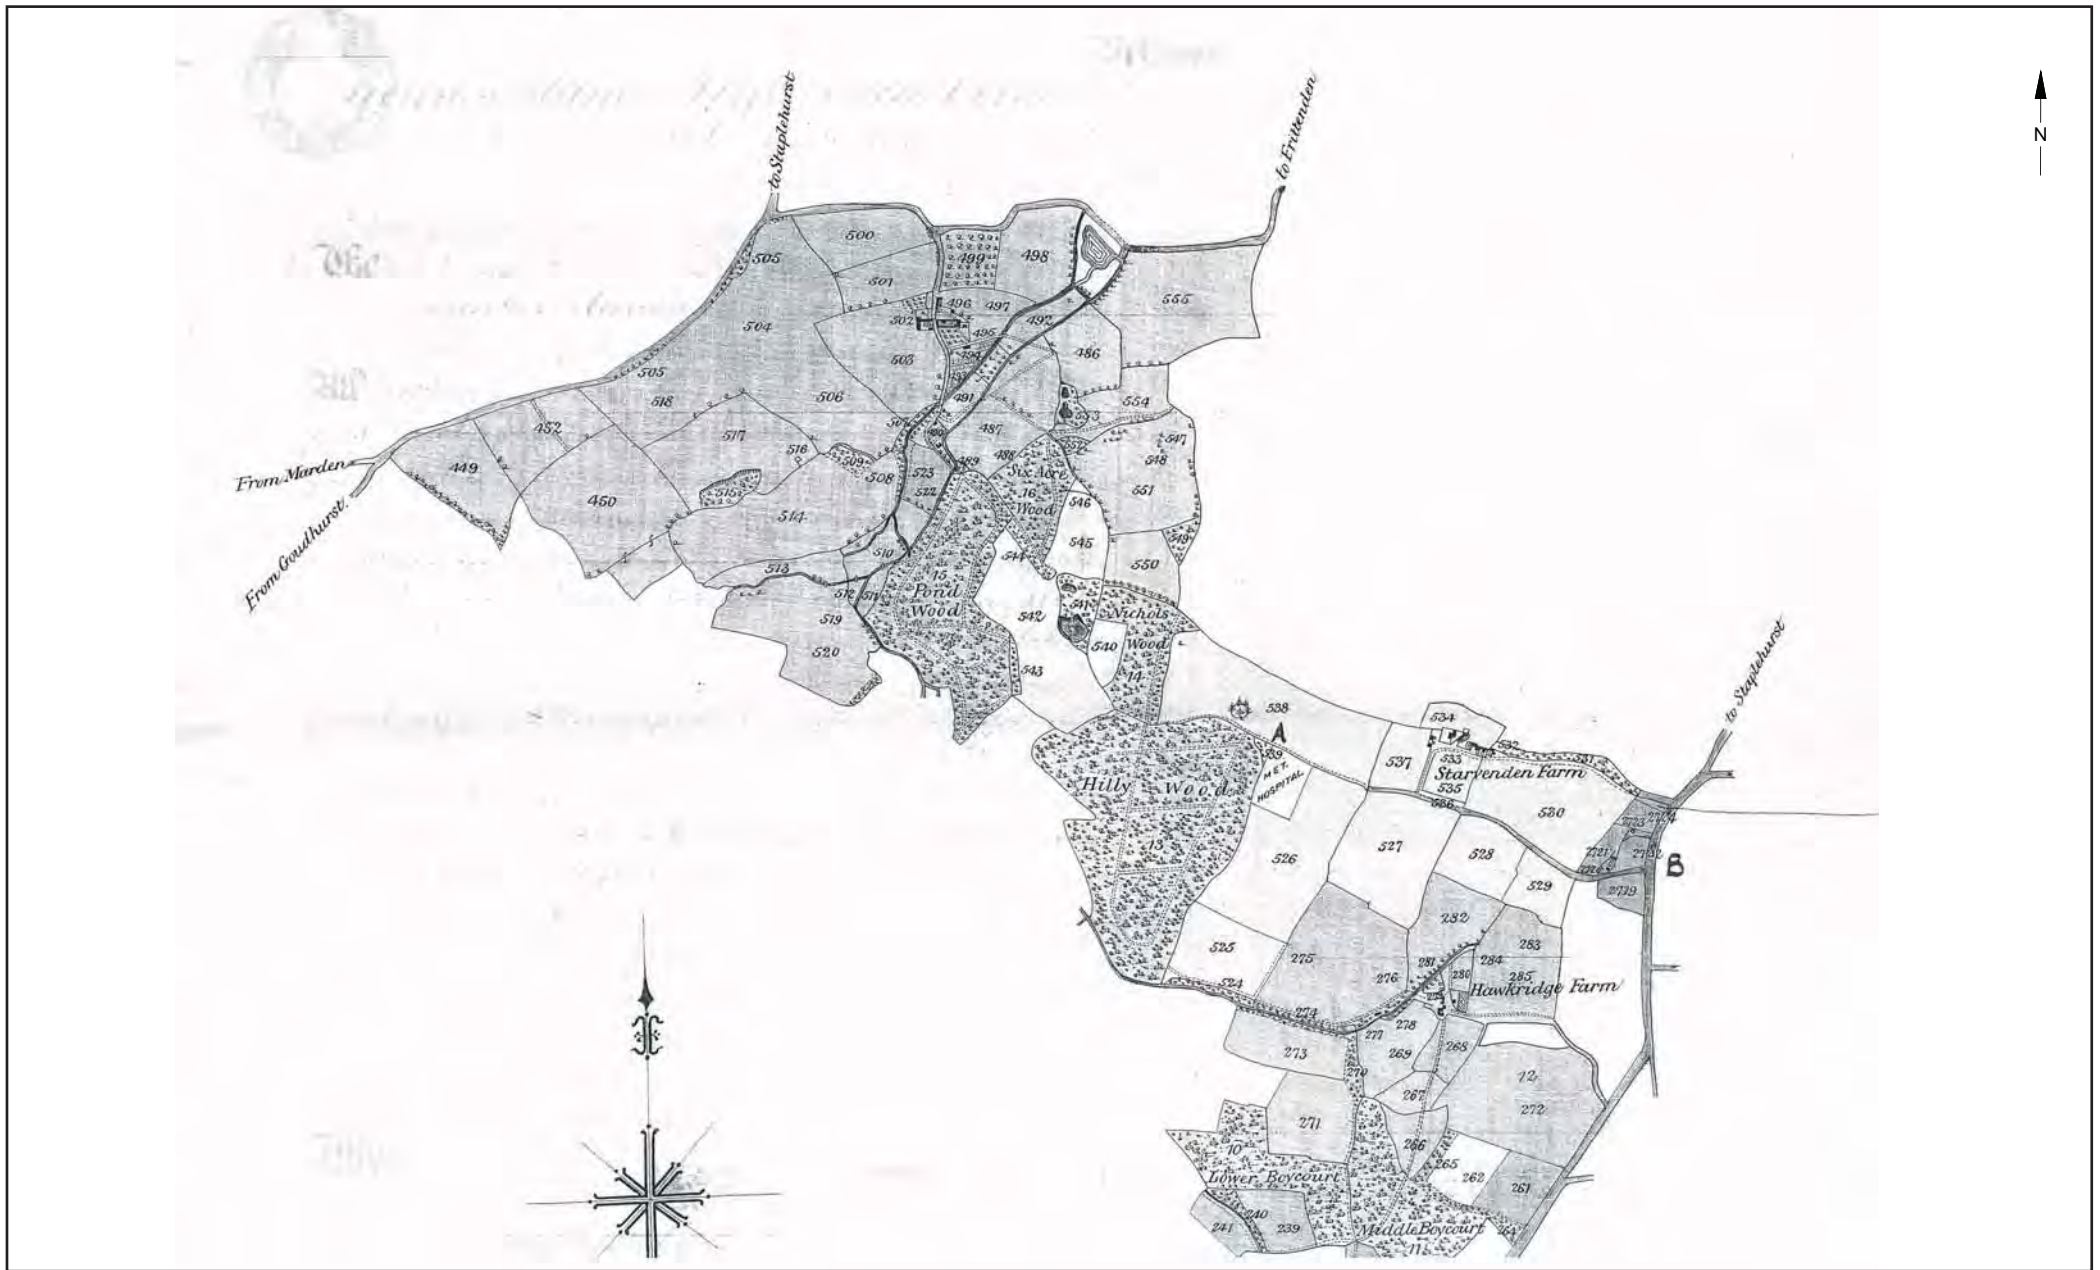
© Archaeology South-East		Hartridge Manor Cottage, Cranbrook, Kent	Fig. 7
Project Ref: 4364	May 2010	Plan of plots included in sale, 1897	
Report Ref: 2010075	Drawn by: JC

- 6.3 In 1897, Fiennes Stanley Wykeham Cornwallis of Linton Park, Maidstone (no longer titled) sold much, if not all, of his Cranbrook property to Charles Hoare of 37 Fleet Street, London (CKS U242/4/4/7). The farms in the portfolio consisted of: Part of Barrack Farm; Hawridge Farm; Part of Folly Hill Farm; Hartridge Farm; Starvenden Farm; Part of Tolehurst Farm and also included were various other properties, including: allotments; an unnamed field; house, mill &c; Old Mill Pond and woods. Figure 7 shows the plots numbered in the schedule. Hartridge Mill Farm is not listed but a house and mill are listed without connected land: this suggests that by this date the mill and the buildings around it had been separated from the farmland, which was likely

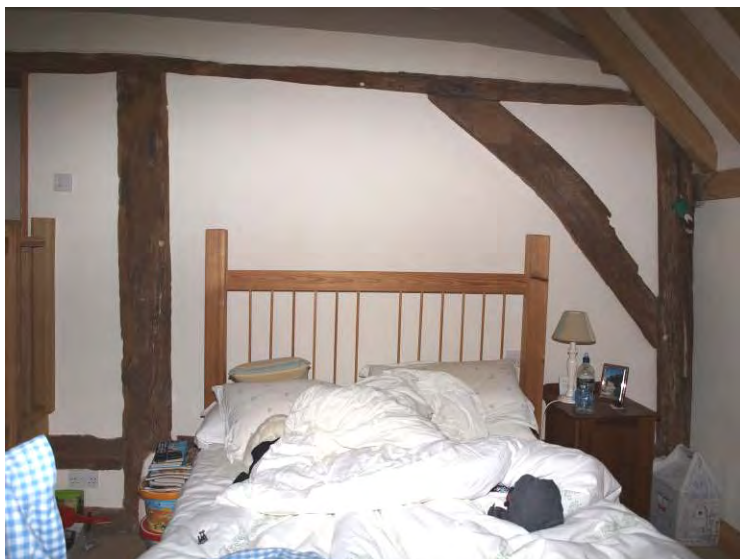
Plate 3

- 7.7 The wall construction of the main range is of large-panel type, incorporating standard bracing (Plate 3), and with the walls divided by vertical studs pegged to the principal timbers. In some cases the studs are notched into the tiebeams: this usually indicates a later insertion, but the studs in question are door jambs, and probably represent a feature which has been fitted after initial erection of the frame, rather than being planned and jointed during the original laying-out of the frame. The original wall panels are of lath and plaster. The

Northern end of rear wall of main range showing headbrace as seen from the rear range

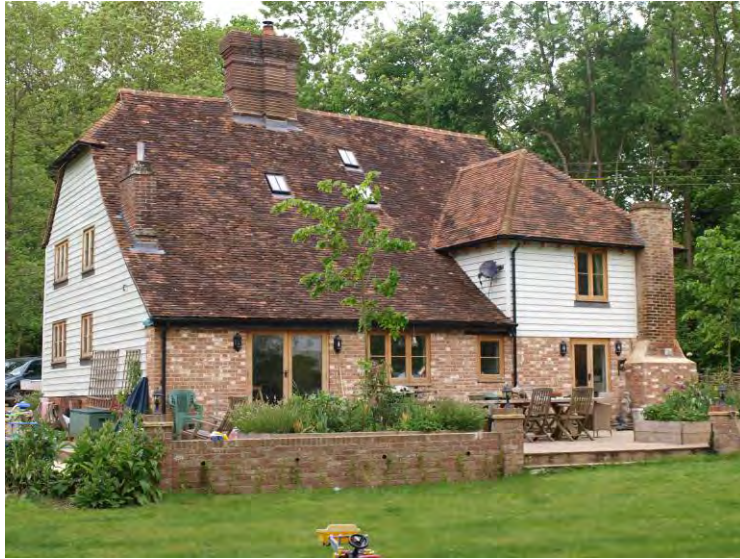
Plate 4

- 7.8 The rear range, as it displays no corner posts, is likely to be of regular-stud construction which was designed to be plastered-over from the outset. However, the walls are currently hidden. The range is clearly subsidiary to the front range as it supported on the frame of the front range. The eastern ground-floor wall has been rebuilt in brickwork at the same time as the walls around the lean-to outshut have been rebuilt. This brickwork dates from the 20th century, and incorporates queen-closers at the jambs of the windows and doors in this walls (Plate 4).

Rear and south elevations
of Hartridge Manor Cottage

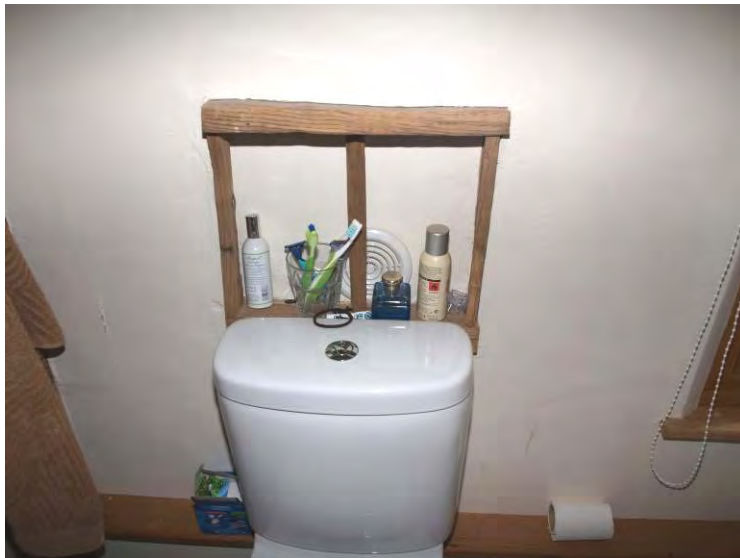
Plate 5

Small window (blocked) in
front wall

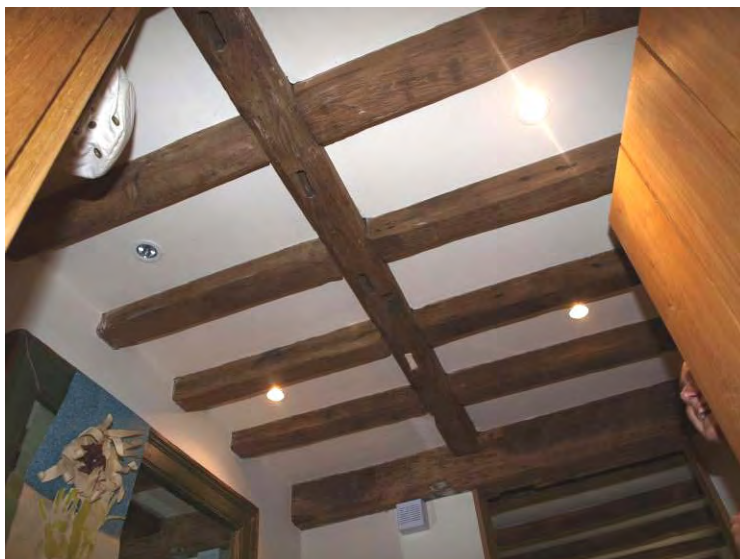
Plate 6

- 7.13 A series of stave holes in a trimmer joist above the lobby suggests that there may once have been a partition dividing the area between the front door and the chimney stack (Plate 6). If this was the case, it is likely that the original stairs to the first floor were positioned in this location, probably rising from the parlour to the hall chamber, as indicated by the first-floor doorway in truss T3 (Plate 7).
- 7.14 As the ground slopes slightly to the east, the floor level within the rear range and lean-to is lower by 560 mm than the floor level in the main range. This has resulted in the insertion of steps leading down from the main range into the rear rooms. This seems to have been a historical feature, as the brick, timber-nosed steps (Plate 8) leading down from the parlour to the lean-to outshut are of some antiquity, likely predating the outshut.

Trimmer joist in lobby
showing mortices for
earlier stair partition

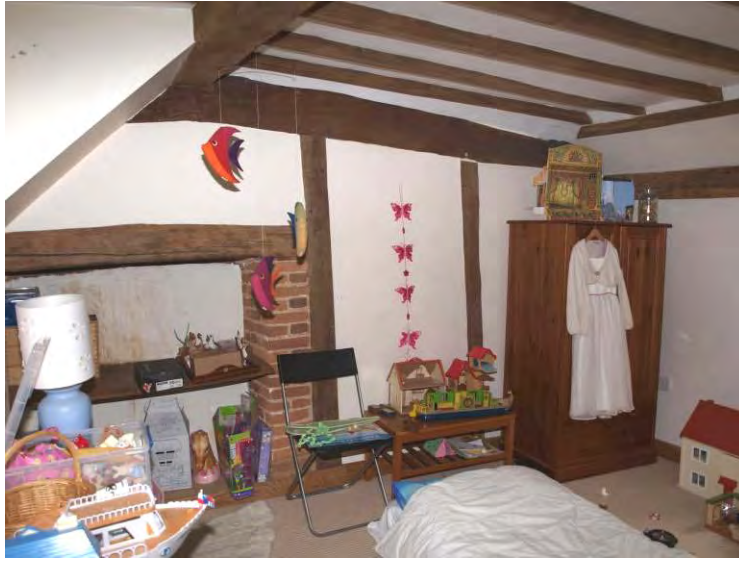
Plate 7

Hall chamber fireplace and possible stair door to the right

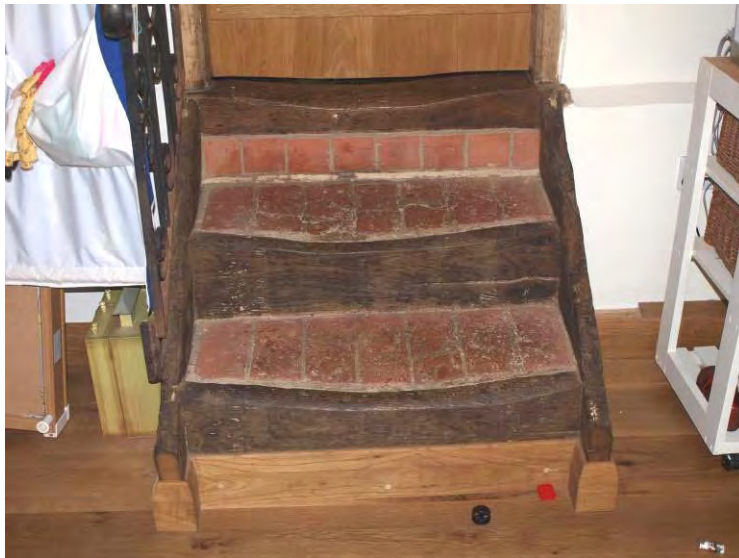
Plate 8

Steps leading from parlour to lean-to outshut

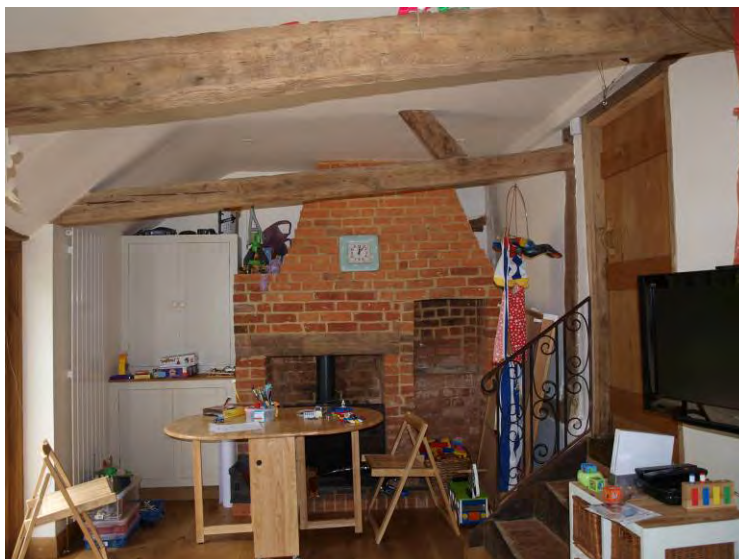
Plate 9

19th-century fireplace and oven in lean-to outshut

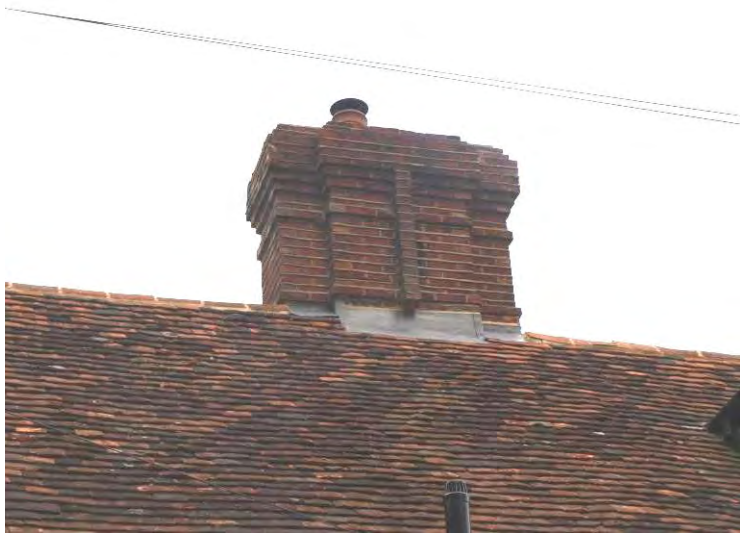
Plate 10

- 7.16 It is clear from the external chimney stack that the west elevation has been considered the principal façade from the outset, as the west face of the stack incorporates a projecting pilaster (Plate 10). This is only formed of plain brick headers, but is nevertheless a decorative feature which is absent from the eastern - rear - face of the stack.

Front of chimney stack
showing plain pilaster

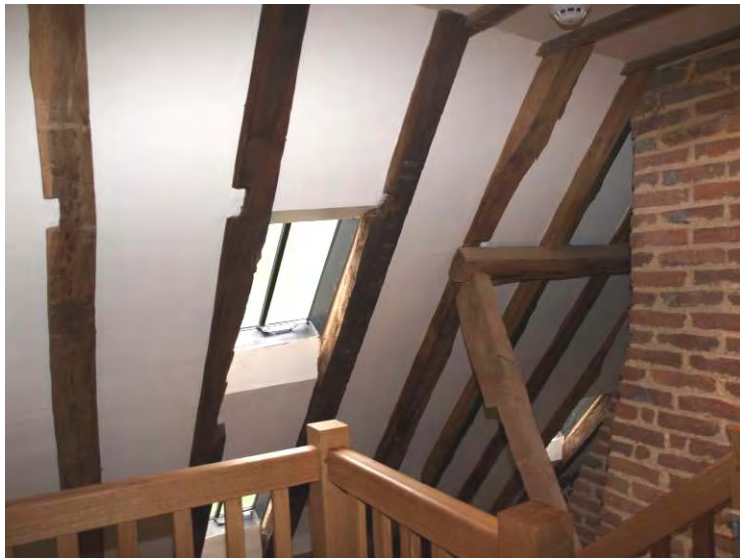
Plate 11

- 7.19 Prior to renovation works, the roof over the rear range was of 'M' profile (Emma Jordan, pers. comm.). Today it is hipped to the east and has a single ridge: it is constructed in hardwood, in a traditional style, using apparently traditional methods. The lean-to outshut is ceiled in flush plasterwork above the level of the tiebeams, hiding the rafters, though the tiebeams and the lower parts of the raking struts which help support the roof are exposed.

Section of original rear roof
showing surviving raking
strut and purlin
