**An Archaeological Evaluation
on Land off Victoria Road
Dartford, Kent**

**NGR 554039 174566
(TQ 54039 74566)**

Project No: 4933

Site Code: DVL11

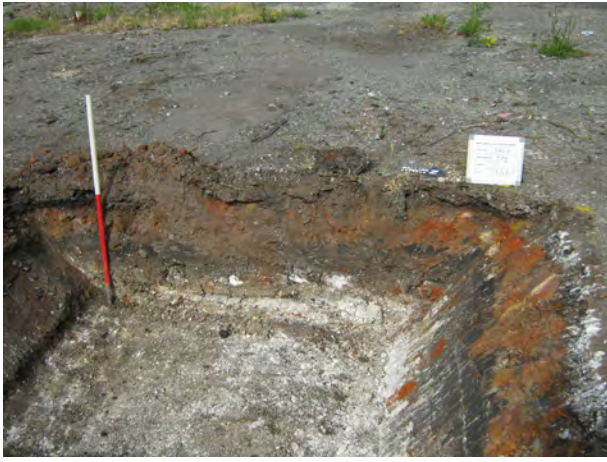
A deposit of chalk [1/003] was encountered at the limit of excavation; the chalk was loosely packed with a redeposited appearance. Overlying the chalk was a 0.22m thick deposit of alluvium [1/002] which was heavily contaminated. The area was topped by a series of modern made ground deposits [1/001] comprising a 0.30m thick brick rubble deposit overlain by a 0.12m thick tarmac deposit. No archaeological finds or features were identified. The water table was observed to seep into the base of the trench at limit of excavation.

Test Pit 1 looking west

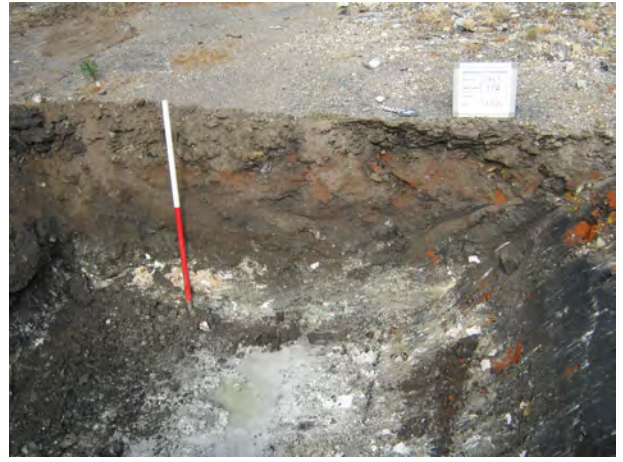
A deposit of chalk [2/003] was encountered at the limit of excavation; the chalk was loosely packed with a redeposited appearance. Overlying the chalk was a 0.32m thick deposit of alluvium [2/002] which was heavily contaminated. The area was topped by a series of modern made ground deposits [2/001] comprising a 0.34m thick brick rubble deposit overlain by a 0.15m thick tarmac deposit. No archaeological finds or features were identified. The water table was observed to seep into the base of the trench at limit of excavation.

Test Pit 2 looking south west

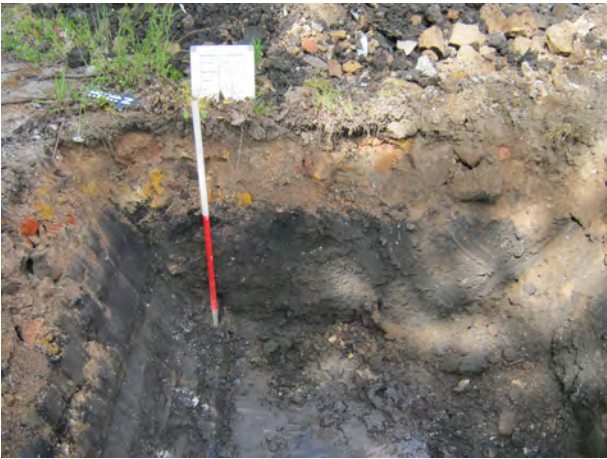
A deposit of very dark, contaminated alluvial silt [3/002] was observed to the limit of excavation this was overlain by a 0.57m thick made ground deposit [3/001] of brick rubble of 0.44m thickness overlain by tarmac of 0.13m thickness. No archaeological finds or features were present, ground water was found to well up at the limit of excavation.

Test Pit 3 looking west

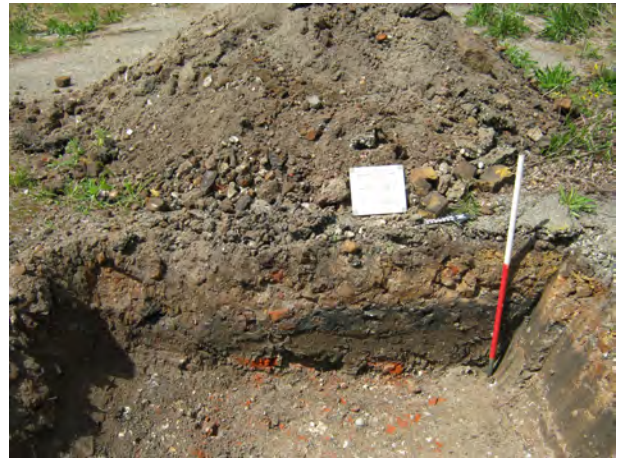
At the limit of excavation a light greyish brown clayey silt [4/003] was encountered. This was overlain by a slightly contaminated mid greyish brown clayey silt [4/002] of 0.33m thickness. The sequence was capped by a deposit of rubble [4/001]. No archaeological finds or features were observed.

Test Pit 4 looking west

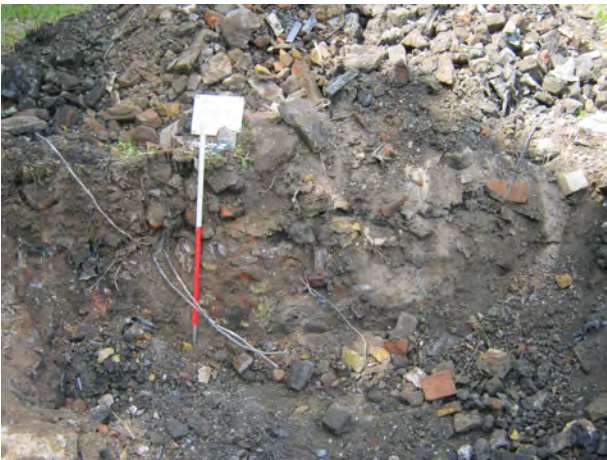
To the limit of excavation was a rubble and demolition deposit [5/001] containing highly compact modern material. No archaeological finds or features were observed.

Test Pit 5 looking west

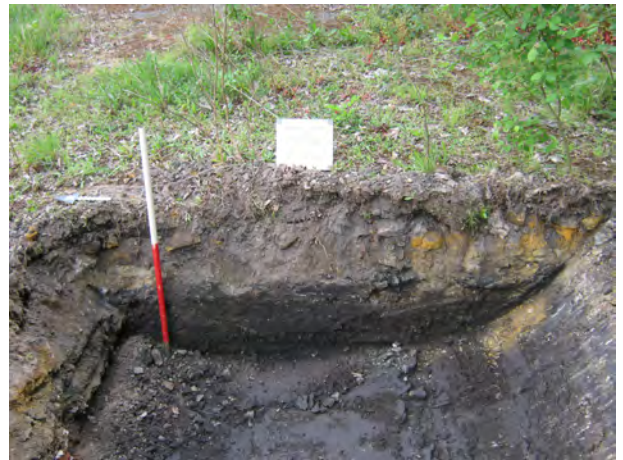
Very dark greyish brown alluvium [6/002] was observed to the limit of excavation; the deposit had chalk flecking and appeared contaminated. The subsoil deposit was overlain by 0.73m of made ground brick and rubble [6/001]. No archaeological finds or features were observed.

Test Pit 6 looking east

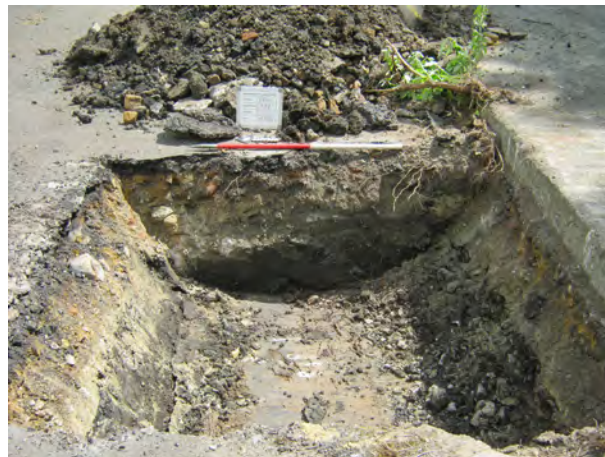
A mid orange-brown silt clay deposit [7/003] was identified to the limit of excavation; this was overlain by a 0.18m thick contaminated subsoil deposit [7/002]. This was in turn overlain by a modern hardcore brick and tarmac made ground surface [7/001] of 0.45m thickness. No archaeological finds or features were identified.

Test Pit 7 looking east

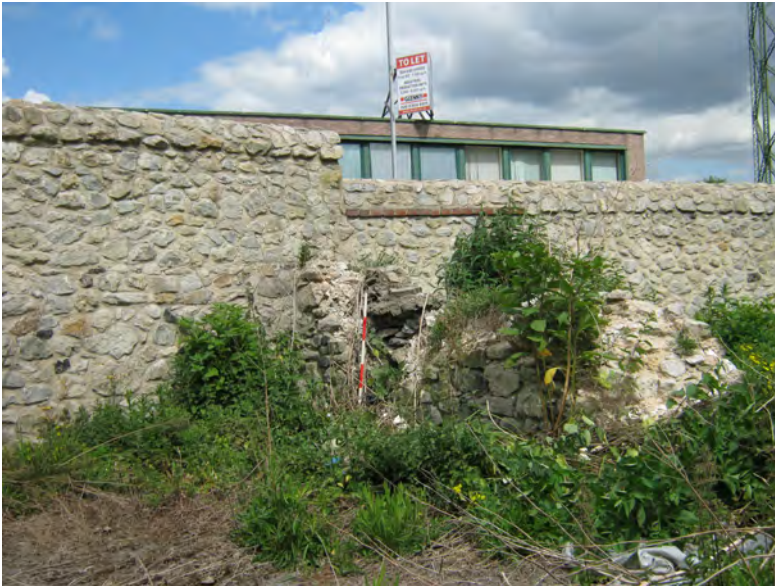
- 4.8.6 A short section of a second wall was recorded abutting the main wall at right angles. This was poorly keyed into the main wall (Fig 4 photo 1). The wall may relate to later divisions of the site and probably forms part of the post-medieval rebuild. The dividing wall is depicted on the 1868 Dartford town plan map stretching across the site to the railway embankment.

Photo 1: Abutting Wall

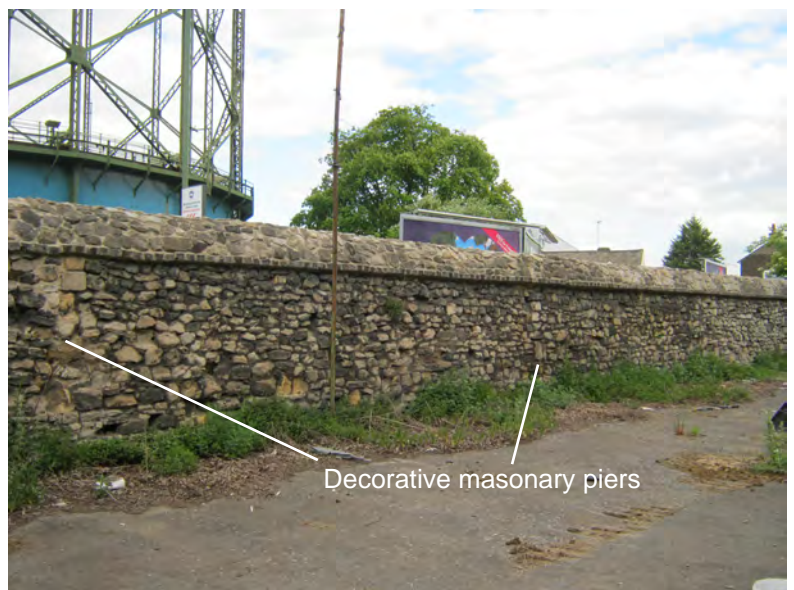
- 4.8.3 A small section, thought to represent original masonry, was observed between two of these piers (Fig. 4; photo 2). However, dating masonry without tool marks or distinctive features is difficult, so determining contemporaneity with the priory is conjectural. The masonry in this section was more regularly laid out than the rest of the wall and was built of similarly sized stone blocks in unmortared regular courses.

Photo 2: Possible original wall below decorative masonry pier (to left of shot)

- 7.2** A survey of the upstanding boundary wall reveals that it is likely to have been substantially rebuilt in the post-medieval and modern periods, in some cases reusing masonry which may have originated from the priory. In some places the original wall may be preserved. If further work involves changes to the wall an historic building record may be advisable.

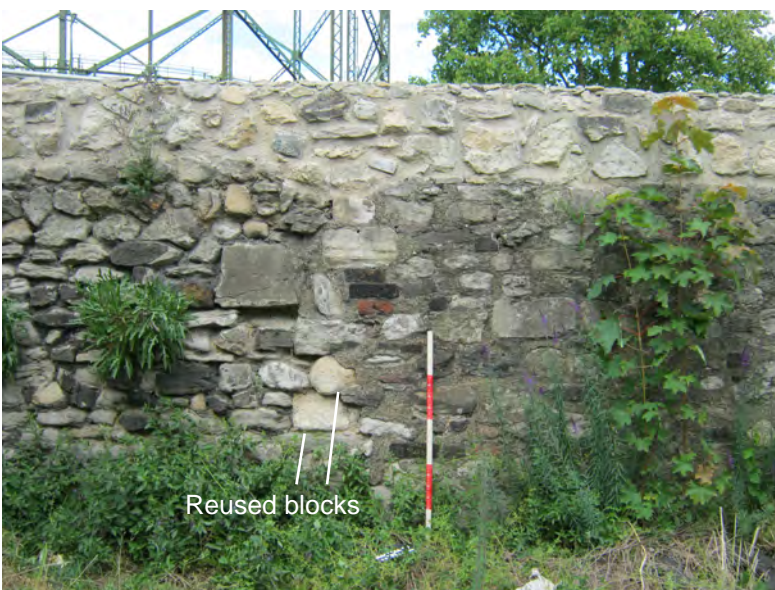
- 4.8.2 Much of the wall has been rebuilt; integrating mortared well-cut square sandstone or limestone blocks which may have originated from the priory. These have been incorporated as piers into the wall at intervals along its length and differ from the bulk of the rest of the wall fabric which is of a grey stone with no discernable coursing structure (Fig.4, photos 2 and 3). The piers occur approximately every 8m. Masonry along the western half of the wall does not contain these piers. 'Hippo' sacks were still present on the site containing sand and masonry of the type used in the wall.

Photo 3: Reused shaped masonry blocks (to left of ranging pole)
