**An Archaeological Interpretative Survey
of
Farm Buildings at Colbrans,
Laughton, East Sussex**

Project Ref. 2945

REPORT NO. 1660

LAUGHTON - FARM BUILDINGS AT COLBRANS

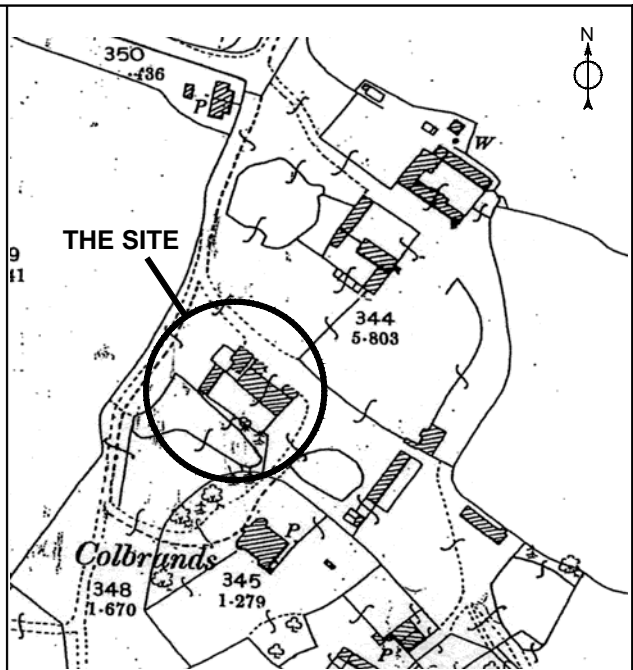
ENLARGED EXTRACT FROM 2nd EDITION 25" O.S. PLAN, 1899
 [Crown Copyright Ordnance Survey 100021184. All rights reserved]

in 1899 and that of 1910 in that the former shows the south wall of the barn set in line with the yard's northern wall, whereas the 1910 plan shows the same kinked alignment as exists within the arrangement today (compare enlarged details in Drawing No. 1660/4 with the outline plan as currently existing and depicted in Drawing No. 1660/2). This cartographic evidence does not prove that the barn was rebuilt between 1899 and 1910 - the difference could be accounted for by the removal of a southern aisle, but such a date fits well with the architectural features contained within the building - walls of cavity construction built in stretcher bond with a slate damp proof course, concrete lintels to the openings, iron ventilation grills, and a cut-and-pitch roof of reused, widely-spaced machine-cut softwood designed to carry a sheet covering. Under normal circumstances the combination of these two sources of data would be sufficient, though some local residents apparently give the date of the barn's reconstruction as the mid 20th century (*pers. comm.* Glenn Moore) and, although such a late date seems less likely on account of the slate dpc and the present condition of the ventilation grills, such a date cannot be ruled out. What is certain is that the present building represents a total 20th-century rebuild on the footprint of its predecessor - the only material reused from the earlier structure are four tiebeams, refixed out of sequence.
