**An Archaeological Interpretative Survey  
of  
1 & 2 Coppard's Bridge,  
Chailey, East Sussex**

**Project Ref. 3208**

## REPORT NO. 1676

### CHAILEY - 1-2 COPPARD'S BRIDGE

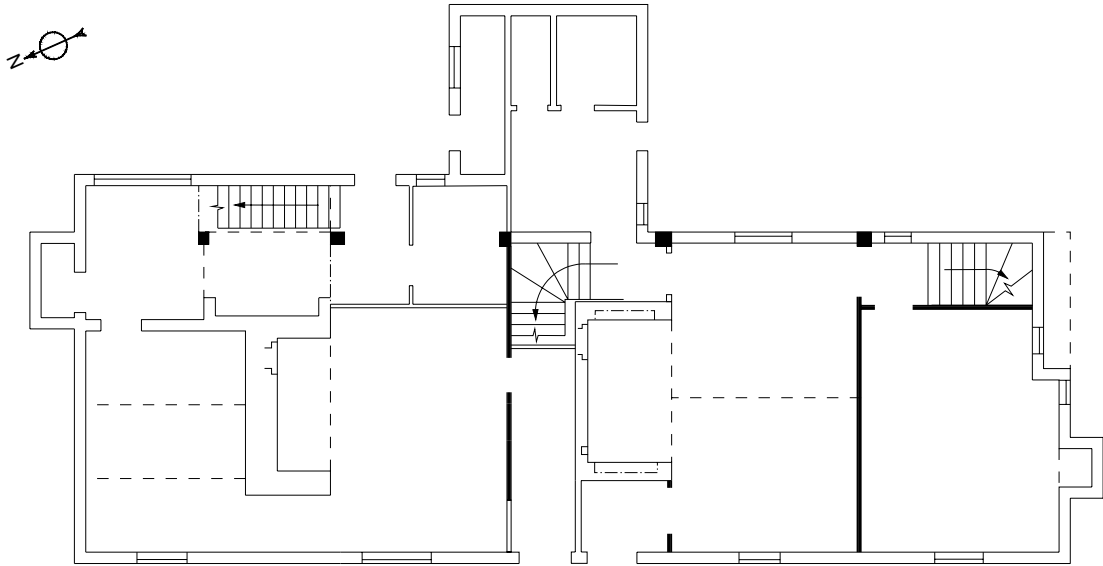
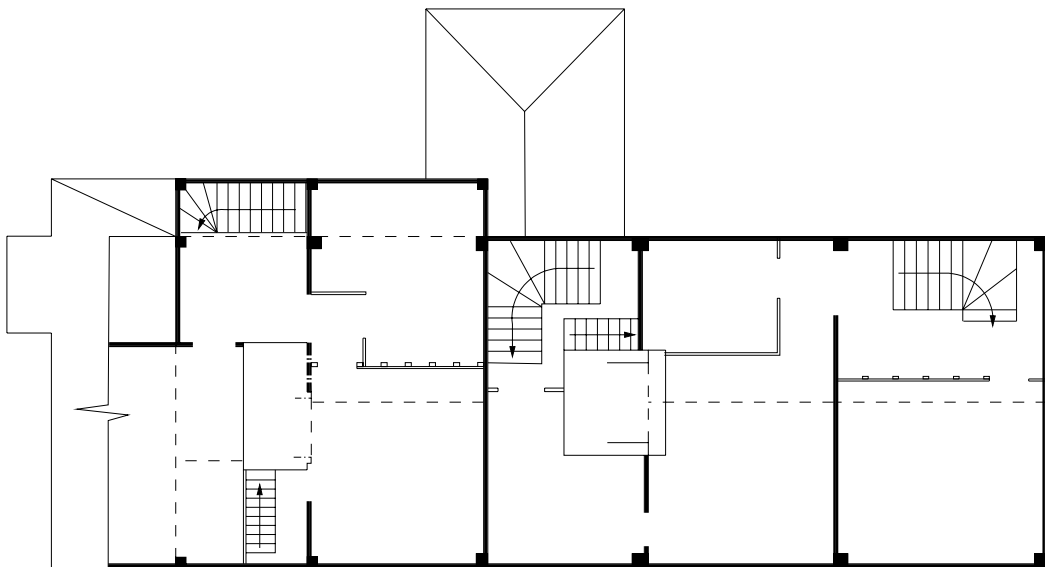
<b>1-2 COPPARD'S BRIDGE, CHAILEY, EAST SUSSEX OUTLINE PLAN SHOWING SEQUENCE OF DEVELOPMENT</b>				Site Ref	<b>P117/03</b>
				Drawing No.	<b>1676/1</b>
Drawn By	J Clubb	Revision No	-	Date of original survey	2008
				Date of this revision	2008

Both cottages have been upgraded during the 20th century. Those alterations made to No. 2 have mostly been cosmetic, but have included the partial/complete reconstruction of some of the partitions inserted during the cottage-phase, and the construction of modern internal brick features. The solid ground floors in this area have been replaced by modern suspended floors. The southern cottage (No. 1) was sympathetically restored late in the 20th century, carefully repairing some of the damaged medieval features. It was at this date that a few of the period-B joists were removed from the eastern part of the hall's low-end bay in order to allow the creation of a new staircase. A small modern rear lean-to outshut was replaced by a single-storeyed extension as part of this work

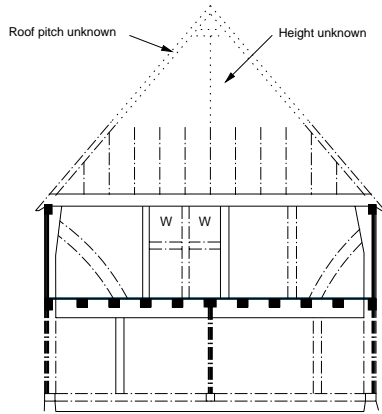
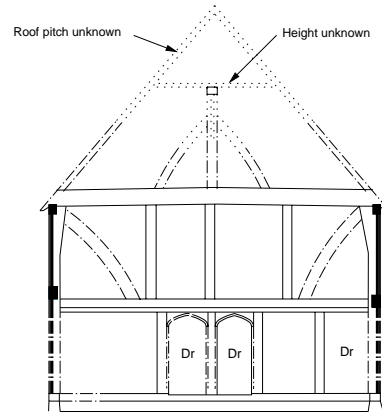
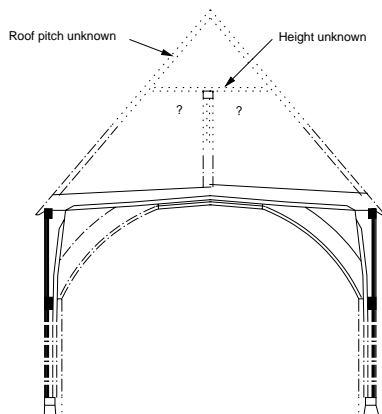
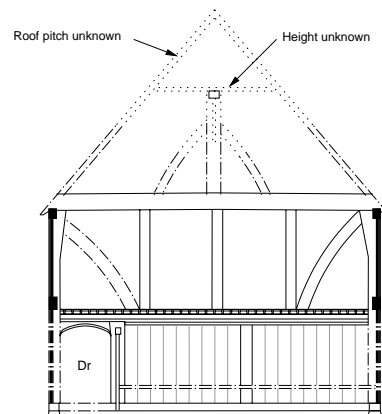
<b>1-2 COPPARD'S BRIDGE, CHAILEY, EAST SUSSEX PERIOD-A RECONSTRUCTION DRAWINGS</b>				Site Ref	<b>P117/03</b>
				Drawing No.	<b>1676/4</b>
Drawn By	<b>J Clubb</b>	Revision No	-	Date of original survey	<b>2008</b>
				Date of this revision	<b>2008</b>

Reconstructions of the wall design are shown in Drawing Nos. 1676/4-5. The walls are framed using large panels of daub, separated one from the other by studs and triangulated to the principal posts at first-floor level using curved footbraces. At least within the rear wall, northern wall, and the two internal trusses, the braces are/were positioned so as to be exposed within the external/primary face. It should be noted that not all the joints which secure the period-A braces and studs to the frame are pegged, and thus in some places the presence of setting-out lines have had to be utilized to identify the locations of hidden/removed timbers. The period-A daub infill was supported by traditional staves fitted at their heads into typical small round-ended mortices or 'stave holes'.

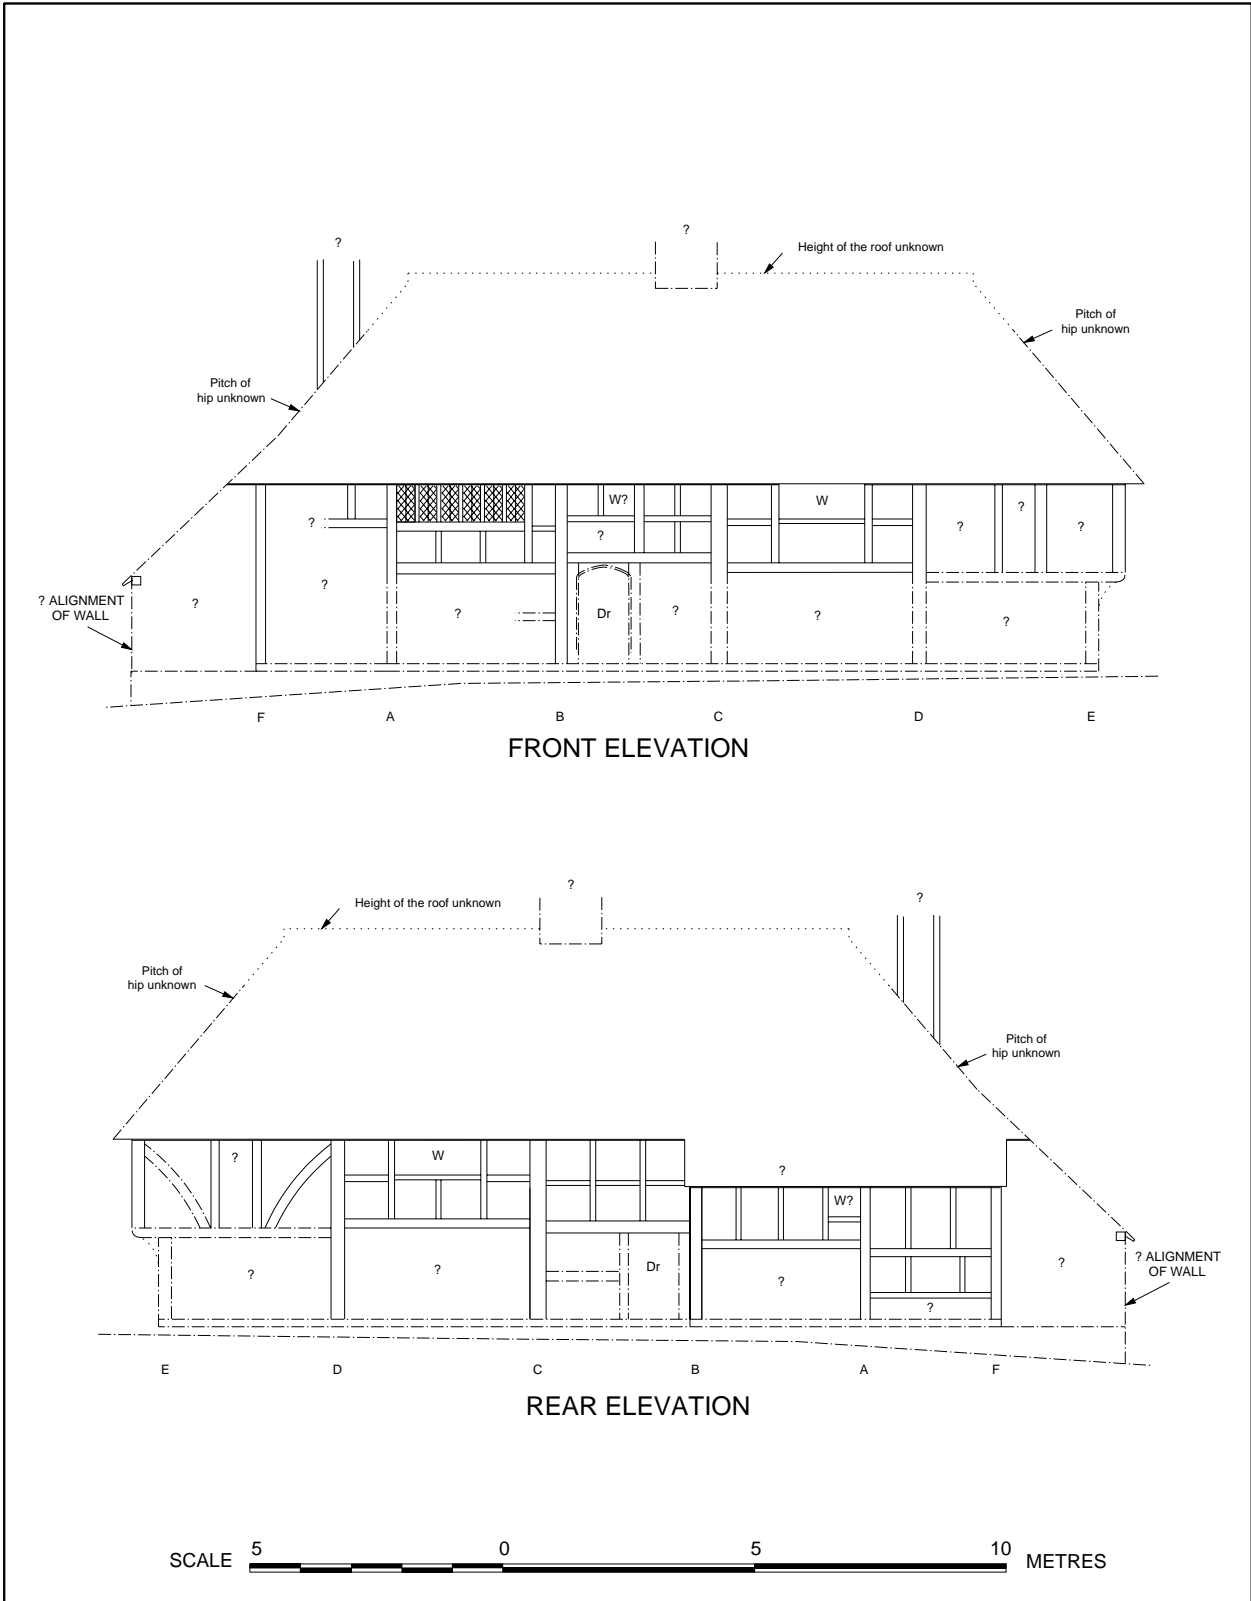
<b>1-2 COPPARD'S BRIDGE, CHAILEY, EAST SUSSEX PERIOD-C RECONSTRUCTION DRAWINGS</b>				Site Ref	<b>P117/03</b>
				Drawing No.	<b>1676/7</b>
Drawn By	J Clubb	Revision No	-	Date of original survey	2008
				Date of this revision	2008

As already mentioned, both medieval stairs were replaced at this date by new staircases in revised locations (see Drawing No.1676/7). Both stairs have been replaced since. In contrast, the staircase leading to the attic area over the hall chamber and parlour chamber still survives. Sited within the hall's low-status low-end chamber, it consists of a straight flight of triangular-section treads supported by a sloping carriage. It is tempting to suggest that the treads have been reused from one of the two removed period-A stairs. A second similar flight survives within the period-C extension beside the kitchen chimney, but this was refixed in this location at a subsequent date. Originally, this too was located within the hall's low-end chamber and gave access to the attic area over the northern end of the house. As a blocked doorway at attic level shows, the stair remained in this location during period D. To judge from three mortices in the southern face of the tiebeam of truss B-B, immediately beneath the blocked attic doorway, the stair evidently incorporated a landing arrangement at its head.
