**A Desk-based Assessment and  
Brief Historical Interpretation  
of  
Outbuildings at Buxted Park,  
Buxted, East Sussex**

**Commissioned by Hand Picked Hotels**

## REPORT NO. 1243 (Revised)

### BUXTED - OUTBUILDINGS at BUXTED PARK

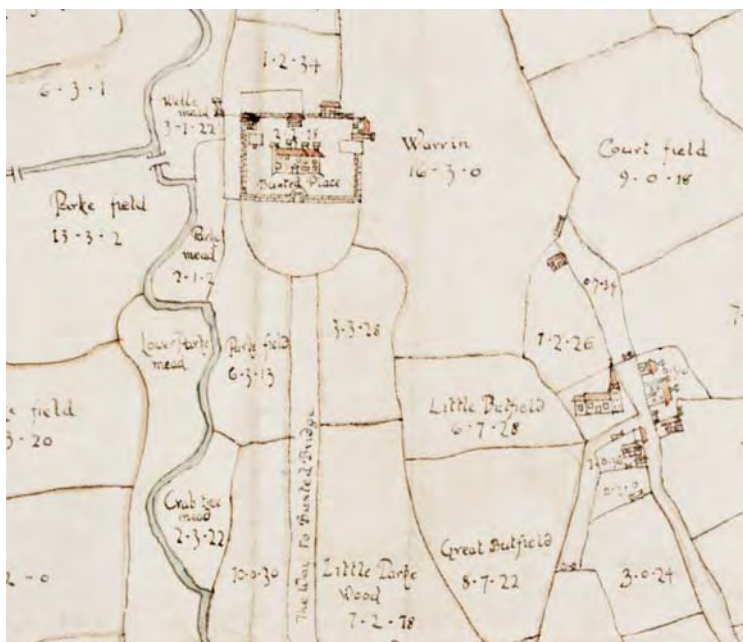
*Plate 2*

*Extract from a map of Buxted Place estate dated 1654 [ESRO AMS 6362]. South is to the top, with the old mansion towards top left and Buxted church and village towards bottom right.*

approached by a straight drive (Plate 2). If this theory is correct, a possible location for the medieval house is Court Field, shown top right in Plate 2. However, the proximity of the house to the field-names *Park Field*, *Park Mead* and *Warren* suggest the alternative explanation that the house shown in 1654 was the successor to a hunting lodge. The almost uncomfortable proximity of the house to a stream suggests that it might originally have been moated: an improbable feature for a house of the second half of the sixteenth century.

in 1654 and rebuilt it upon a new site to the north west, upon the 16¾ acre field called 'Warrin' in Plate 2. It is this house which survives today, though it was badly damaged by fire in 1940 and was reduced from three storeys to two during the restorations which followed, 1940-1947.

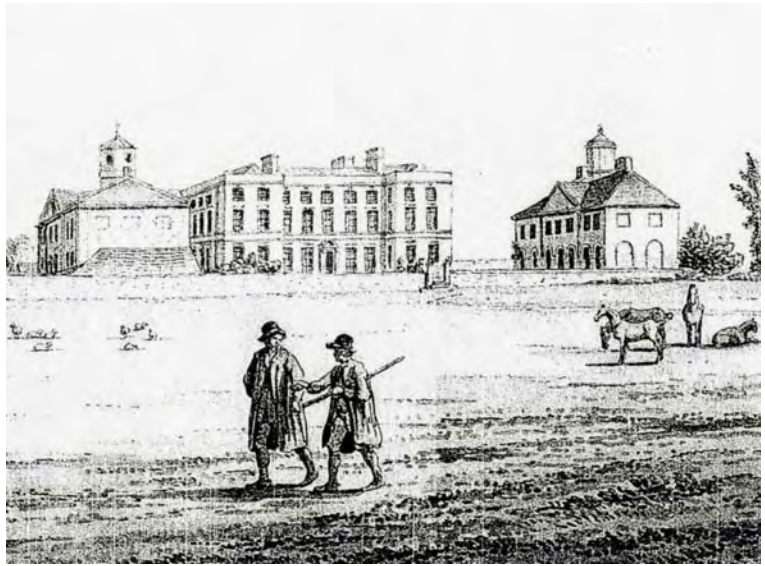
Plate 4

*Buxted Park from the south west in 1785 showing the coach house and stables (present Harcourt Building) left, house central, and the now demolished service outbuilding right.*

As shown in drawing 1243/10, which is based upon structural observation and the 1798 plan: all areas of uncertainty are shown question-marked. The south elevation is shown by Grimm in 1785 - at which date the lower part was hidden by an addition - see Plate 4. By the time the 1798 drawings were made this addition would appear to have been removed, although it is shown on the plan in the same book and made at apparently the same date! The 1798 drawings show the south elevation in detail (Plate 7) whereas the lower part of the north elevation is obscured by vegetation (Plate 6). In all visible respects the two elevations were identical, and the drawings show nothing to contradict this. Both elevations were of three bays. Rebates in the brickwork at either end of the facades gave the impression that the main part is brought forward in imitation of the east and west elevations, but this is achieved by thinning the wall thickness at the quoins and is not reflected internally. In essence the design is a repeat of the central three bays of the west facade, except that in these two elevations there are no ground floor openings whilst the clerestory openings beneath the arches of the arcade and the first floor windows were (at least on the south) all blind, having been included merely for architectural integrity. There are some unresolved problems regarding interpretation of the clerestory within the north elevation, for which see 'Present Form' below). A patch in the brickwork of the eastern pier within the north elevation marks the alignment of the tall garden wall which connected this building to the mansion.

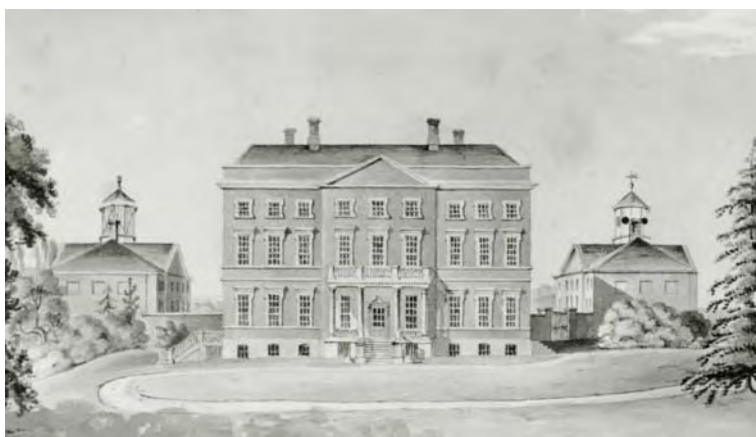
*Plate 6*

*Buxted Park from the north east in 1798 showing the coach house and stables (present Harcourt Building) right, house central, and the now demolished service outbuilding left.*

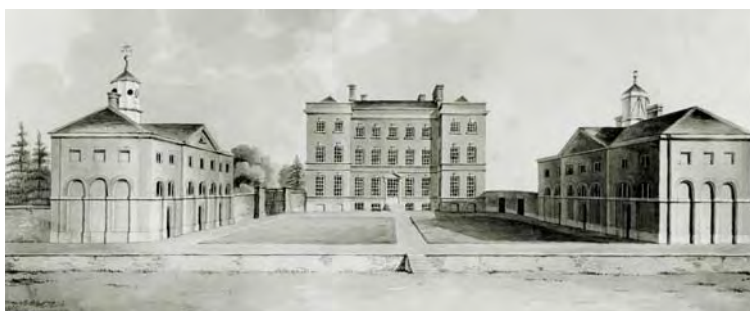
*Plate 7*

*Buxted Park from the south west in 1798 showing the coach house and stables (present Harcourt Building) left, house central, and the now demolished service outbuilding right.*

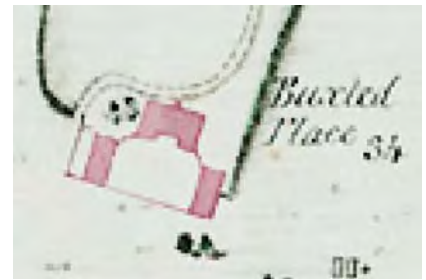
Plate 8  
 Detail from Figg plan of c.1785  
 [ESRO ACC 5179/9]

The precise date of the alterations is more difficult to ascertain. Figg's 1812 plan shows the south-eastern of the two outbuildings (the detached service block) demolished in order to open up views of the park (compare Plates 8 and 9). To compensate for this loss a new service wing was added against the north-west elevation of the house and a new stable yard built against the north-western side of the retained mid 18th-century coach house and stable block (The Harcourt Building). By this date an orangery had been built parallel to the Harcourt Building, a little to its south-east.

constructed when Grimm made his drawing in 1785 (Plate 4). Two other small outhouses appear to have been constructed between c.1785 (Plate 8) and 1798 (Plate 3): these comprised a second coach house (designed to accommodate three carriages) intruded into the northern corner of the yard, linked to the stable block by a much narrower structure - probably a lean-to. All these additions had been demolished by 1812 (Plate 9).

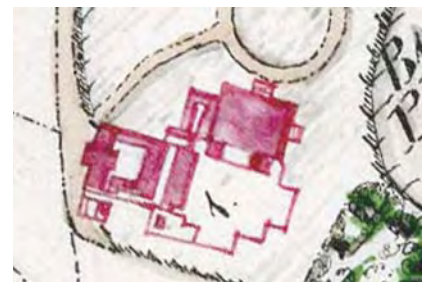
Plate 9  
 Detail from Figg plan of 1812  
 [ESRO BMW C8/2]

At the south-western end is an attached single-storeyed structure (now the laundry) which is likewise constructed in Flemish-bonded brickwork and is set back slightly from the face of the main building. This too has a shallow-pitched roof with hipped terminal. If not original to the build, this part had already been added by 1812 and is shown clearly in the 1840 tithe map (Plates 9 and 10).

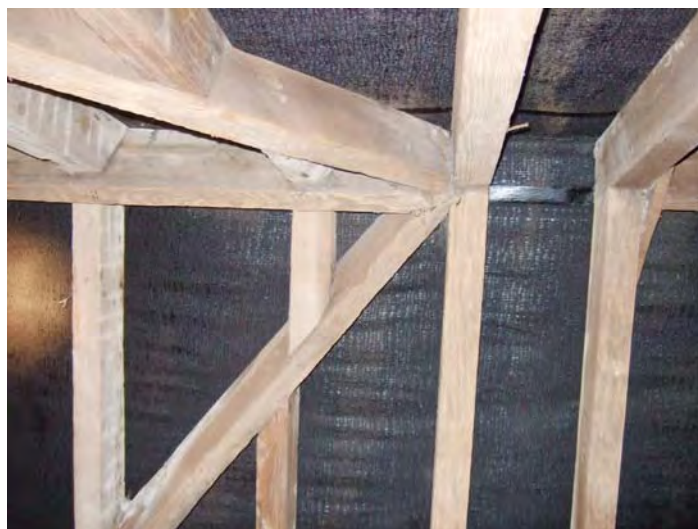
*(Right) Plate 12  
Remains of hip incorporated part way  
along present roof*

With the likely exception of the partition which coincides with the original end wall of the building, all partitions appear to be modern and are of solid construction. The ceiling joists are visible from within the roof void and are of modern softwood, the early part of the structure having originally been open to the roof. The roof to this section is of simple paired rafter, cut-and-pitched construction and retains its original hipped western terminal, now internalized part way along the structure (Plate 12). This original part is divided into four bays by softwood tiebeams, above which the ridge board is interrupted and is carried on cleats. The chimney, which is of two phases, rises within the second bay from the west. The roof over the extension is also of cut-and-pitched type, in this instance with low-set nailed-on collars to each rafter couple. In this instance the ridge board is continuous.

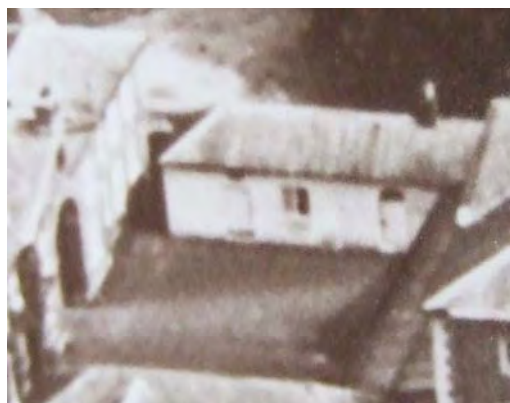
*Plate 13*  
*Enlargement from aerial photograph*  
*taken pre 1940 showing 'The Bungalow'*

Photographs taken early in the 20th century emphasize the amount of alteration which has been made to the building: very little of its front wall now survives (*compare* Plates 13 and 14). Excepting this, the other walls remain (though altered by the

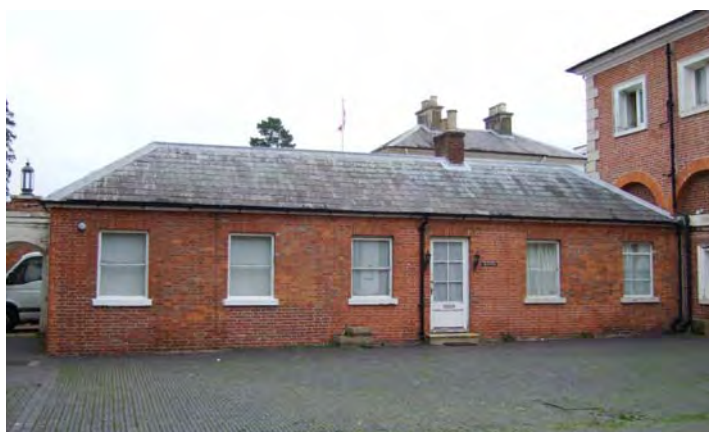
*Plate 14*  
*The same wall as shown in Plate 13*  
*showing the appearance as in 2007*

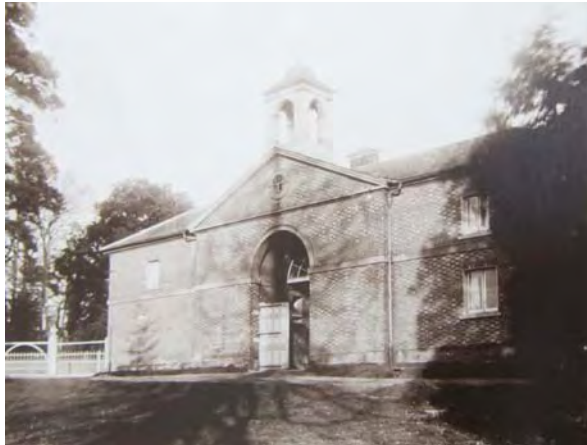
*Plate 15*  
*Main elevation of Briar and Dawn Cottages*  
*in the second quarter of the 20th century*

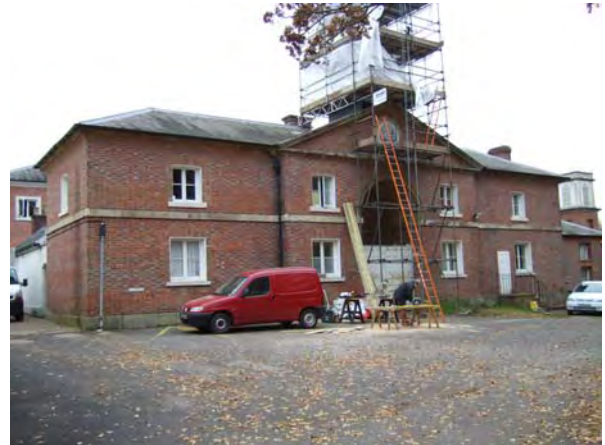
*Plate 16*  
*Main elevation of Briar and Dawn Cottages*  
*in 2007 showing additional windows*

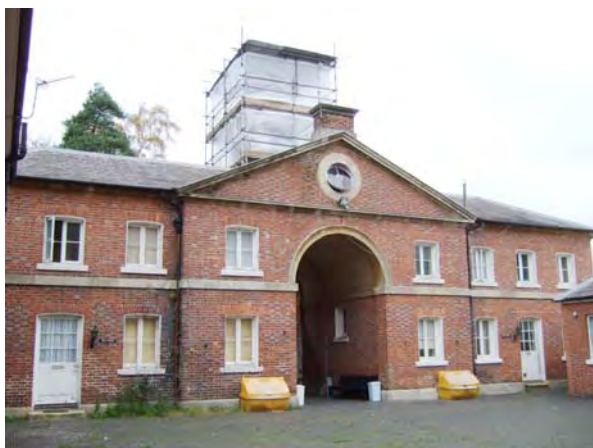
*Plate 17*  
*Courtyard elevation of Briar and Dawn Cottages*  
*in 2007*

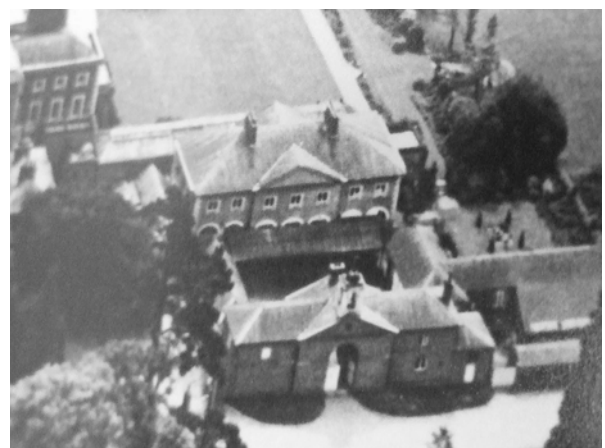
*Plate 18*  
*Courtyard complex from the west*  
*in the second quarter of the 20th century*

This is the least complete of the buildings, having been largely rebuilt and raised from one to two storeys during the second half of the 20th century. It is shown in its single-storeyed form in plate 18. A little 19th-century brickwork survives within the rear wall, but essentially all else was rebuilt during the modifications. All new brickwork is in stretcher bond and is probably of cavity type.
