**An Archaeological Interpretative Survey of
Bull River Farm House, Chiddingly, East Sussex**

**Project Ref. 3251
Report No: 2008233**

CHIDDINGLY - BULL RIVER FARM HOUSE

OVERVIEW OF THE HOUSE [Drawing Nos. 1678/1-2]

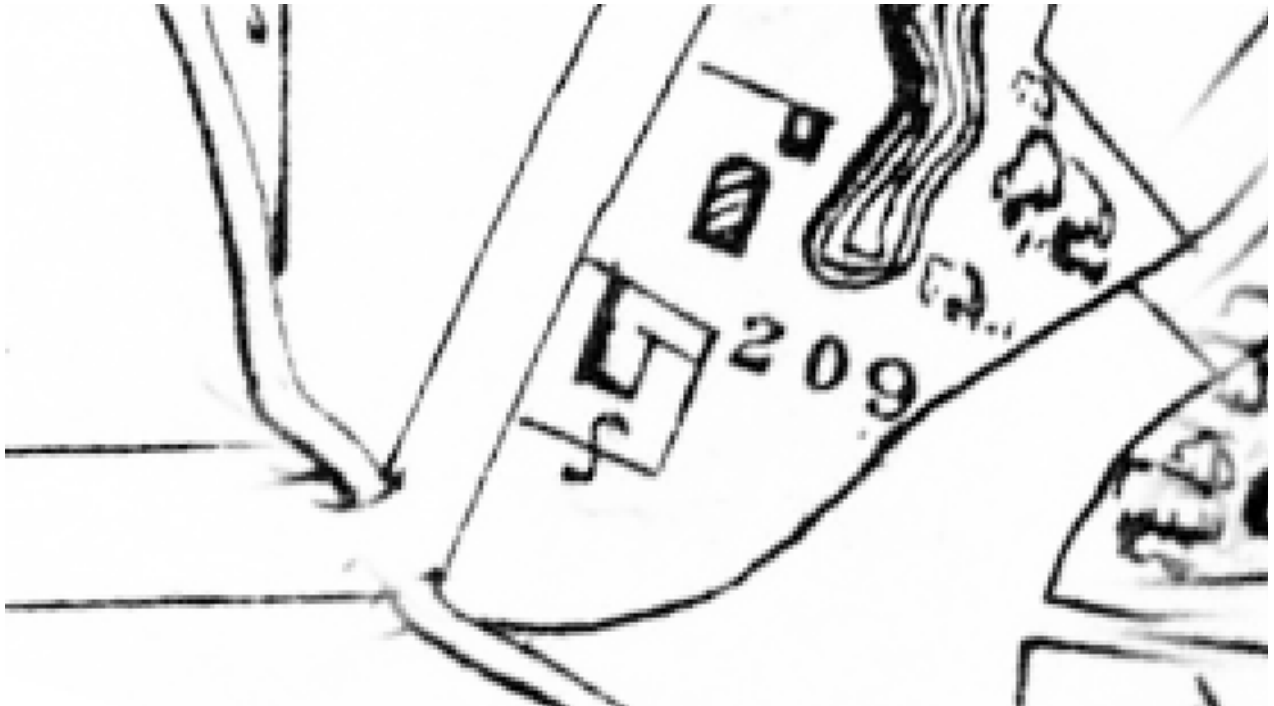
Plate 1
Enlarged extract from 1839 Chiddingly Tithe Map
[East Sussex Record Office TDE 105]

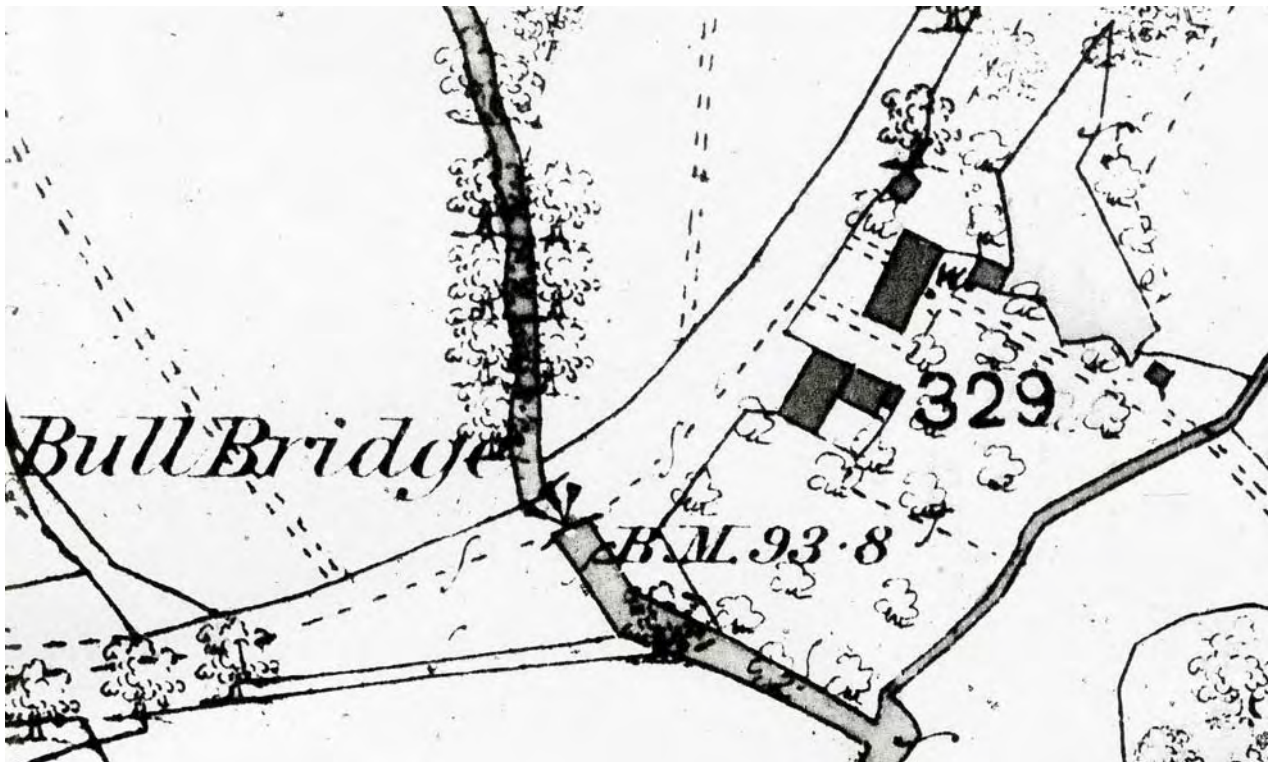
Plate 2
Enlarged extract from 1st Edition 1:2500 O.S. plan, surveyed 1875
[Ordnance Survey Sussex Sheet 55.04]

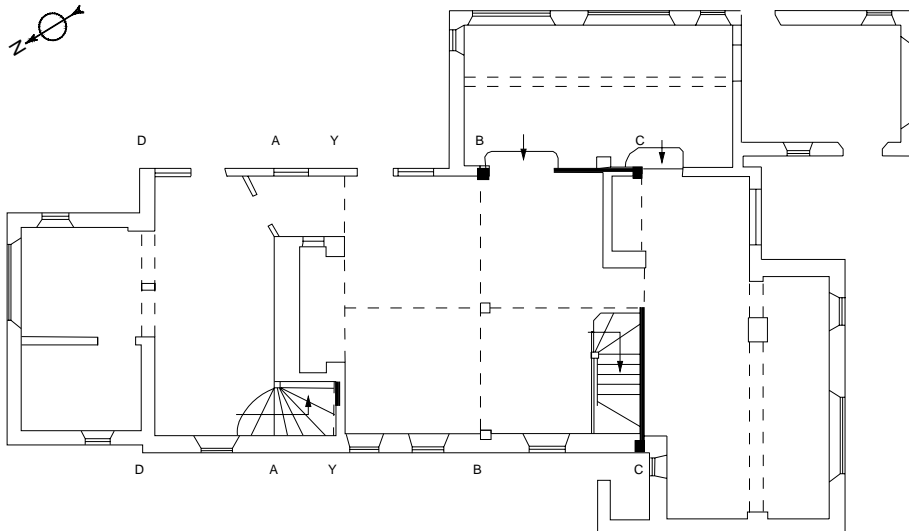
GROUND FLOOR PLAN

Based upon plans supplied by Nigel Braden, Architectural Designs and Consultancy.
